Wetland Delineation Report

University Project

Colliers Engineering & Design Project Number: 21004202A

May 31, 2024

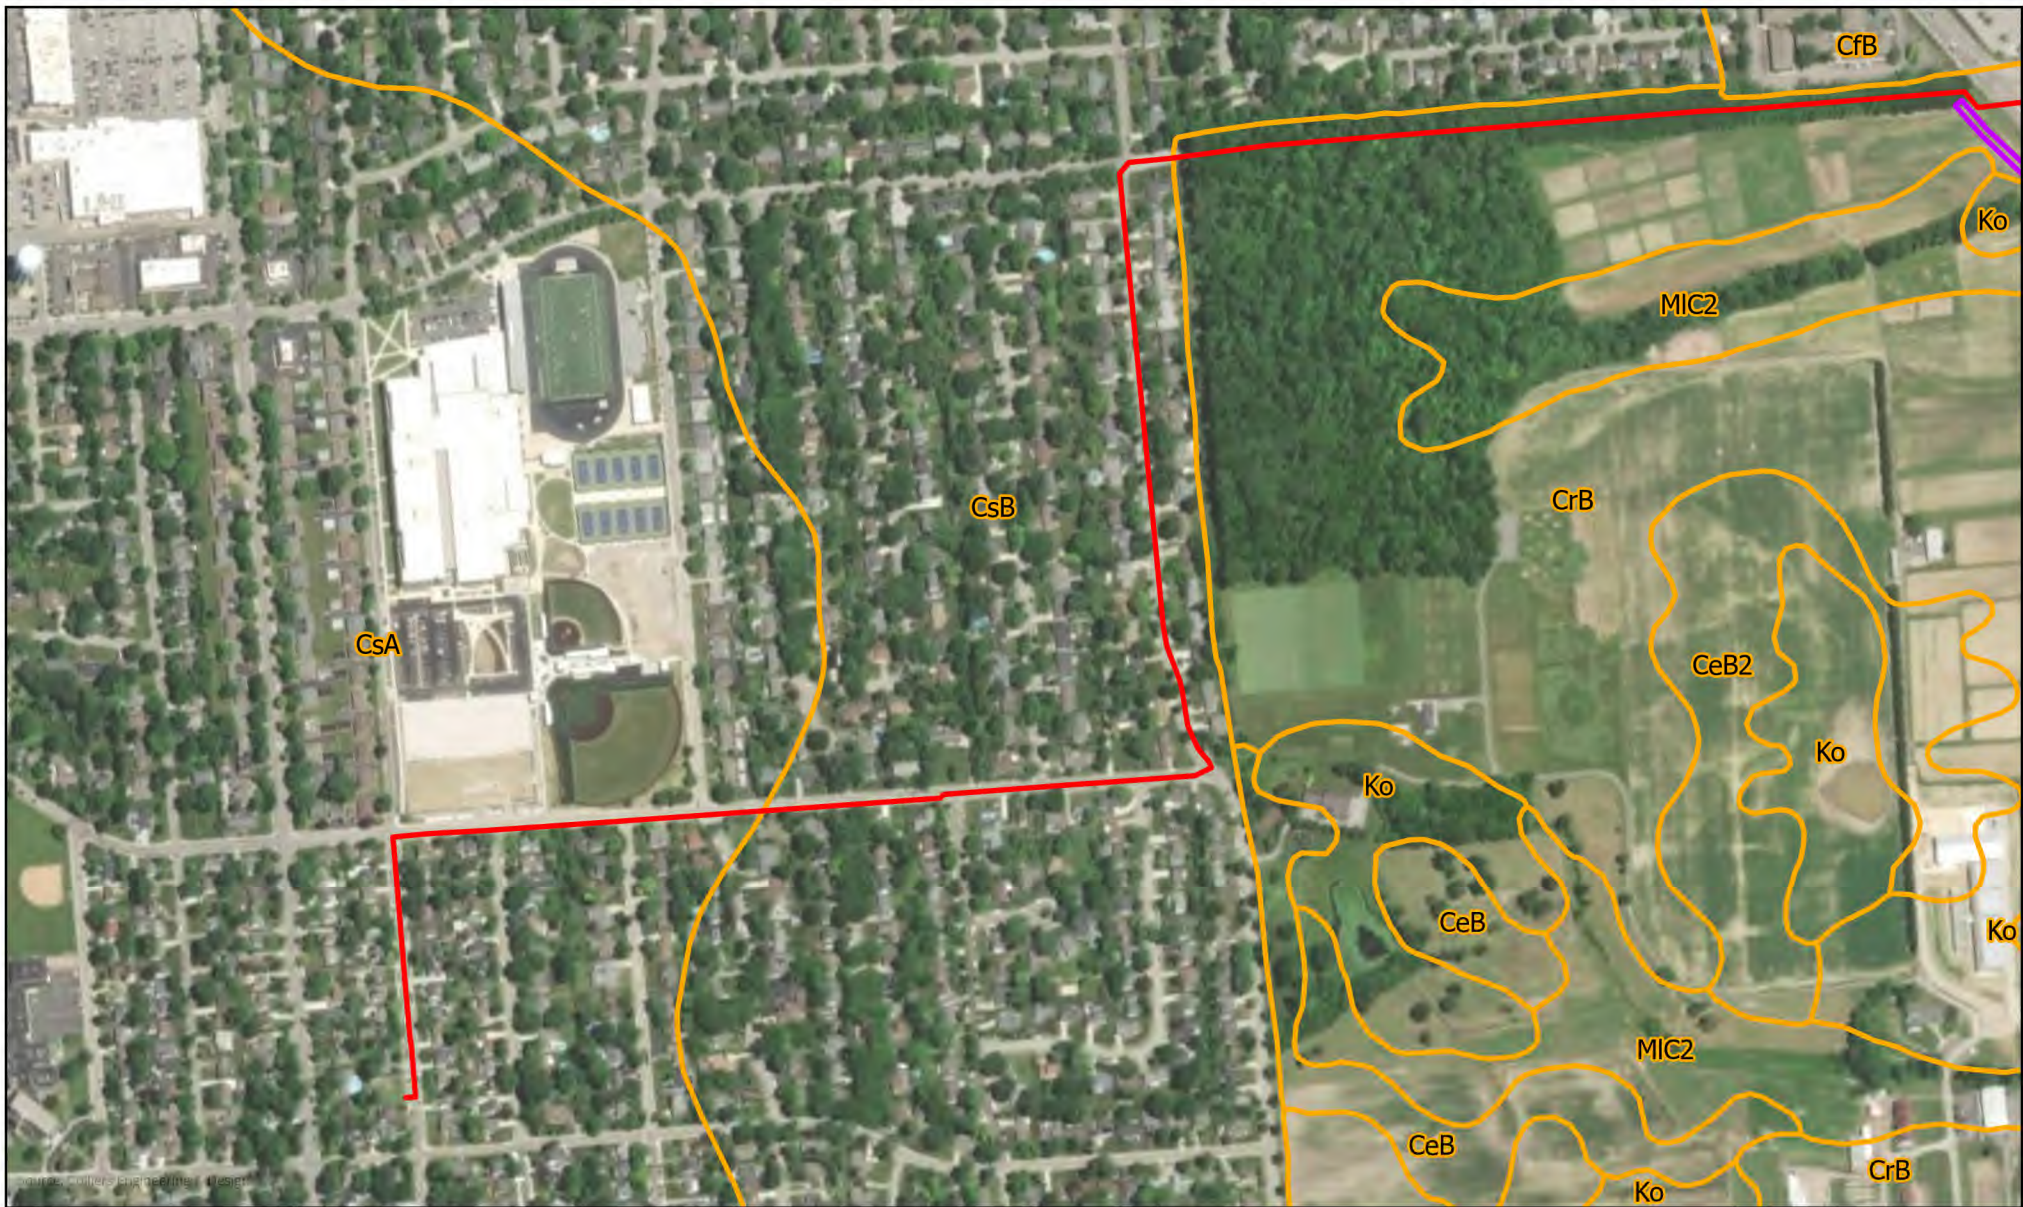
Figure 2 Page 1 of 2

- Alignment
- Workspaces
- Soil Units (SSURGO)

Soil Series Map

The NRCS Web Soil Survey depicts the following Table Soil Series map units within the Survey Corridor and provides a description of the properties and qualities of each soil:

Of the six (6) mapped soil units in the Survey Corridor, one (1) soil unit (Kokomo silty clay loam) is listed as being hydric.

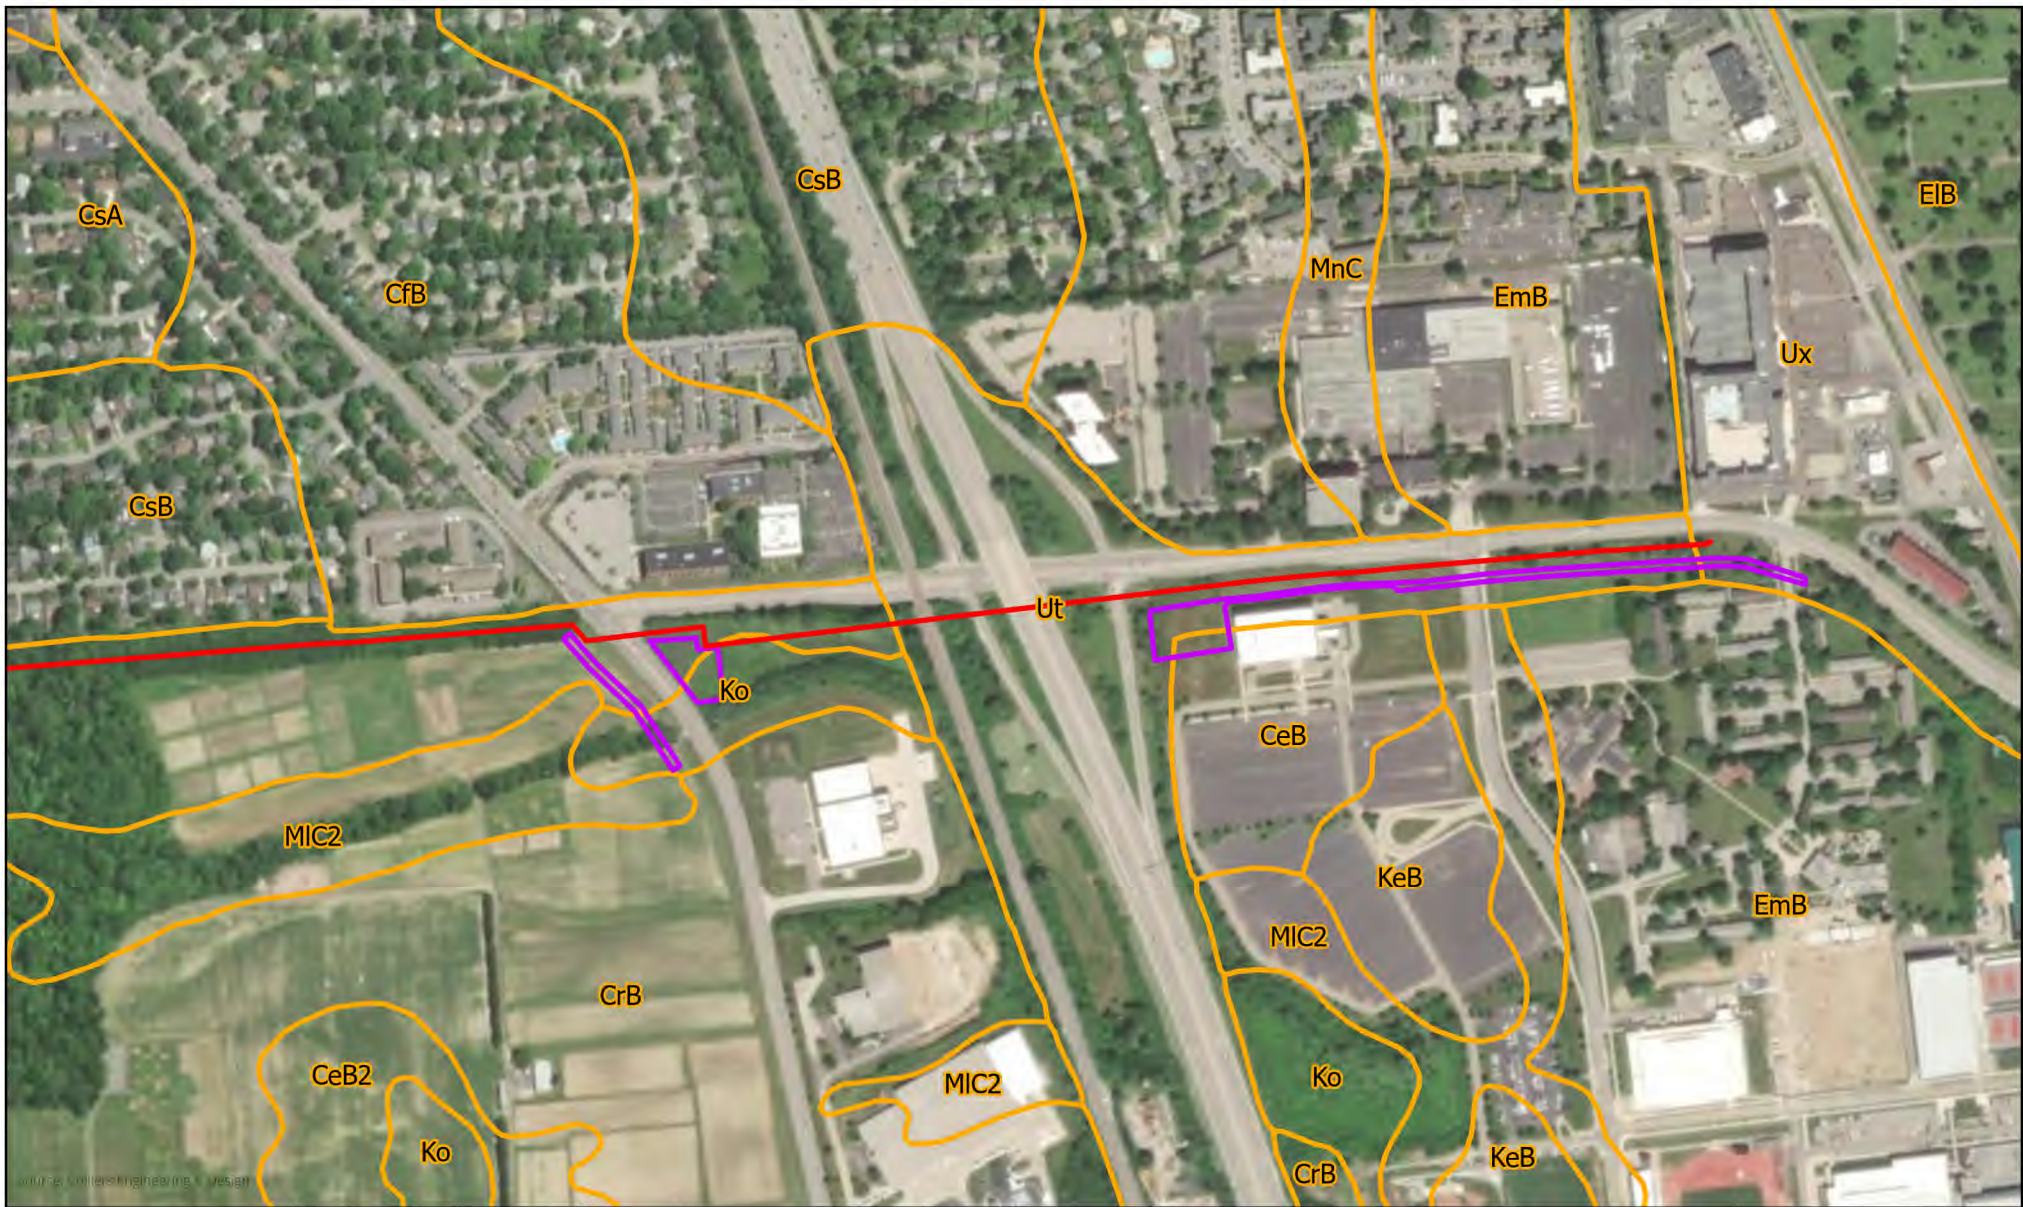
Figure 2 Page 2 of 2

- Alignment
- Workspaces
- Soil Units (SSURGO)

Soil Series Map

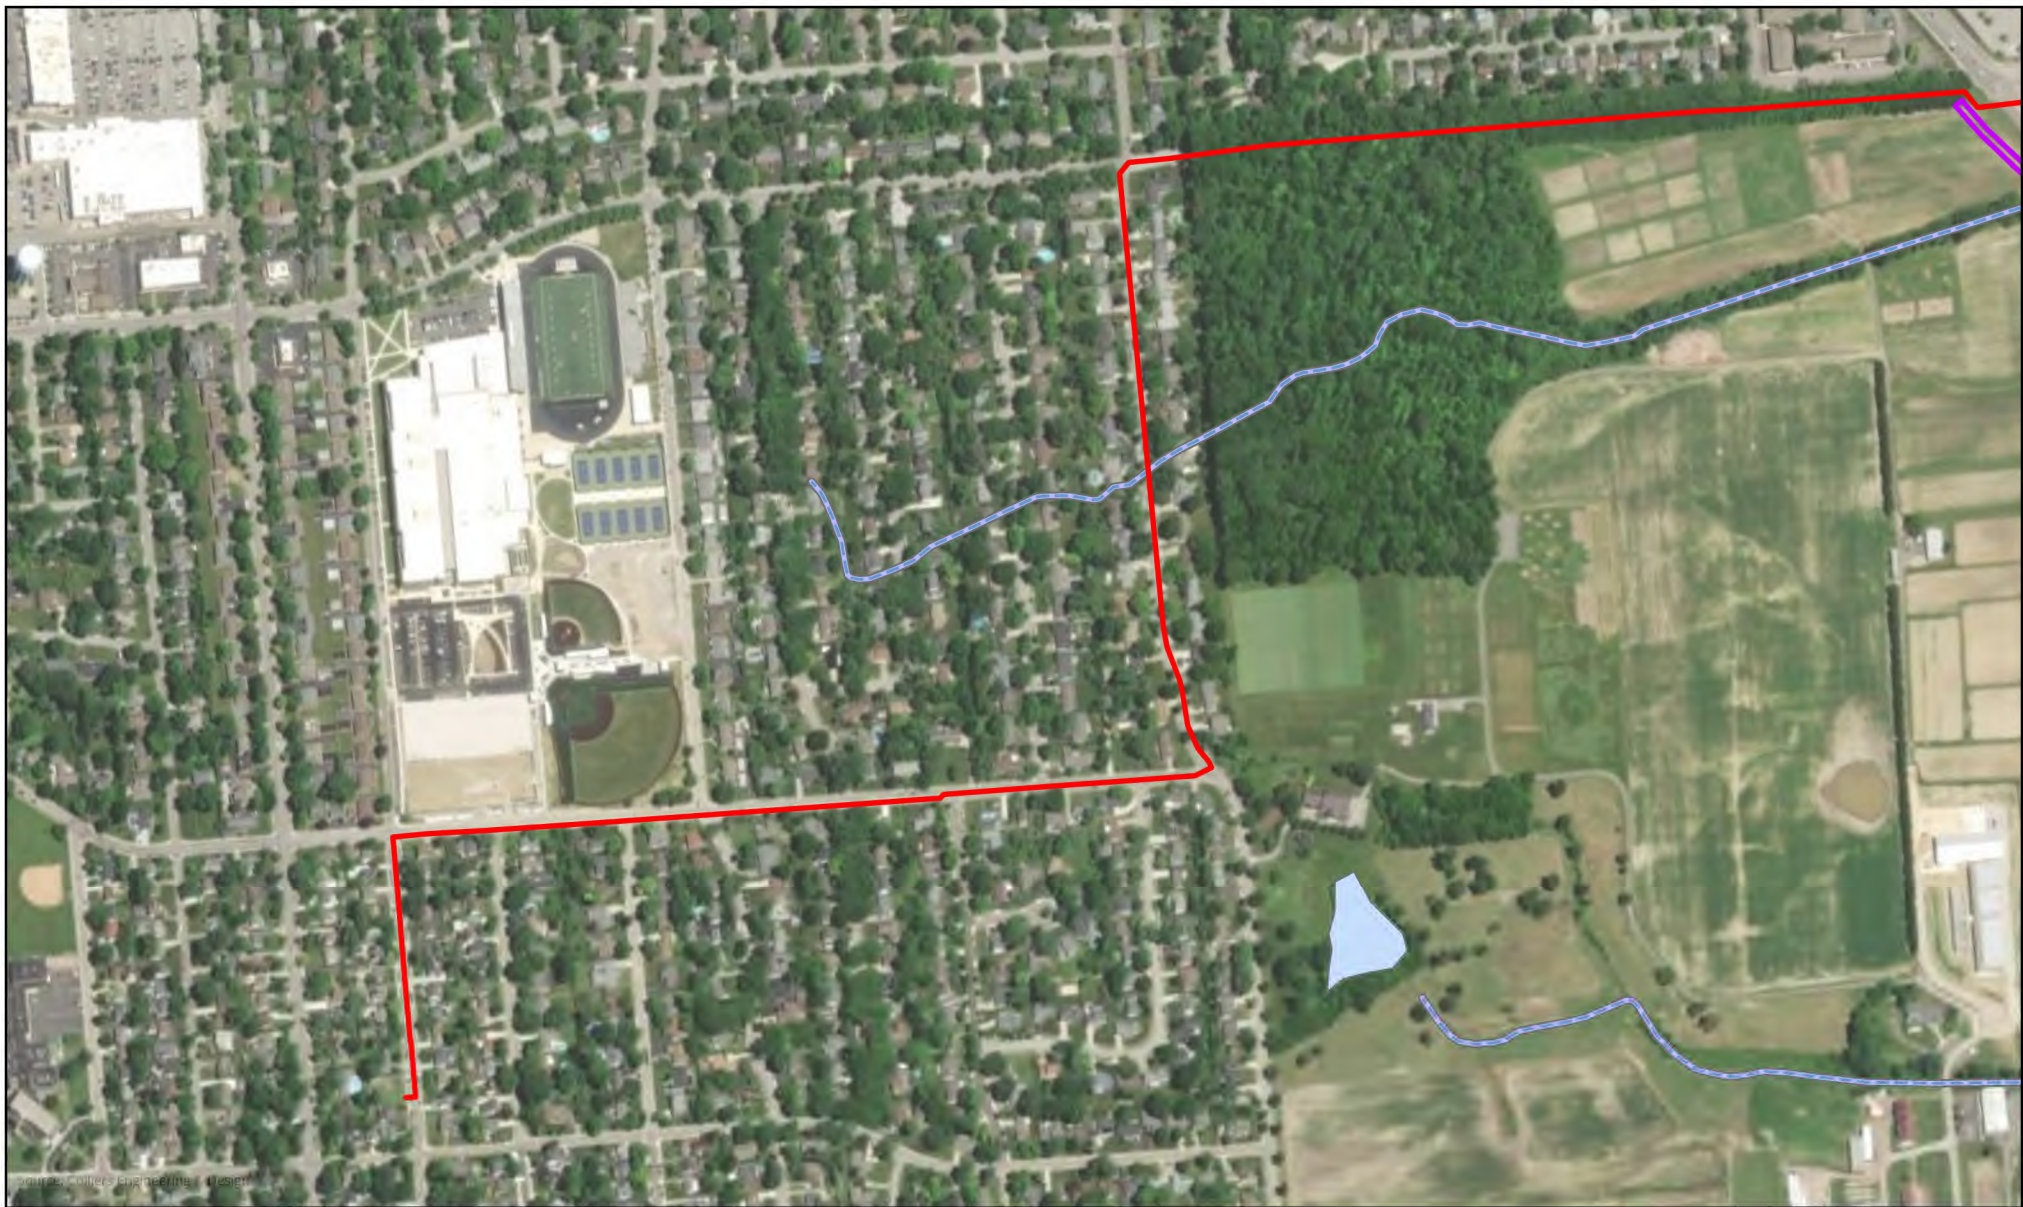
Figure 3 - Page 1

- - - Flowline (NHD)
- Waterbody (NHD)
- National Wetlands Inventory**
- Freshwater Emergent Wetland
- Freshwater Forested/Shrub Wetland
- Freshwater Pond
- Riverine

NWI Series Map

Prior to on-site field investigations, several publicly available sources of information were reviewed to determine the likelihood of wetlands and surface waters occurring within Survey Corridor. These mapping resources generally include, but are not limited to, the United States Geological Survey (USGS) maps (Figure 1. Project Location Map, **Appendix A**), the U.S. Department of Agriculture - Natural Resource Conservation Service (NRCS) soils database (Figure 2. Soil Series Map, **Appendix A**), National Hydrography Dataset (NHD), and the U.S. Fish & Wildlife Service National Wetlands Inventory (NWI) database (Figure 3. National Wetlands Inventory Map, **Appendix A**).

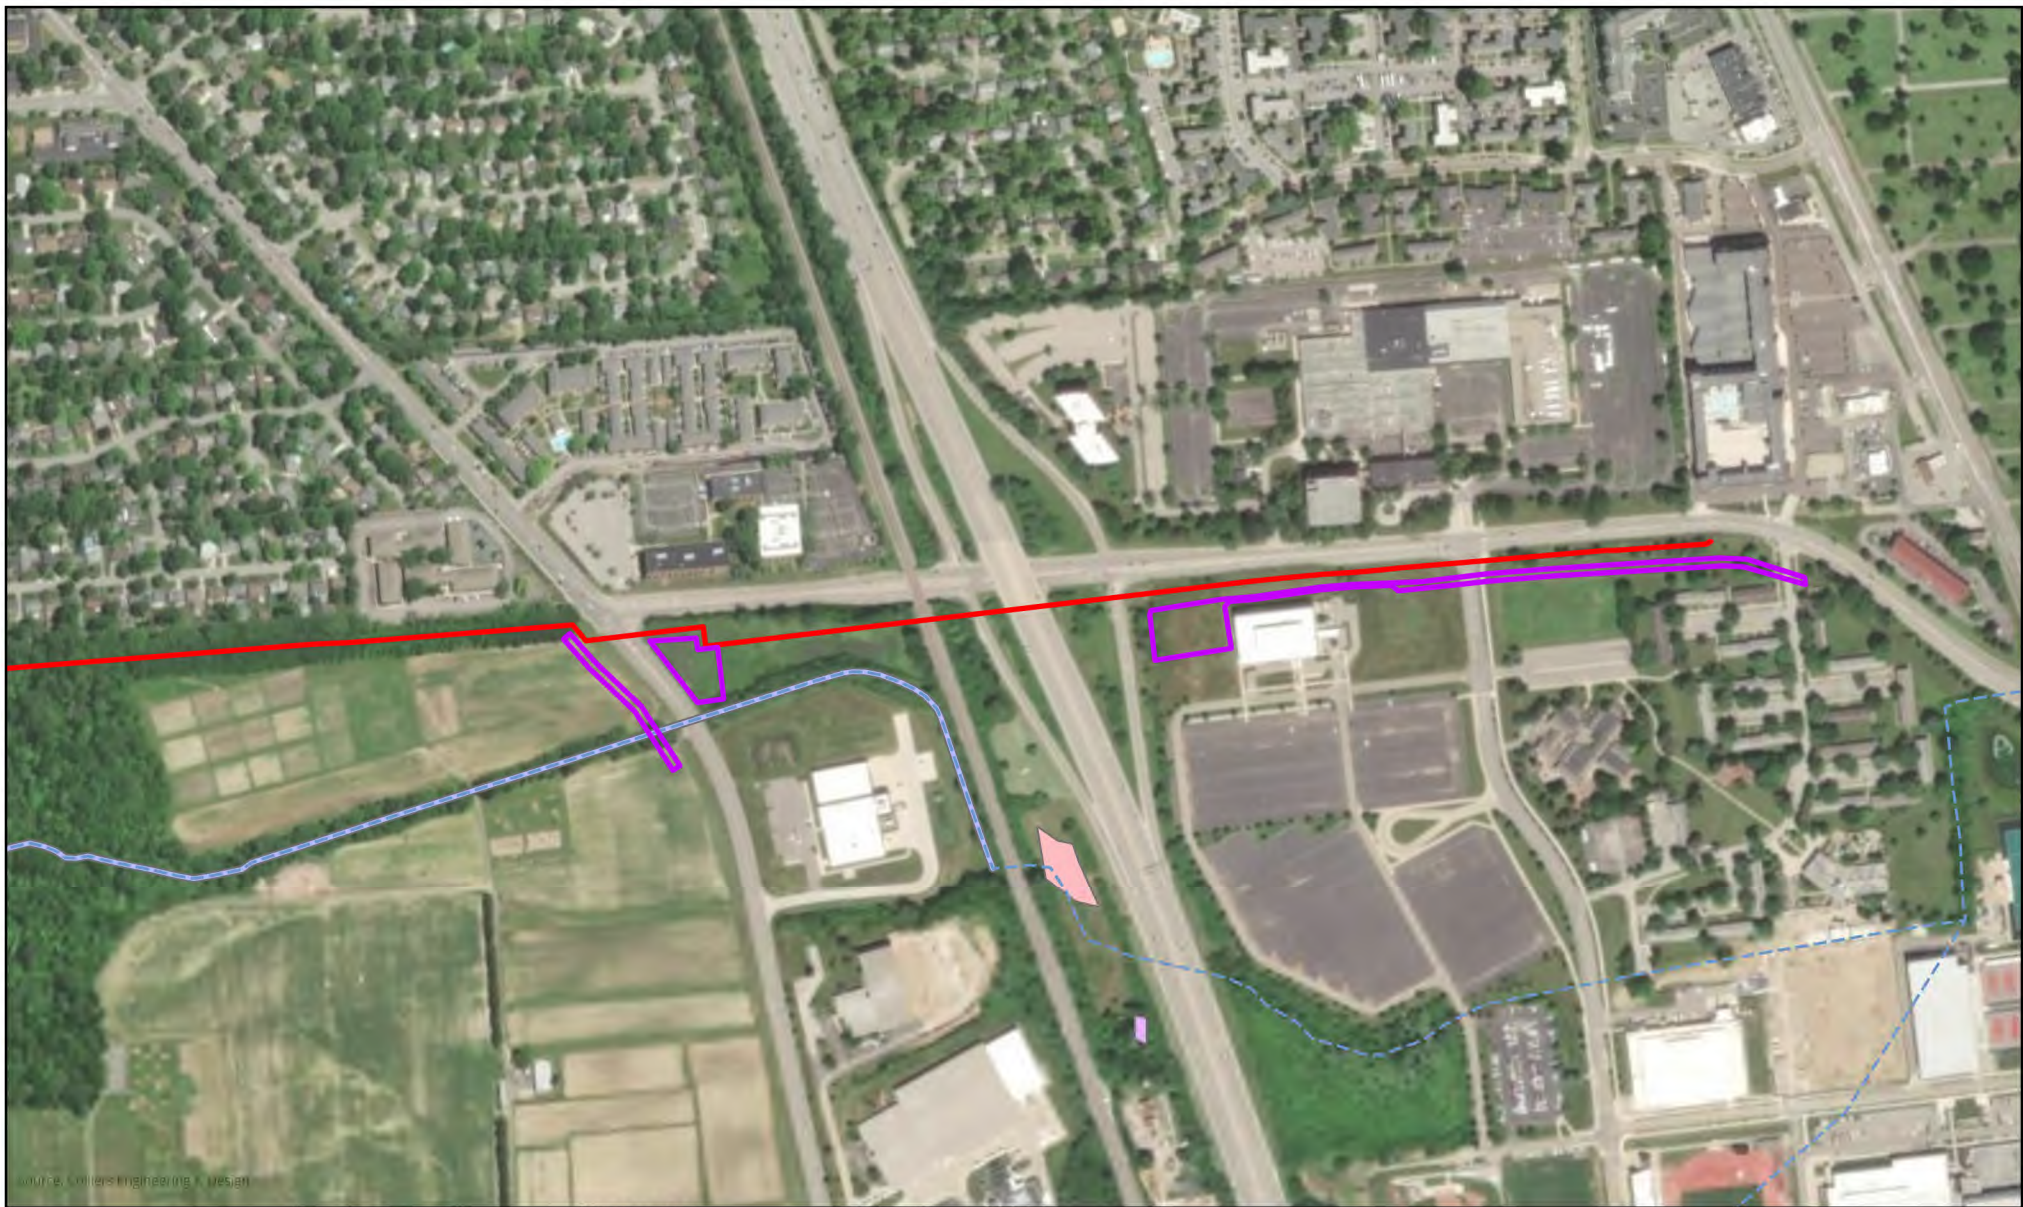
Figure 3 - Page 2

- - - Flowline (NHD)
- Waterbody (NHD)
- National Wetlands Inventory**
 - Freshwater Emergent Wetland
 - Freshwater Forested/Shrub Wetland
 - Freshwater Pond
 - Riverine

NWI Series Map

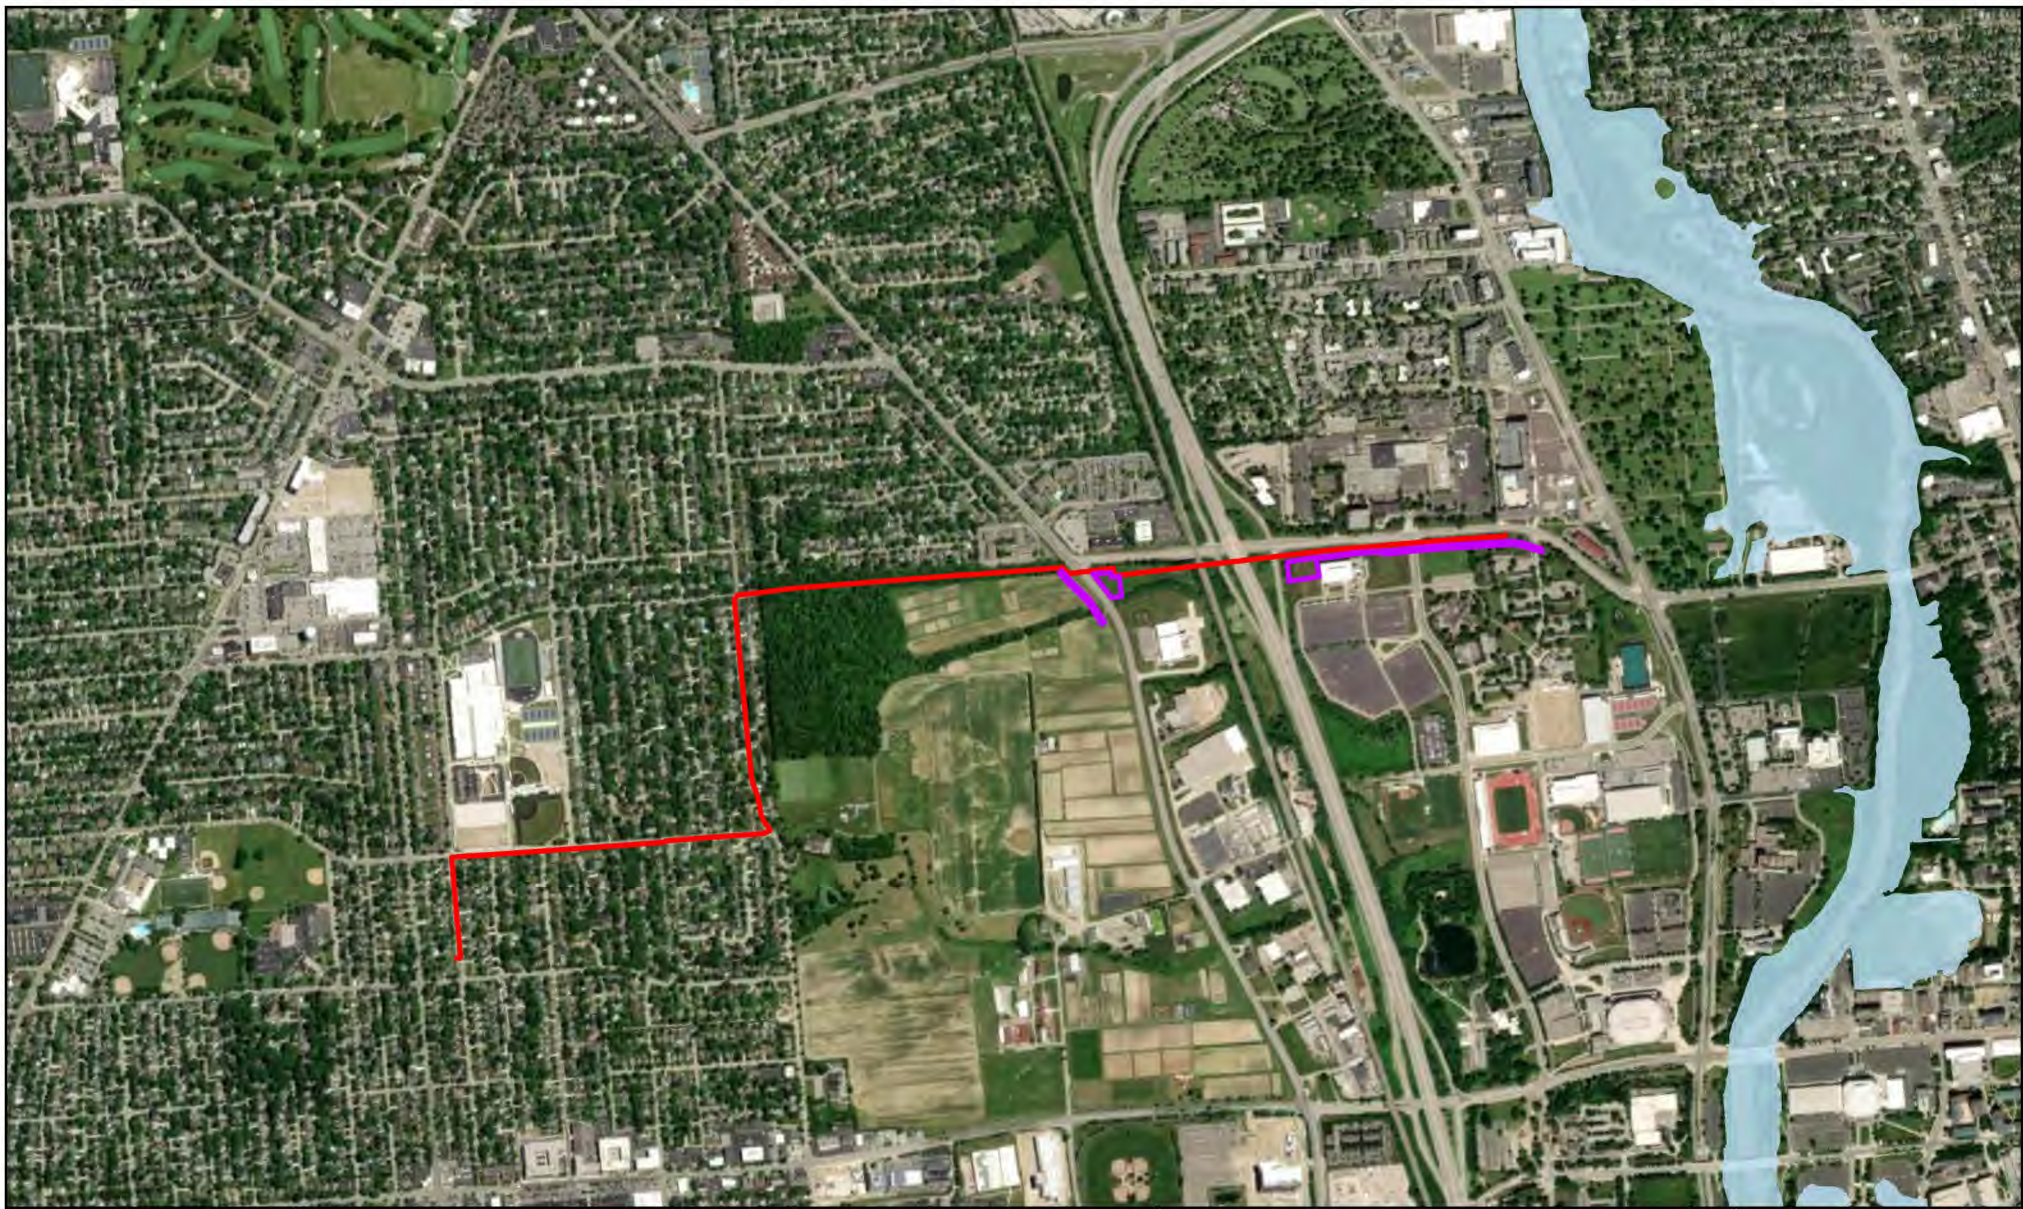
Figure 4

- Alignment
- Workspaces
- 100-year floodplain

Floodplain Series Map

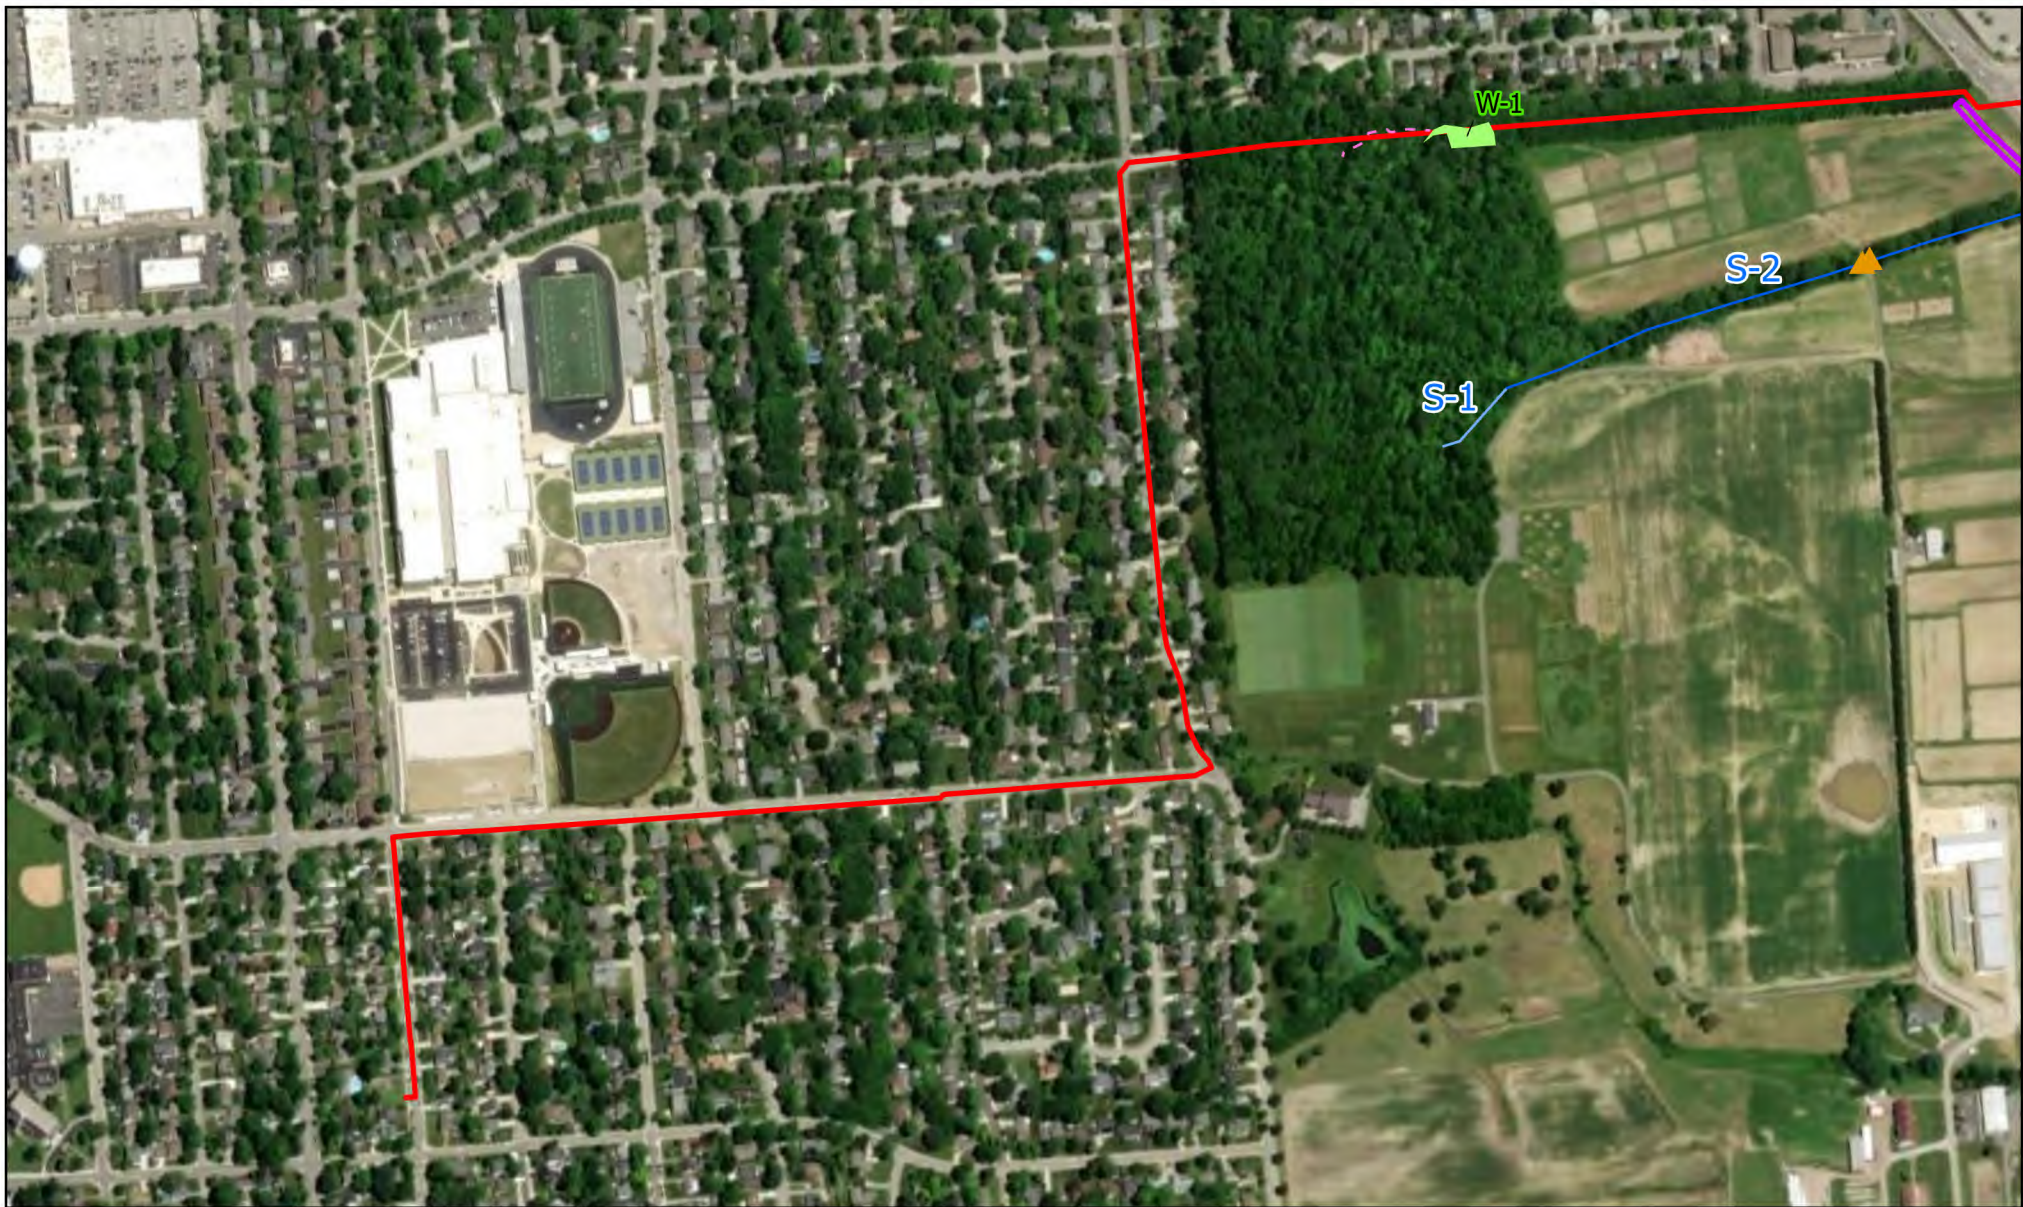
Figure 5 - Page 1

- ▲ Culvert
- - - Stormwater Erosions
- PEM Wetland (W-#)
- Intermittent Stream (S-#)
- Perennial Stream (S-#)

Delineation Results

Based on the field investigations, two (2) stream features and one (1) wetland feature were delineated within the Survey Corridor by CED on March 2nd & 3rd, 2022 and May 19th, 2023. A total of 2,552 linear feet of perennial (R3) stream, 562 linear feet of intermittent (R4) stream, and 0.23 acres of palustrine emergent (PEM) wetland were delineated. It is CED's professional opinion that Stream Features "1" and "2", and the proximal wetland, are considered jurisdictional WOTUS since they drain into the Olentangy River and Scioto River. These stream features can be considered jurisdictional WOTUS since they connect and/or are directly connected to the Olentangy River and Scioto River. The location and size of jurisdictional areas delineated are shown on Figure 5. Delineation Results (**Appendix A**).

On-site field investigations of the Survey Corridor were conducted by CED on March 2nd & 3rd, 2022 and May 19, 2023. The on-site delineation did verify the presence of surface waters within Survey Corridor. A summary of the aquatic resources identified within the Survey Corridor is provided below in Table 2: Aquatic Resource Summary. The location and size of the aquatic resources delineated are shown on Figure 5. Delineation Results (Appendix A).

It is CED's professional opinion that Stream Features "1" and "2" are considered jurisdictional WOTUS since they drain into the Olentangy River and the Scioto River. The wetland can be considered jurisdictional WOTUS since it drains directly to the unnamed tributary to the Olentangy River and the Scioto River. The location and size of jurisdictional areas delineated are shown on Figure 5. Delineation Results (**Appendix A**).

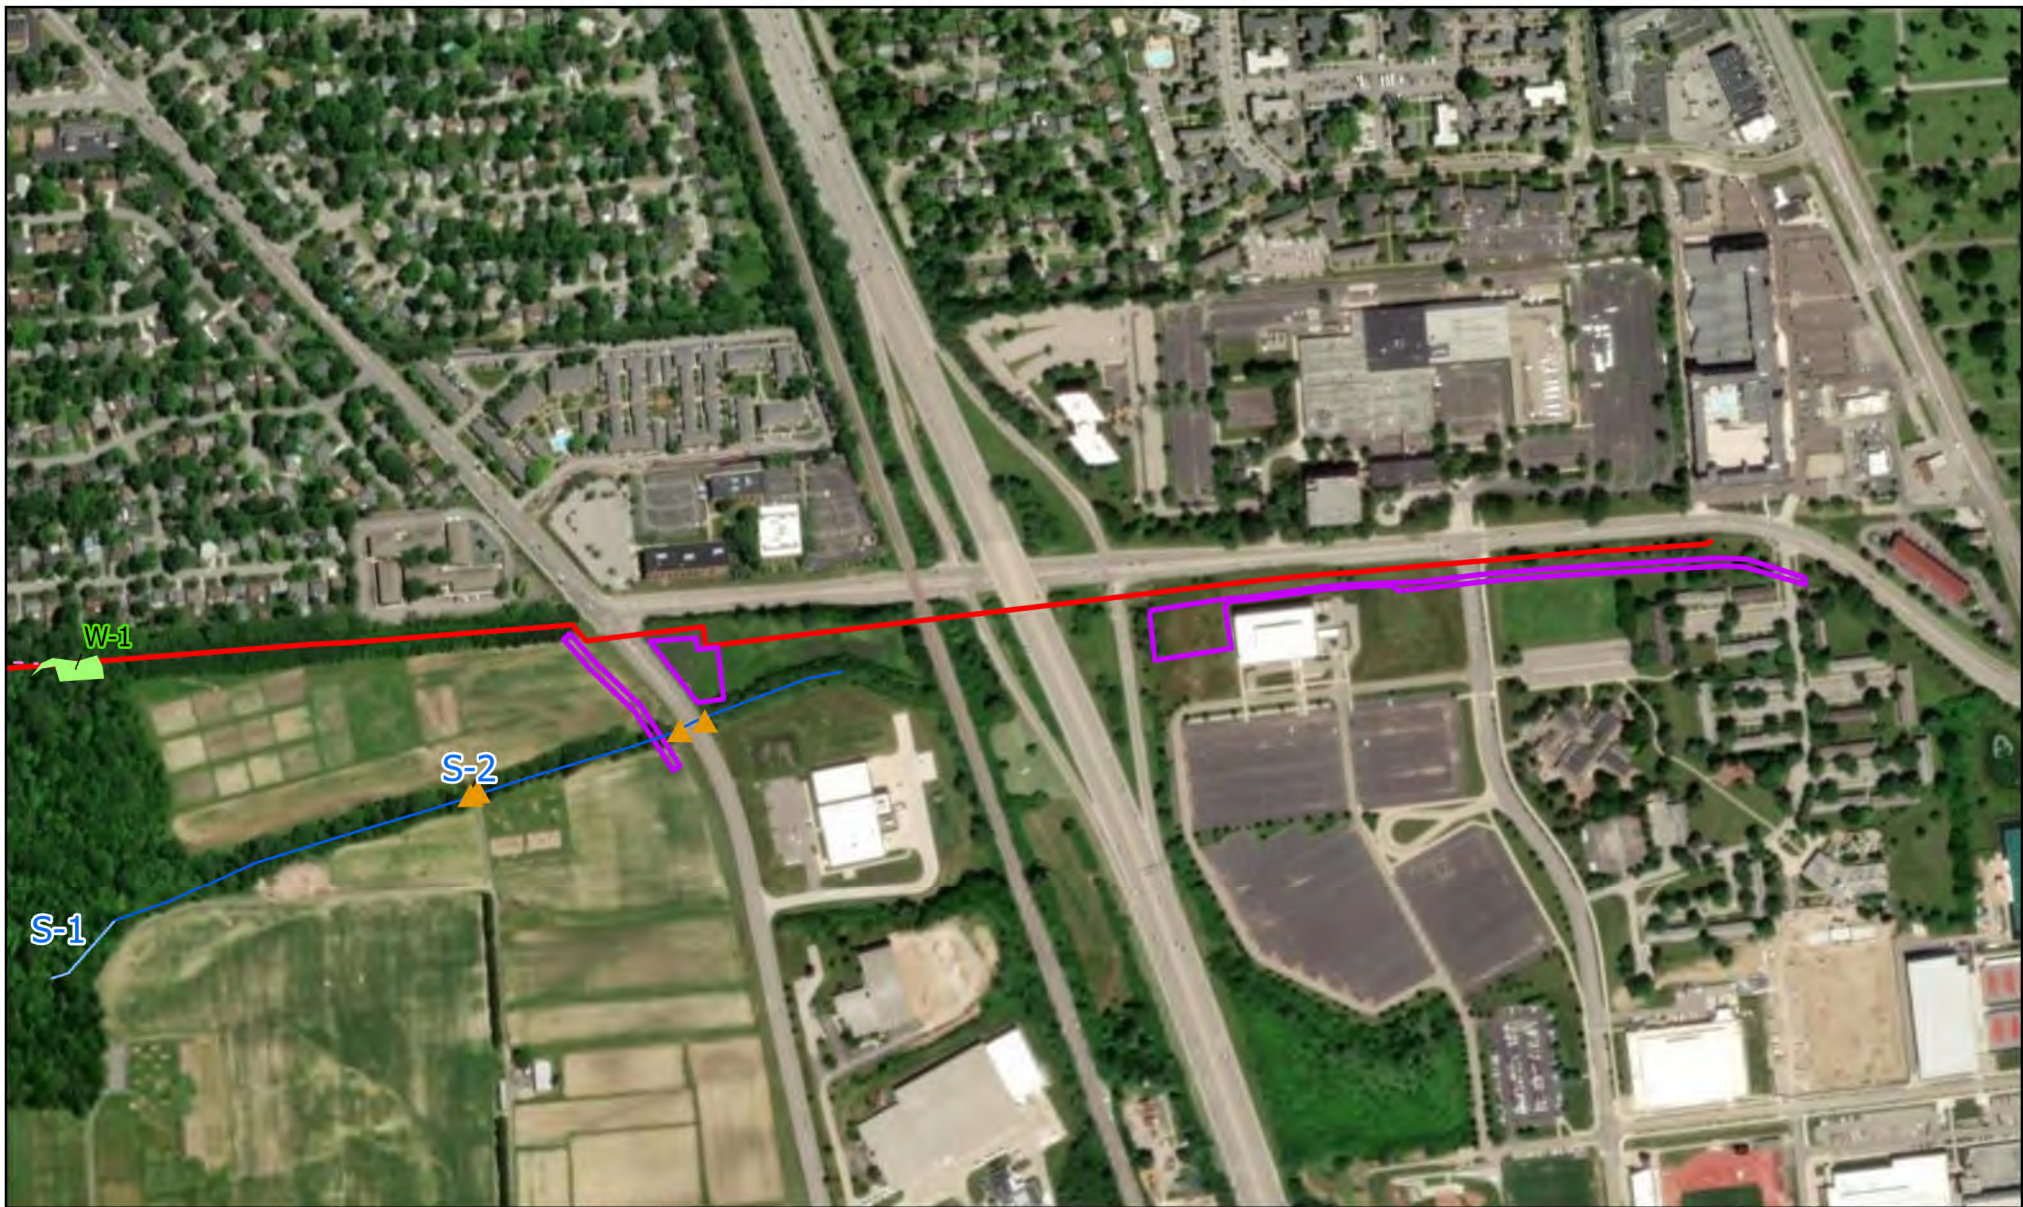
Figure 5 - Page 2

- ▲ Culvert
- Stormwater Erosions
- PEM Wetland (W-#)
- Intermittent Stream (S-#)
- Perennial Stream (S-#)

Delineation Results

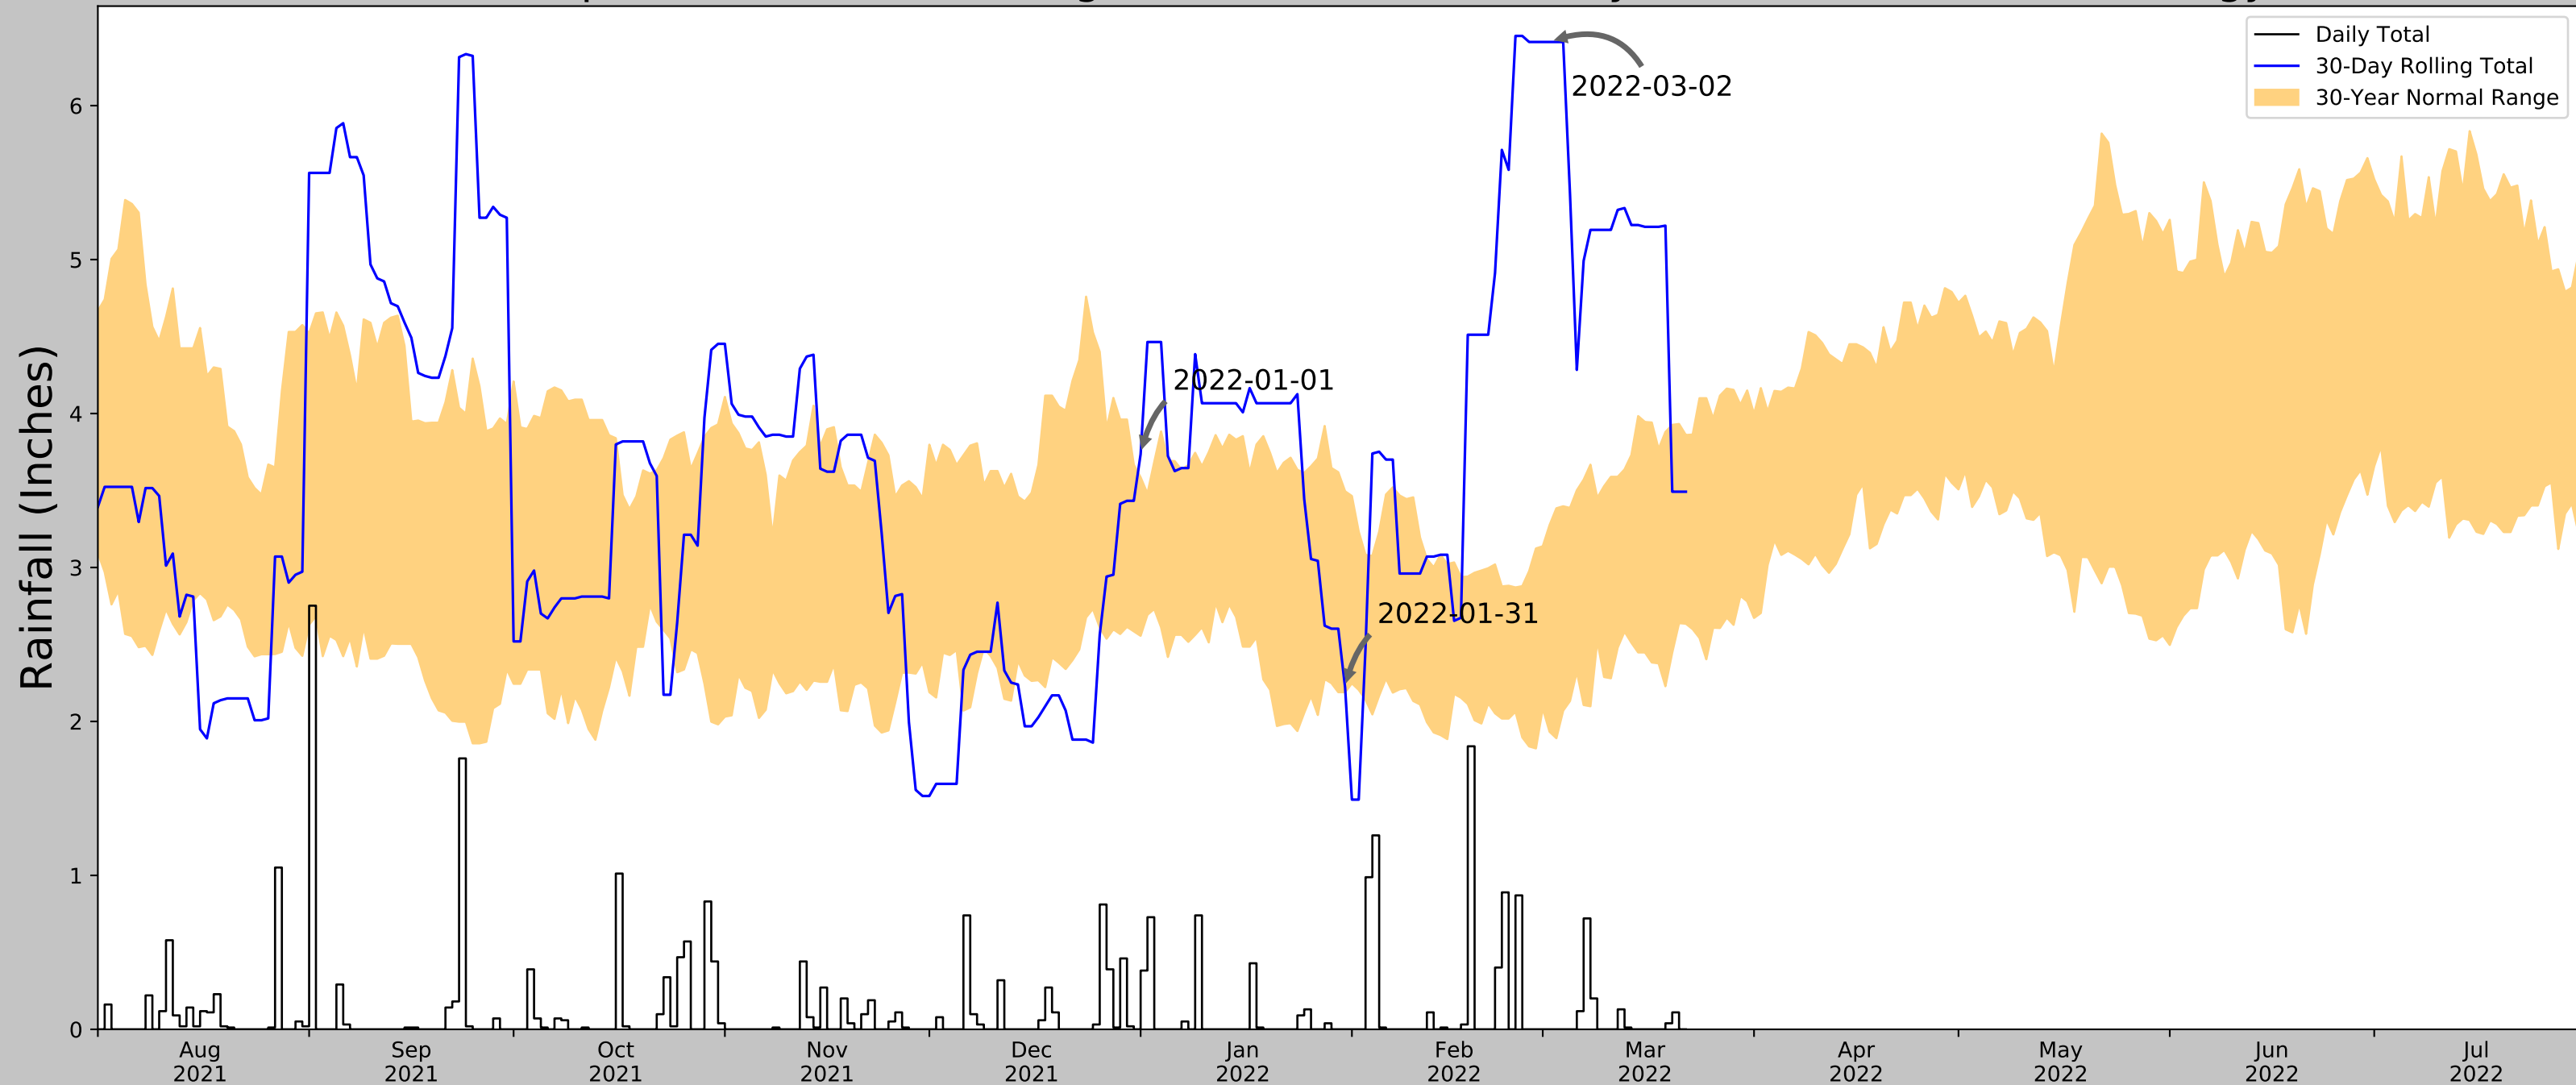
Antecedent Precipitation vs Normal Range based on NOAA's Daily Global Historical Climatology Network

Coordinates	40.011997, -82.572119
Observation Date	2022-03-02
Elevation (ft)	1094.88
Drought Index (PDSI)	Severe wetness (2022-02)
WebWIMP H ₂ O Balance	Wet Season

30 Days Ending	30 th %ile (in)	70 th %ile (in)	Observed (in)	Wetness Condition	Condition Value	Month Weight	Product
2022-03-02	1.933071	3.275197	6.413386	Wet	3	3	9
2022-01-31	2.189764	3.494882	2.220473	Normal	2	2	4
2022-01-01	2.555906	3.585433	3.736221	Wet	3	1	3
Result							Wetter than Normal - 16

On-site field investigations of the Survey Corridor were conducted by CED on March 2nd & 3rd, 2022 and May 19, 2023. The USACE Antecedent Precipitation Tool (APT) was utilized for the Survey Corridor and is provided in **Appendix C**. Based the USACE APT tool, the on-site field investigations were conducted in “Wetter than Normal” precipitation conditions with a 30-day rolling total during the March 2nd & 3rd, 2022 investigations. The on-site field investigations were conducted in “Drier than Normal” precipitation conditions for the May 19th, 2023 investigation.
