Wetland Delineation Report

University Project

Colliers Engineering & Design Project Number: 21004202A

May 31, 2024

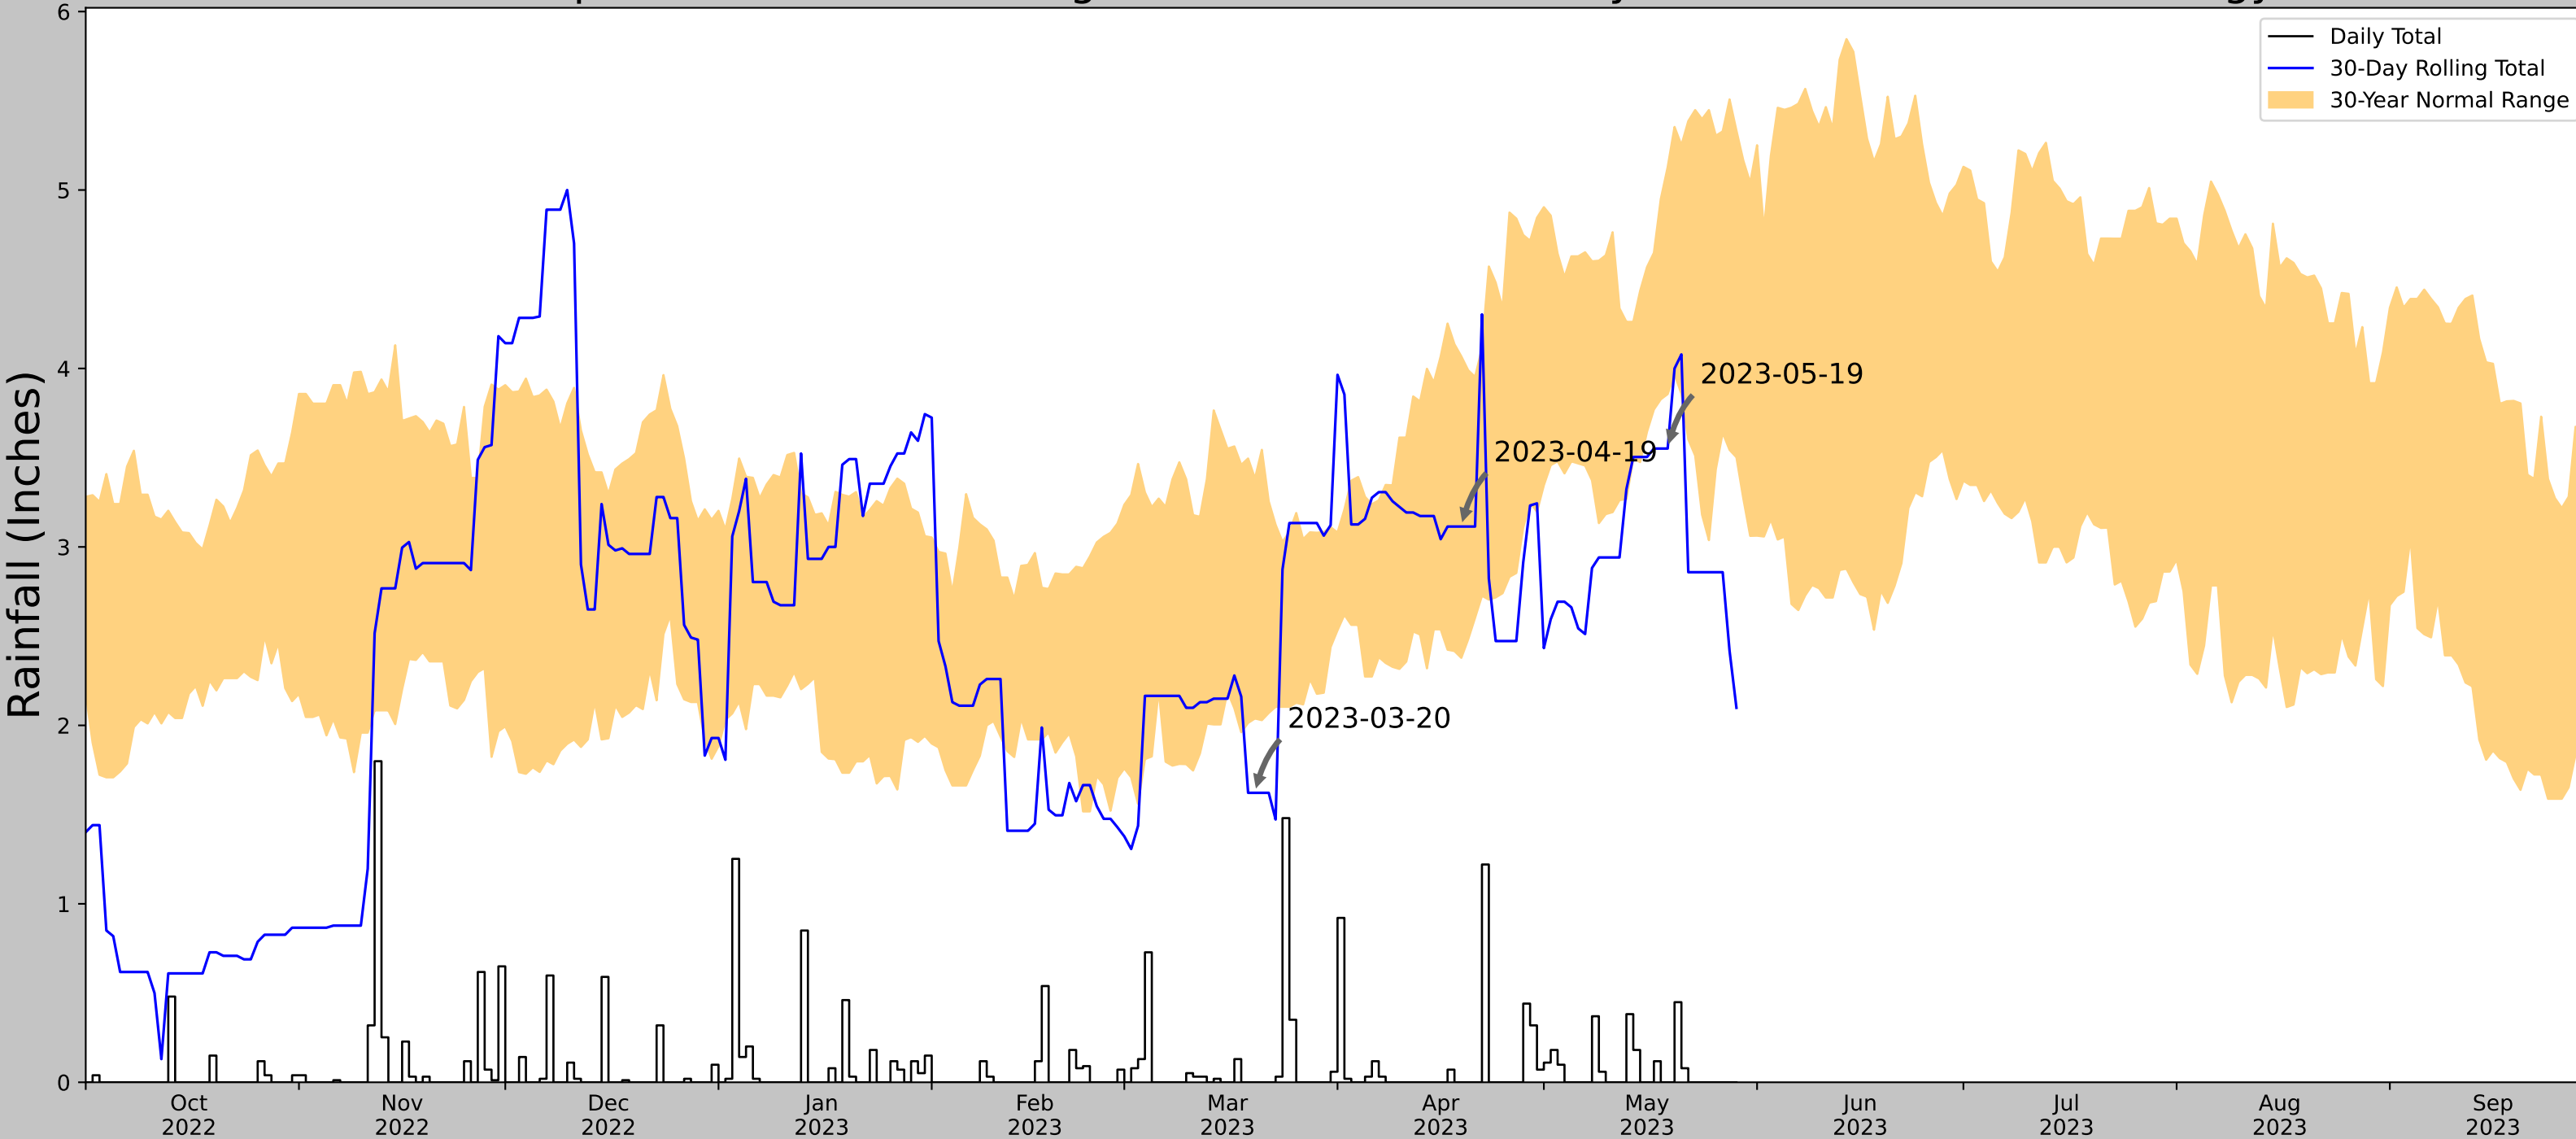
Antecedent Precipitation vs Normal Range based on NOAA's Daily Global Historical Climatology Network

Coordinates	40.021777, -82.950994
Observation Date	2023-05-19
Elevation (ft)	834.369
Drought Index (PDSI)	Mild wetness (2023-04)
WebWIMP H ₂ O Balance	Wet Season

30 Days Ending	30 th %ile (in)	70 th %ile (in)	Observed (in)	Wetness Condition	Condition Value	Month Weight	Product
2023-05-19	3.856299	5.127953	3.551181	Dry	1	3	3
2023-04-19	2.378347	4.067717	3.114173	Normal	2	2	4
2023-03-20	2.038583	3.383858	1.622047	Dry	1	1	1
Result							Drier than Normal - 8

On-site field investigations of the Survey Corridor were conducted by CED on March 2nd & 3rd, 2022 and May 19, 2023. The USACE Antecedent Precipitation Tool (APT) was utilized for the Survey Corridor and is provided in **Appendix C**. Based the USACE APT tool, the on-site field investigations were conducted in “Wetter than Normal” precipitation conditions with a 30-day rolling total during the March 2nd & 3rd, 2022 investigations. The on-site field investigations were conducted in “Drier than Normal” precipitation conditions for the May 19th, 2023 investigation.
