**RE: Columbia Gas of Ohio, Inc.**  
**Letter of Notification: Marysville Connector Pipeline Project**  
**OPSB Case No. 19-2148-GA-BLN**

Columbia Gas of Ohio, Inc. ("Columbia") submits this Letter of Notification, pursuant to R.C. 4906.03(F)(3) and Ohio Admin. Code Chapter 4906-6, concerning a proposed pipeline project known as the Marysville Connector Pipeline Project (the "Project").

This document entitled Marysville Connector Pipeline Project Wetland and Waterbody Delineation Report was prepared by Stantec Consulting Services Inc. ("Stantec") for the account of Columbia Gas of Ohio/NiSource ( (the "Client"). Any reliance on this document by any third party is strictly prohibited. The material in it reflects Stantec's professional judgment in light of the scope, schedule and other limitations stated in the document and in the contract between Stantec and the Client. The opinions in the document are based on conditions and information existing at the time the document was published and do not take into account any subsequent changes. In preparing the document, Stantec did not verify information supplied to it by others. Any use which a third party makes of this document is the

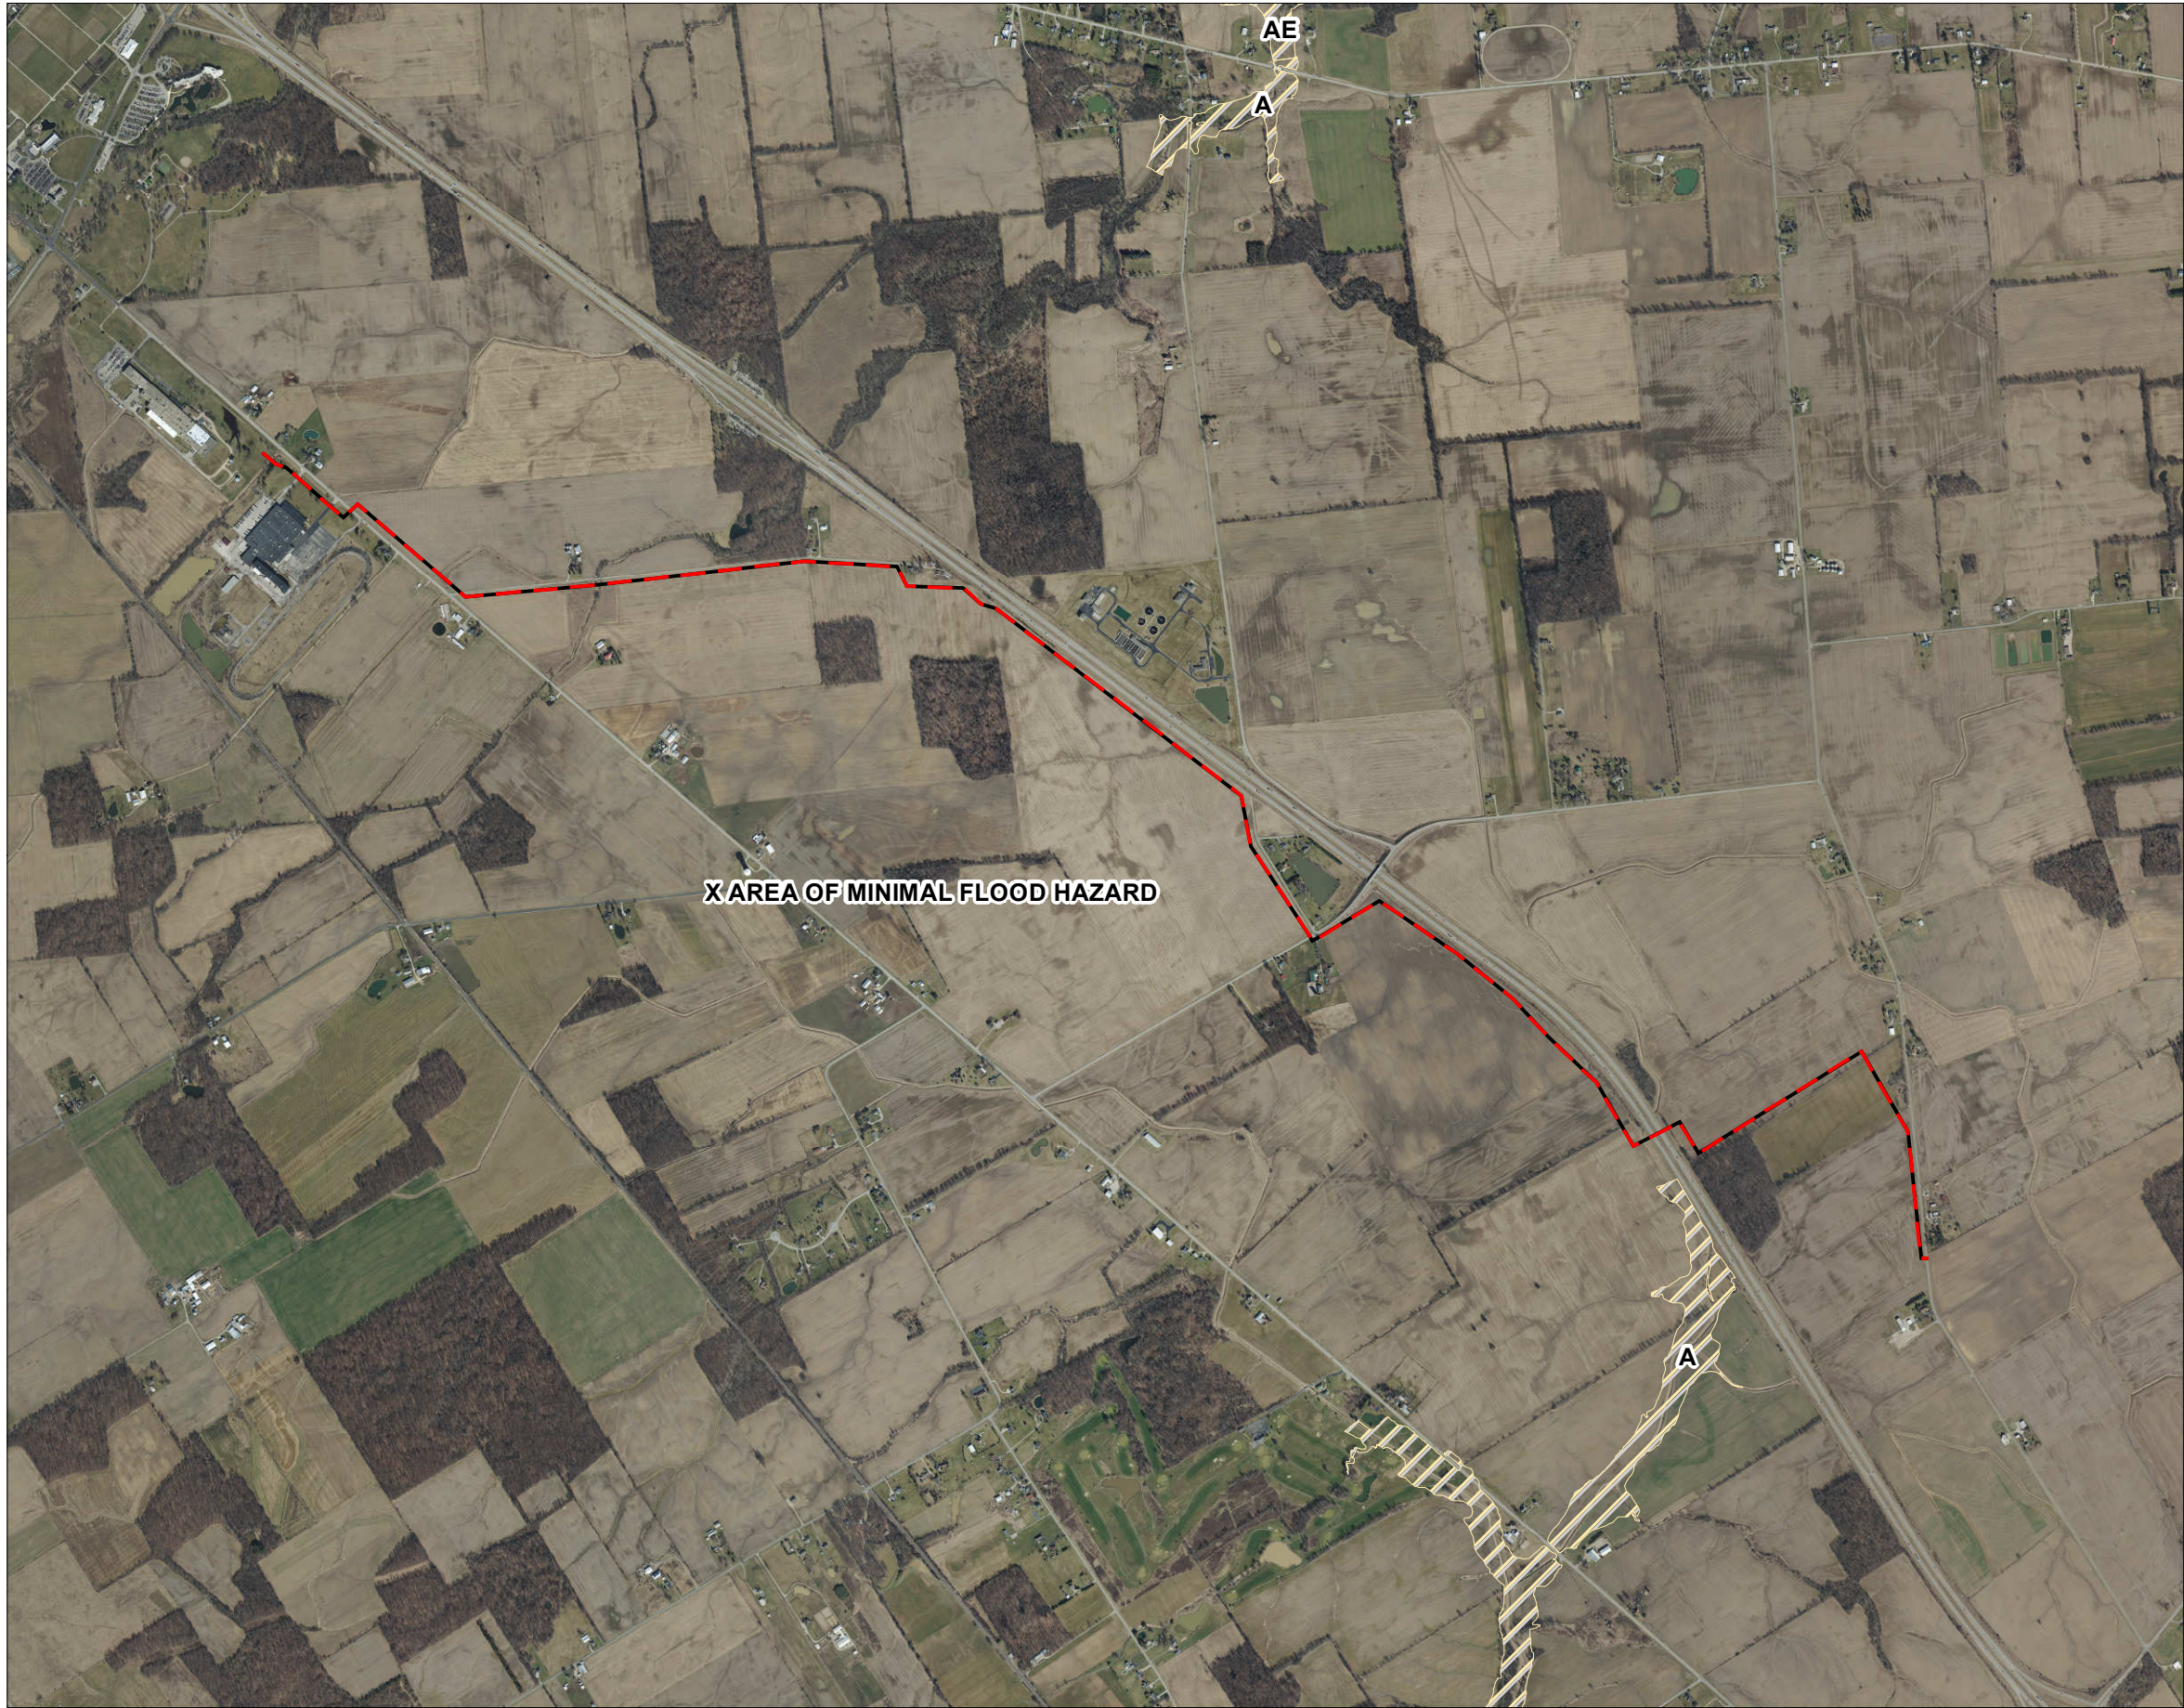
Figure No.  
**3**  
Title  
**FEMA National Flood Hazard Areas**

The Federal Emergency Management Agency (“FEMA”) Flood Insurance Rate Maps (“FIRM”) were reviewed to identify any flood hazard areas that have been mapped for the proposed pipeline route. Specifically, map numbers 39159C0358D, 39159C0359D, 39159C0367D, and 39159C0390D mapped the area of the proposed Project. The proposed pipeline route does not impact any mapped floodplain areas. A copy of the FEMA map with coverage of the Project area is included in Appendix A.

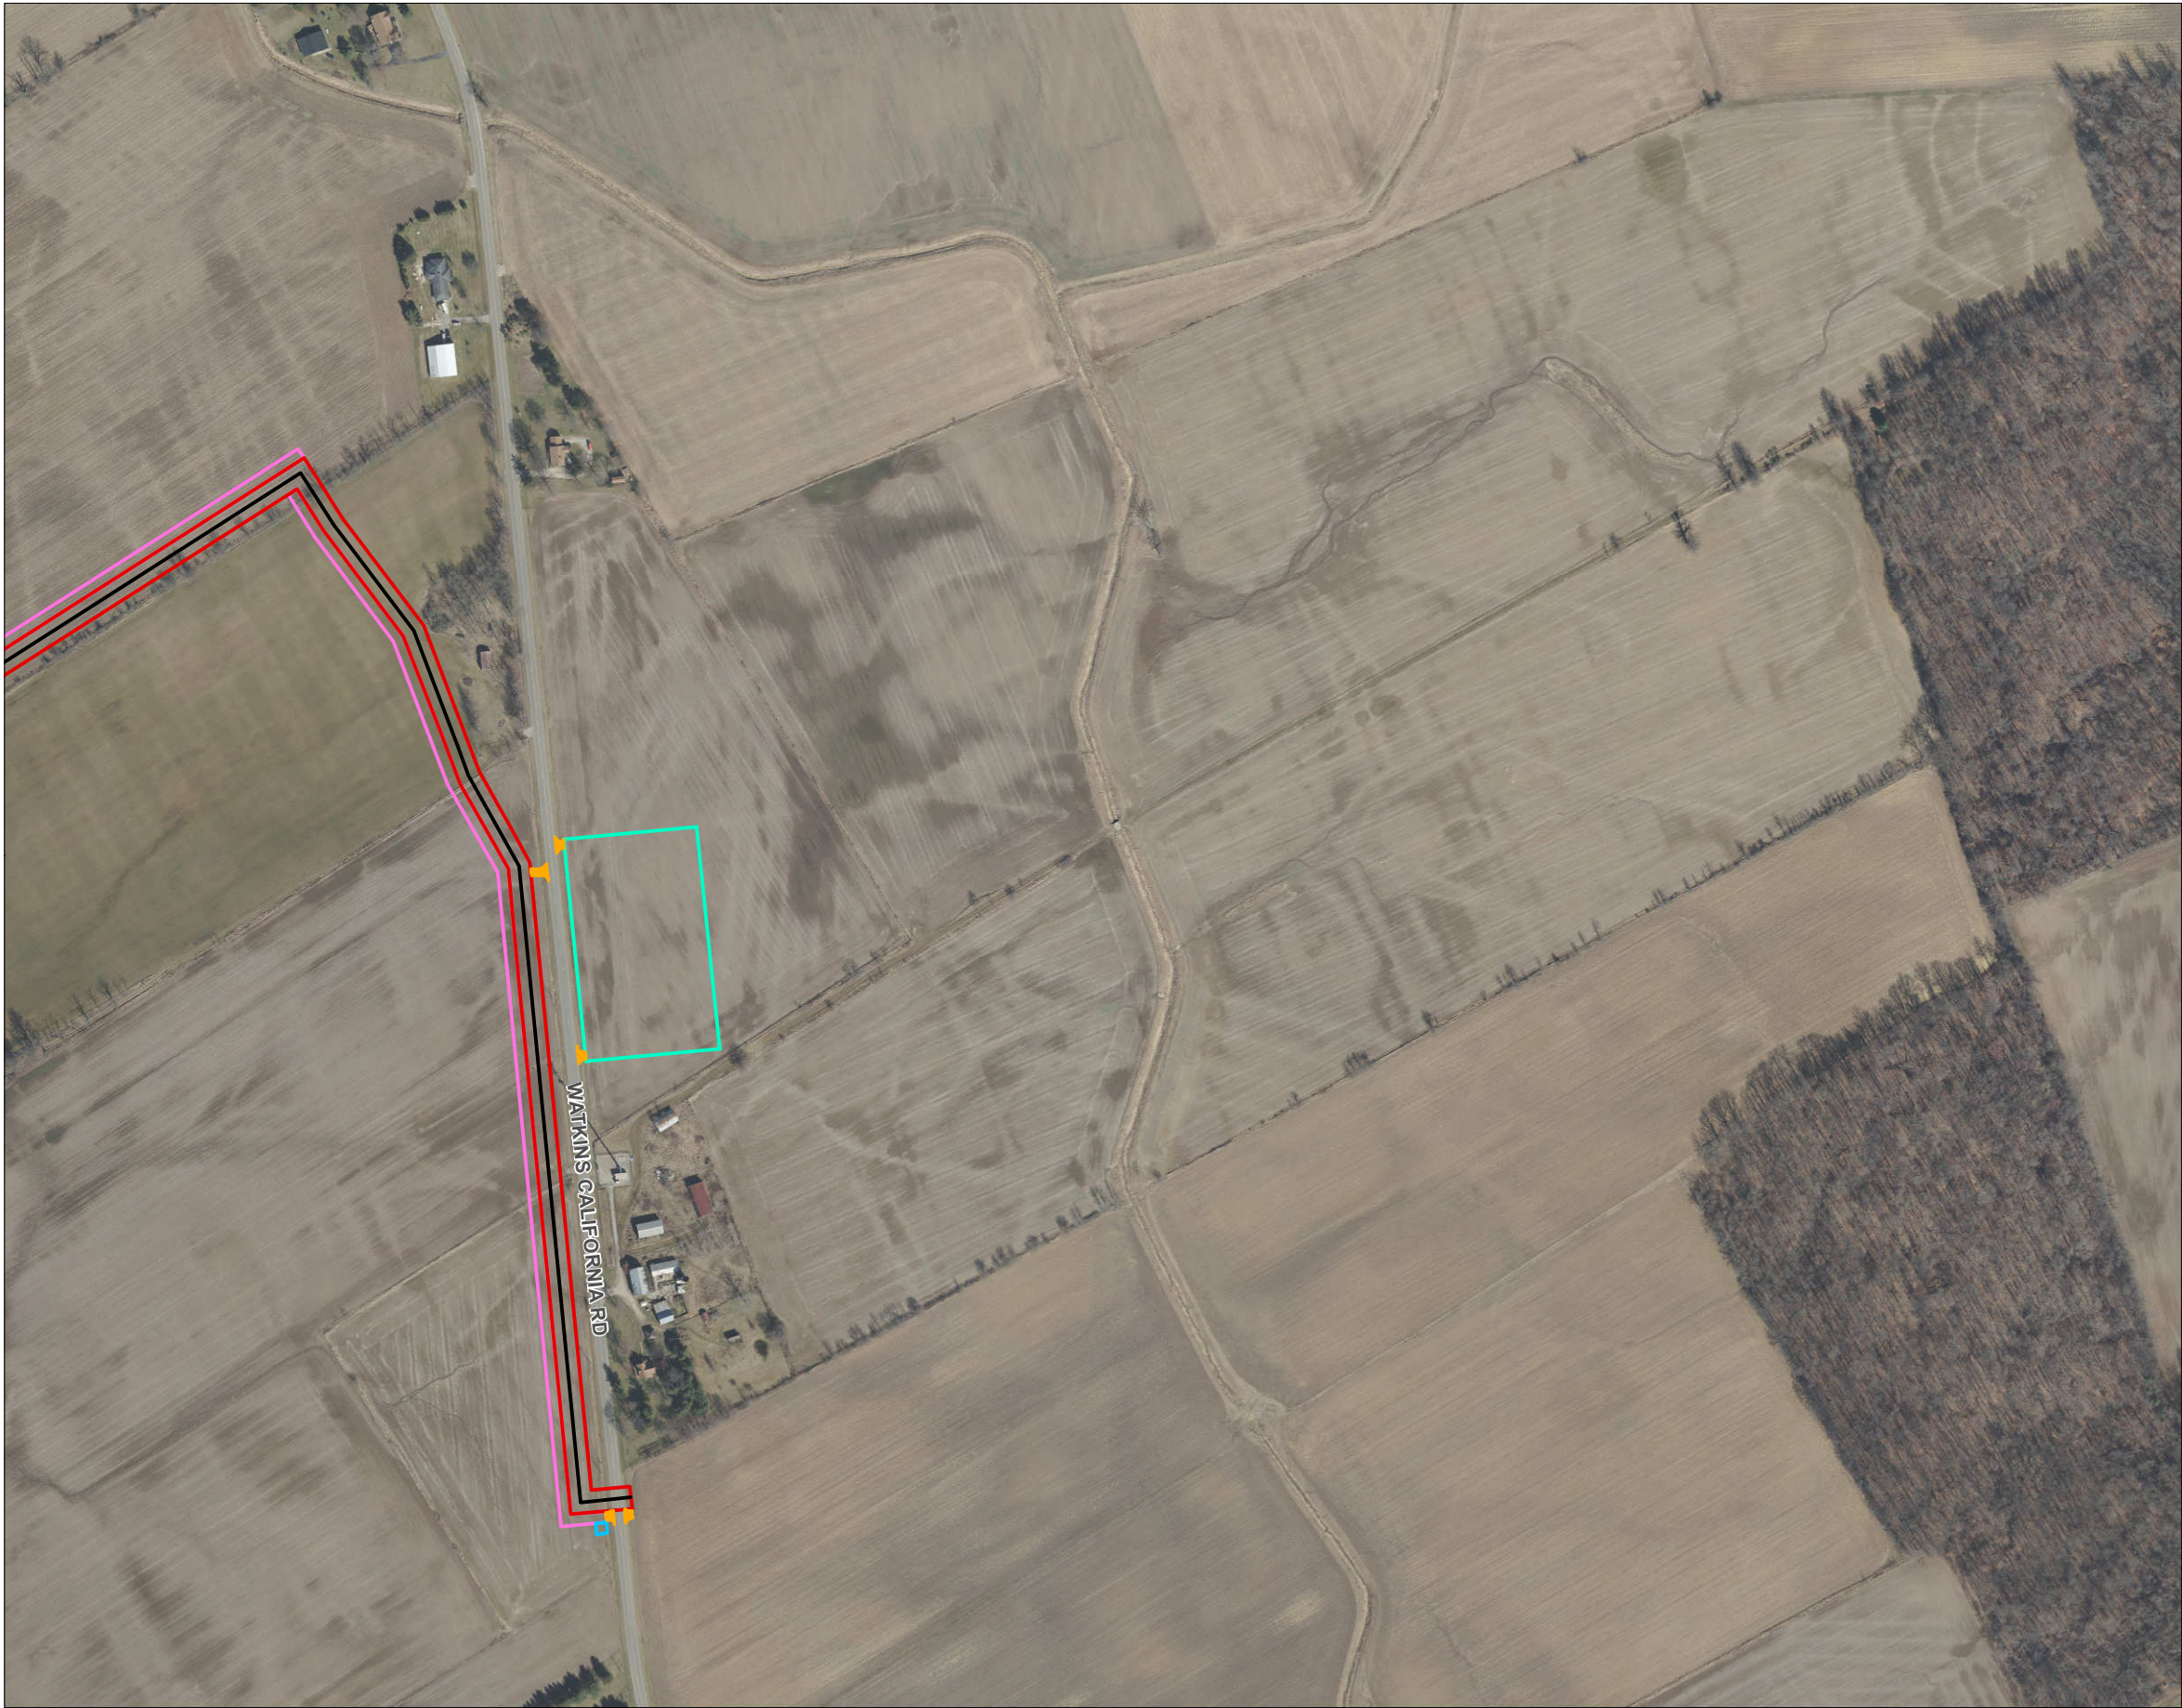
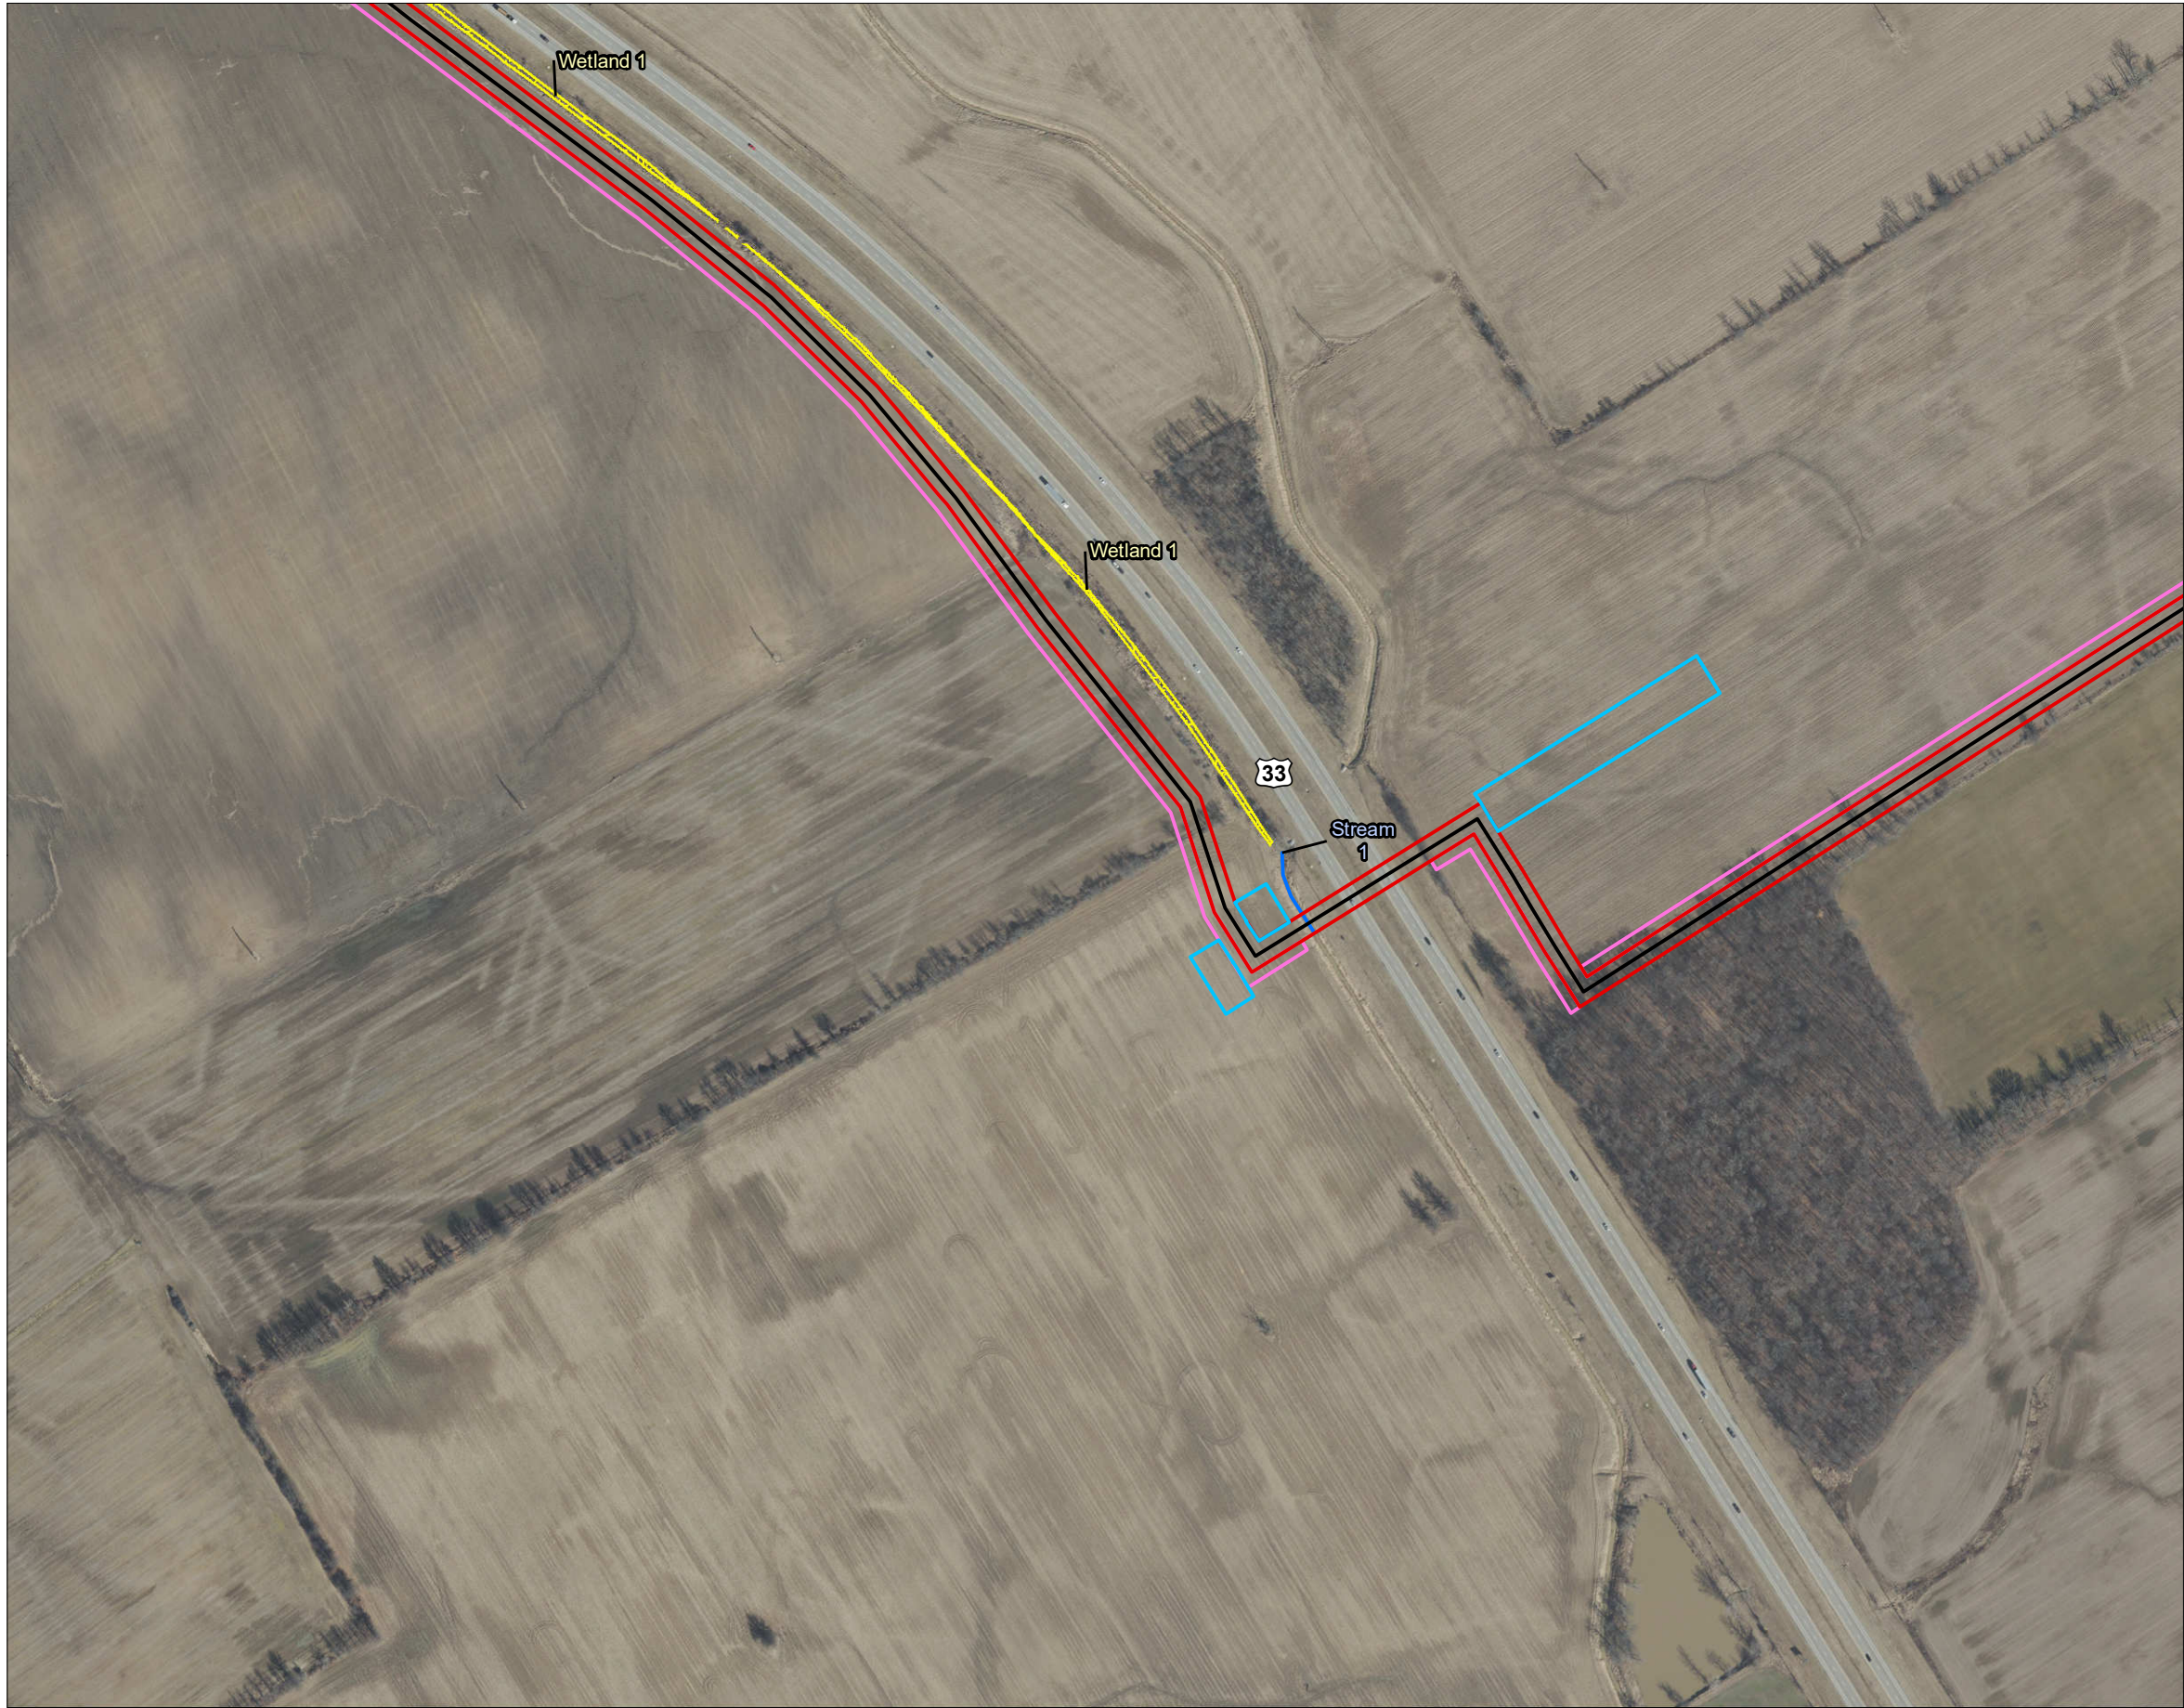
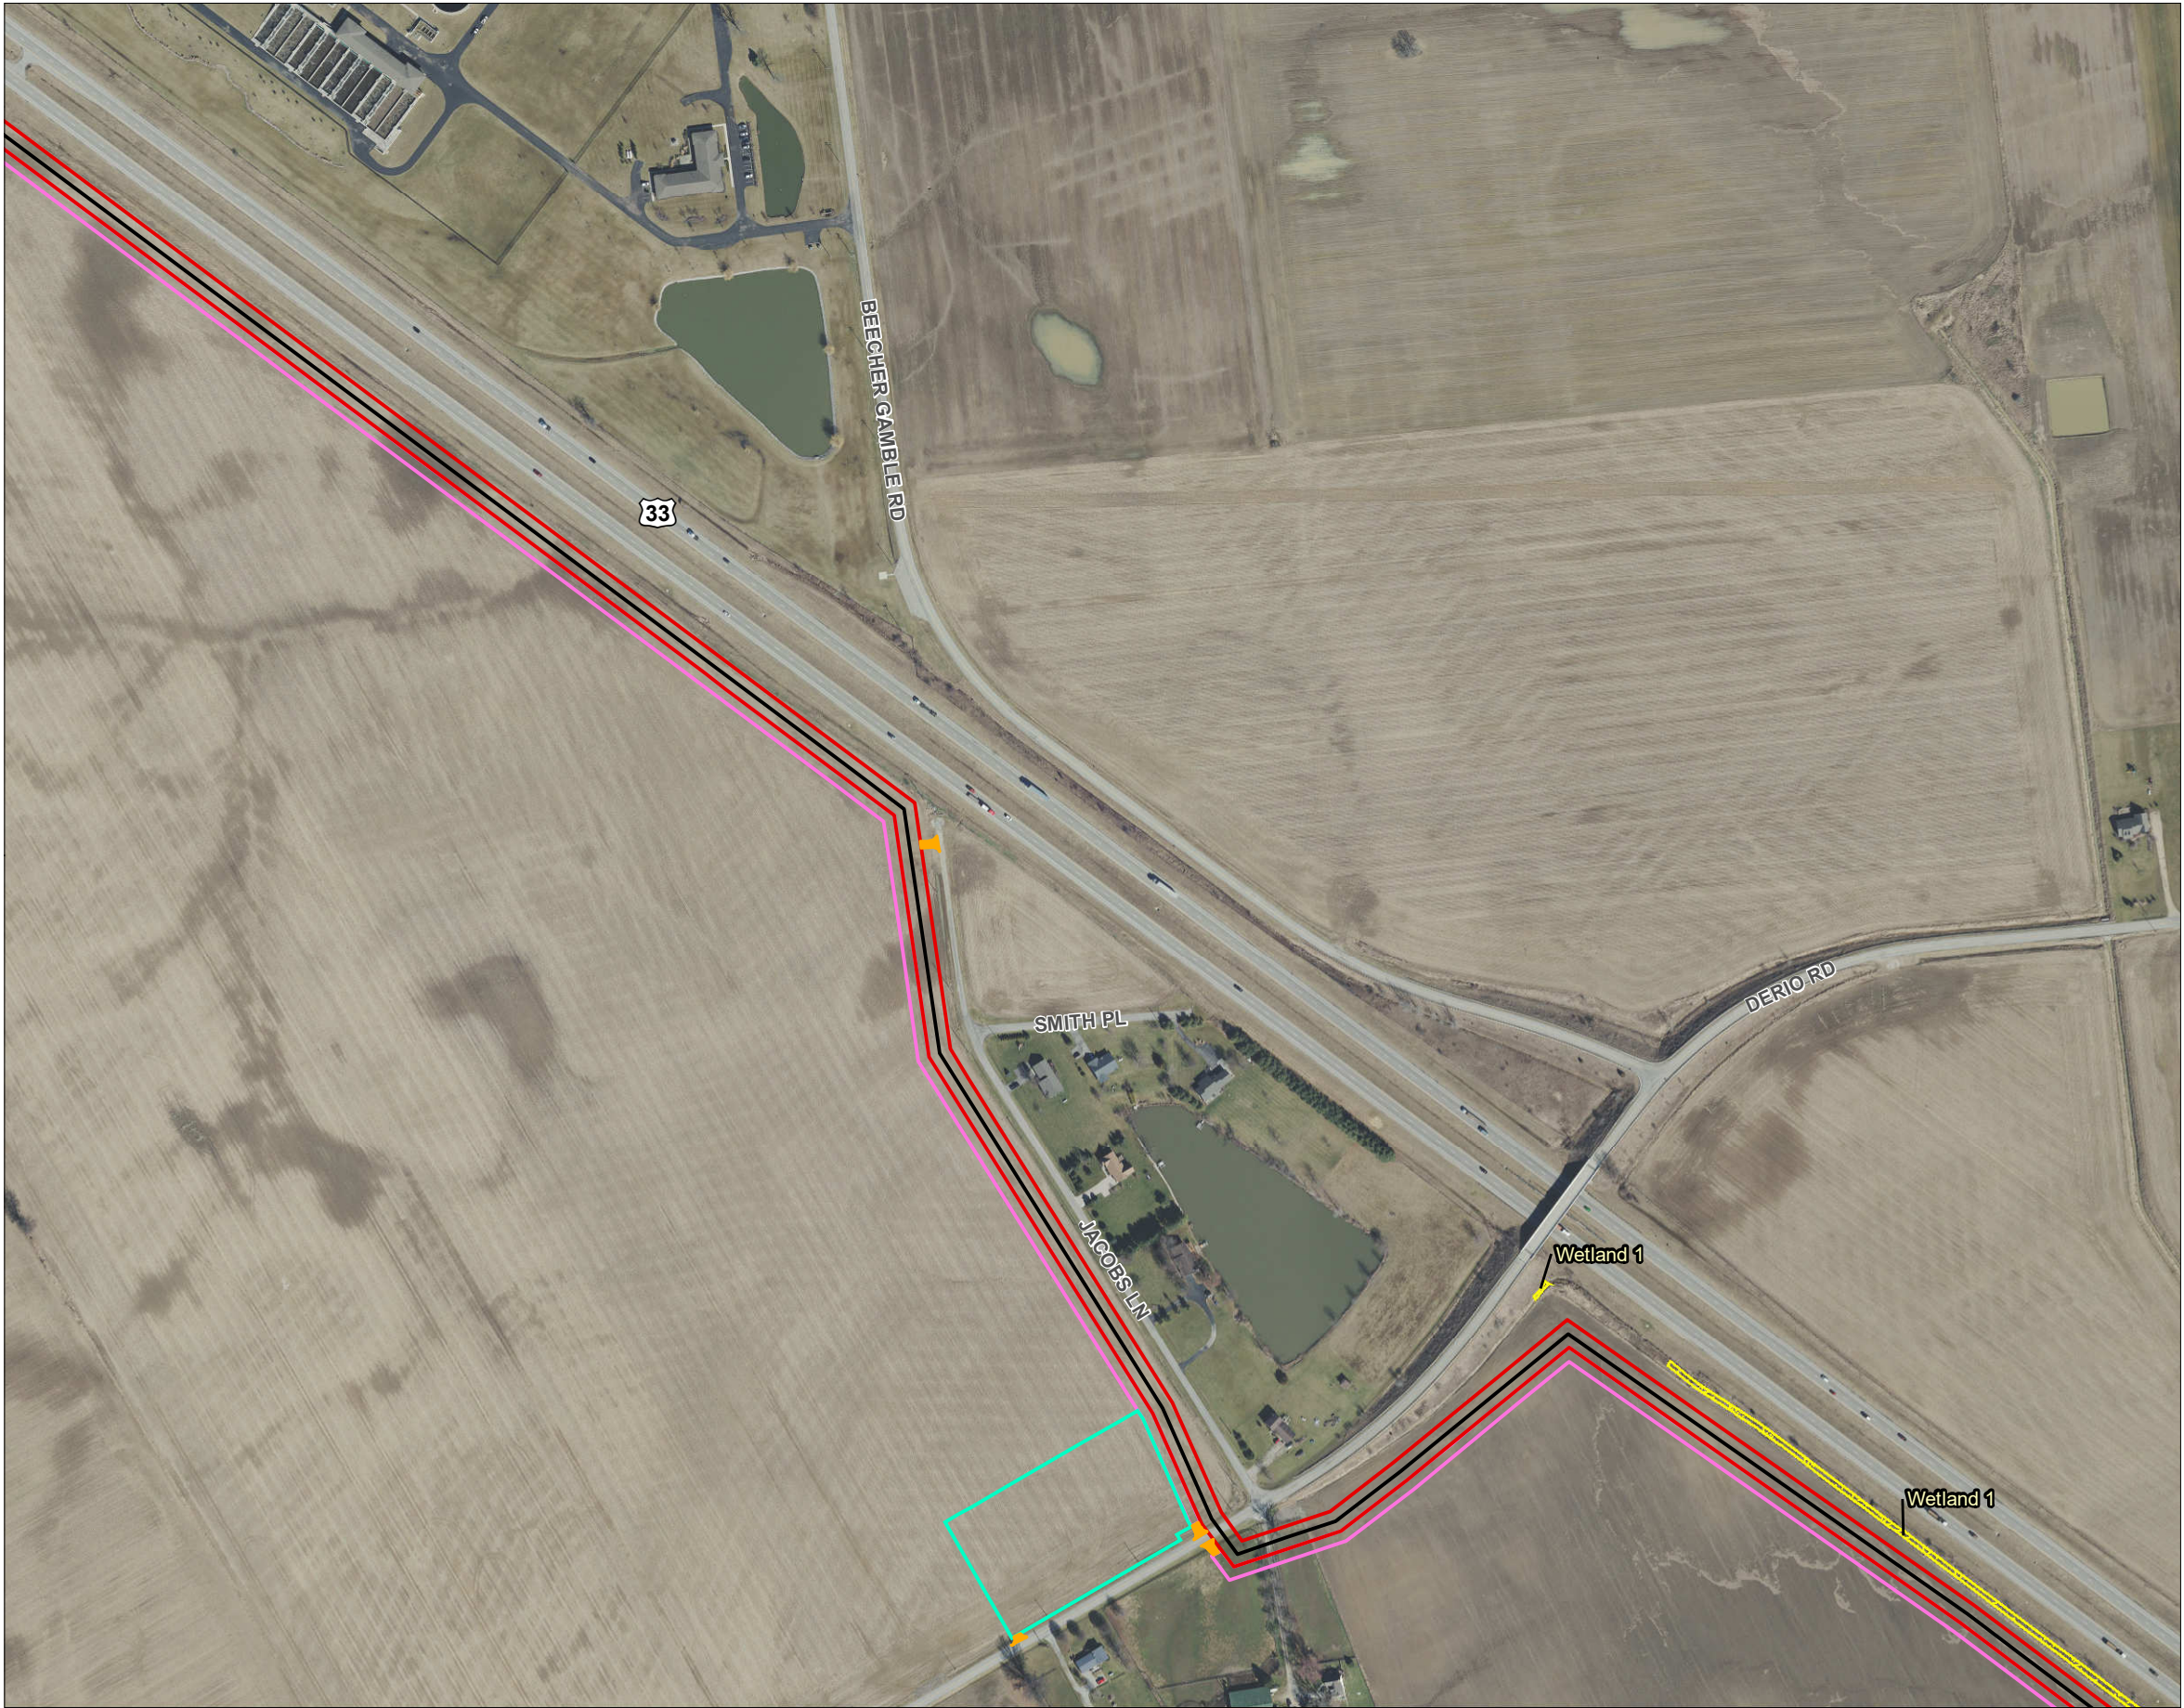
Figure No.  
**1**

Title  
**Construction Plans**  
**Project Area Updated: 12/11/2019**

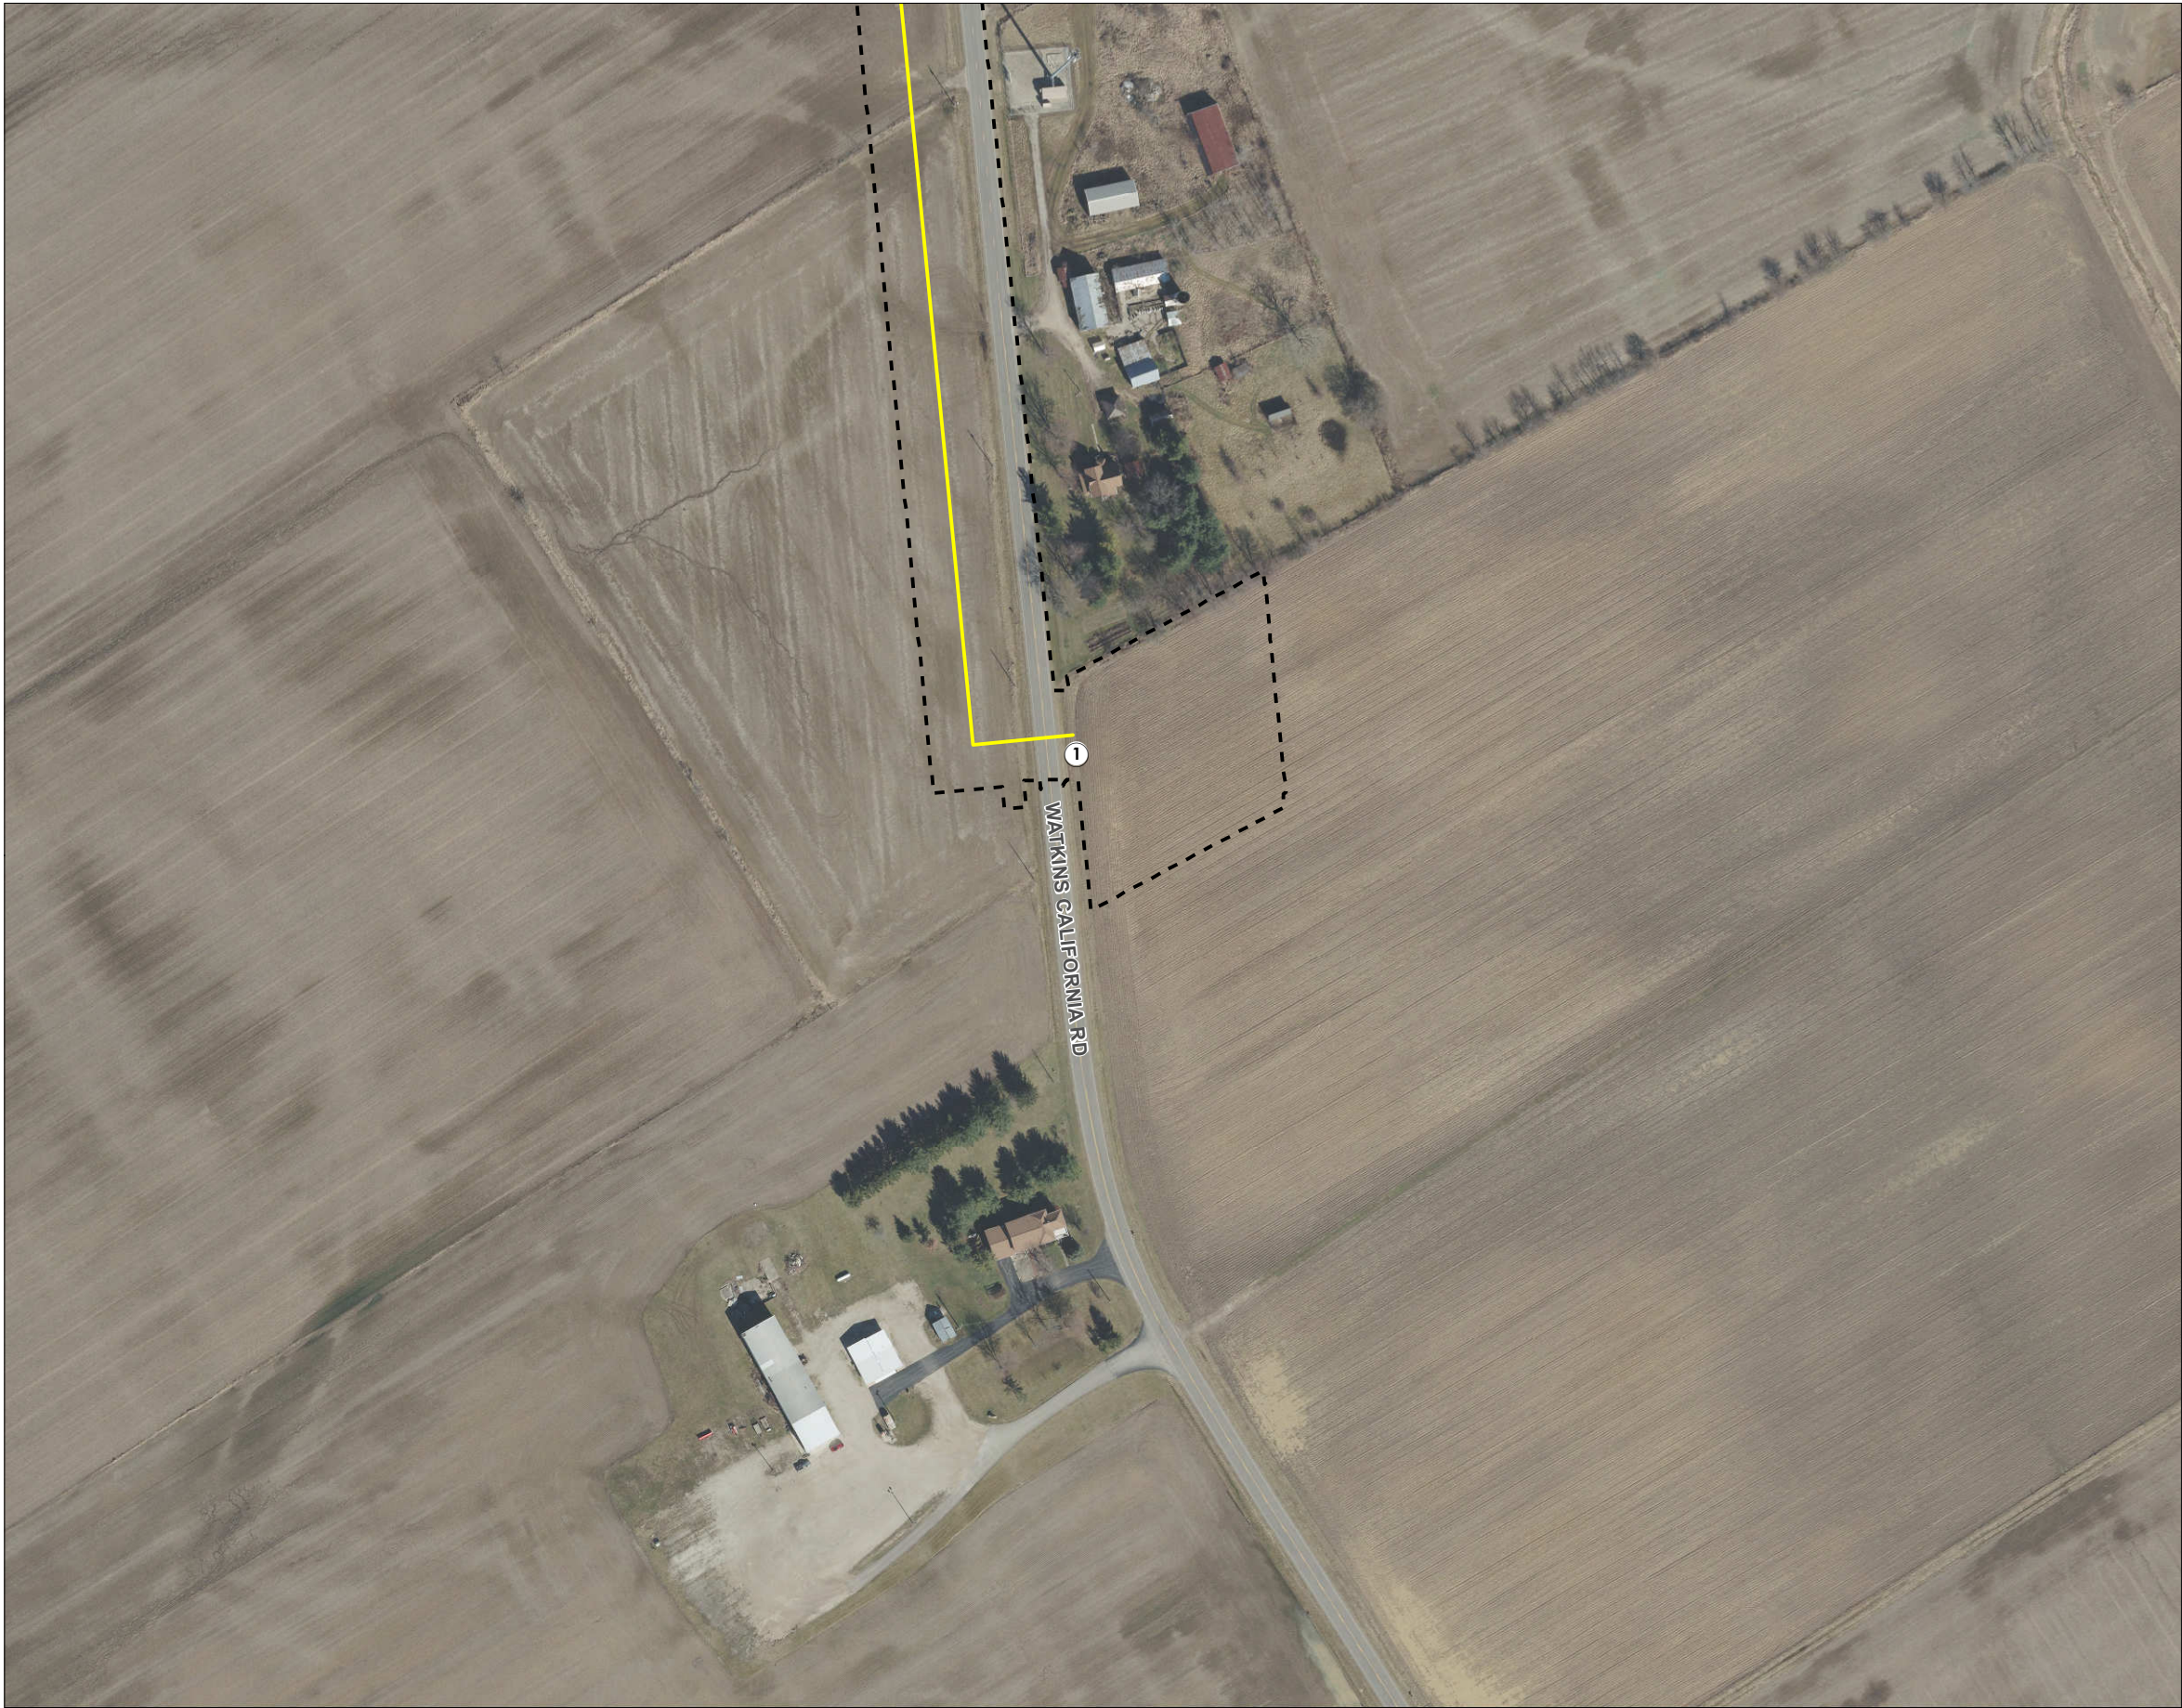
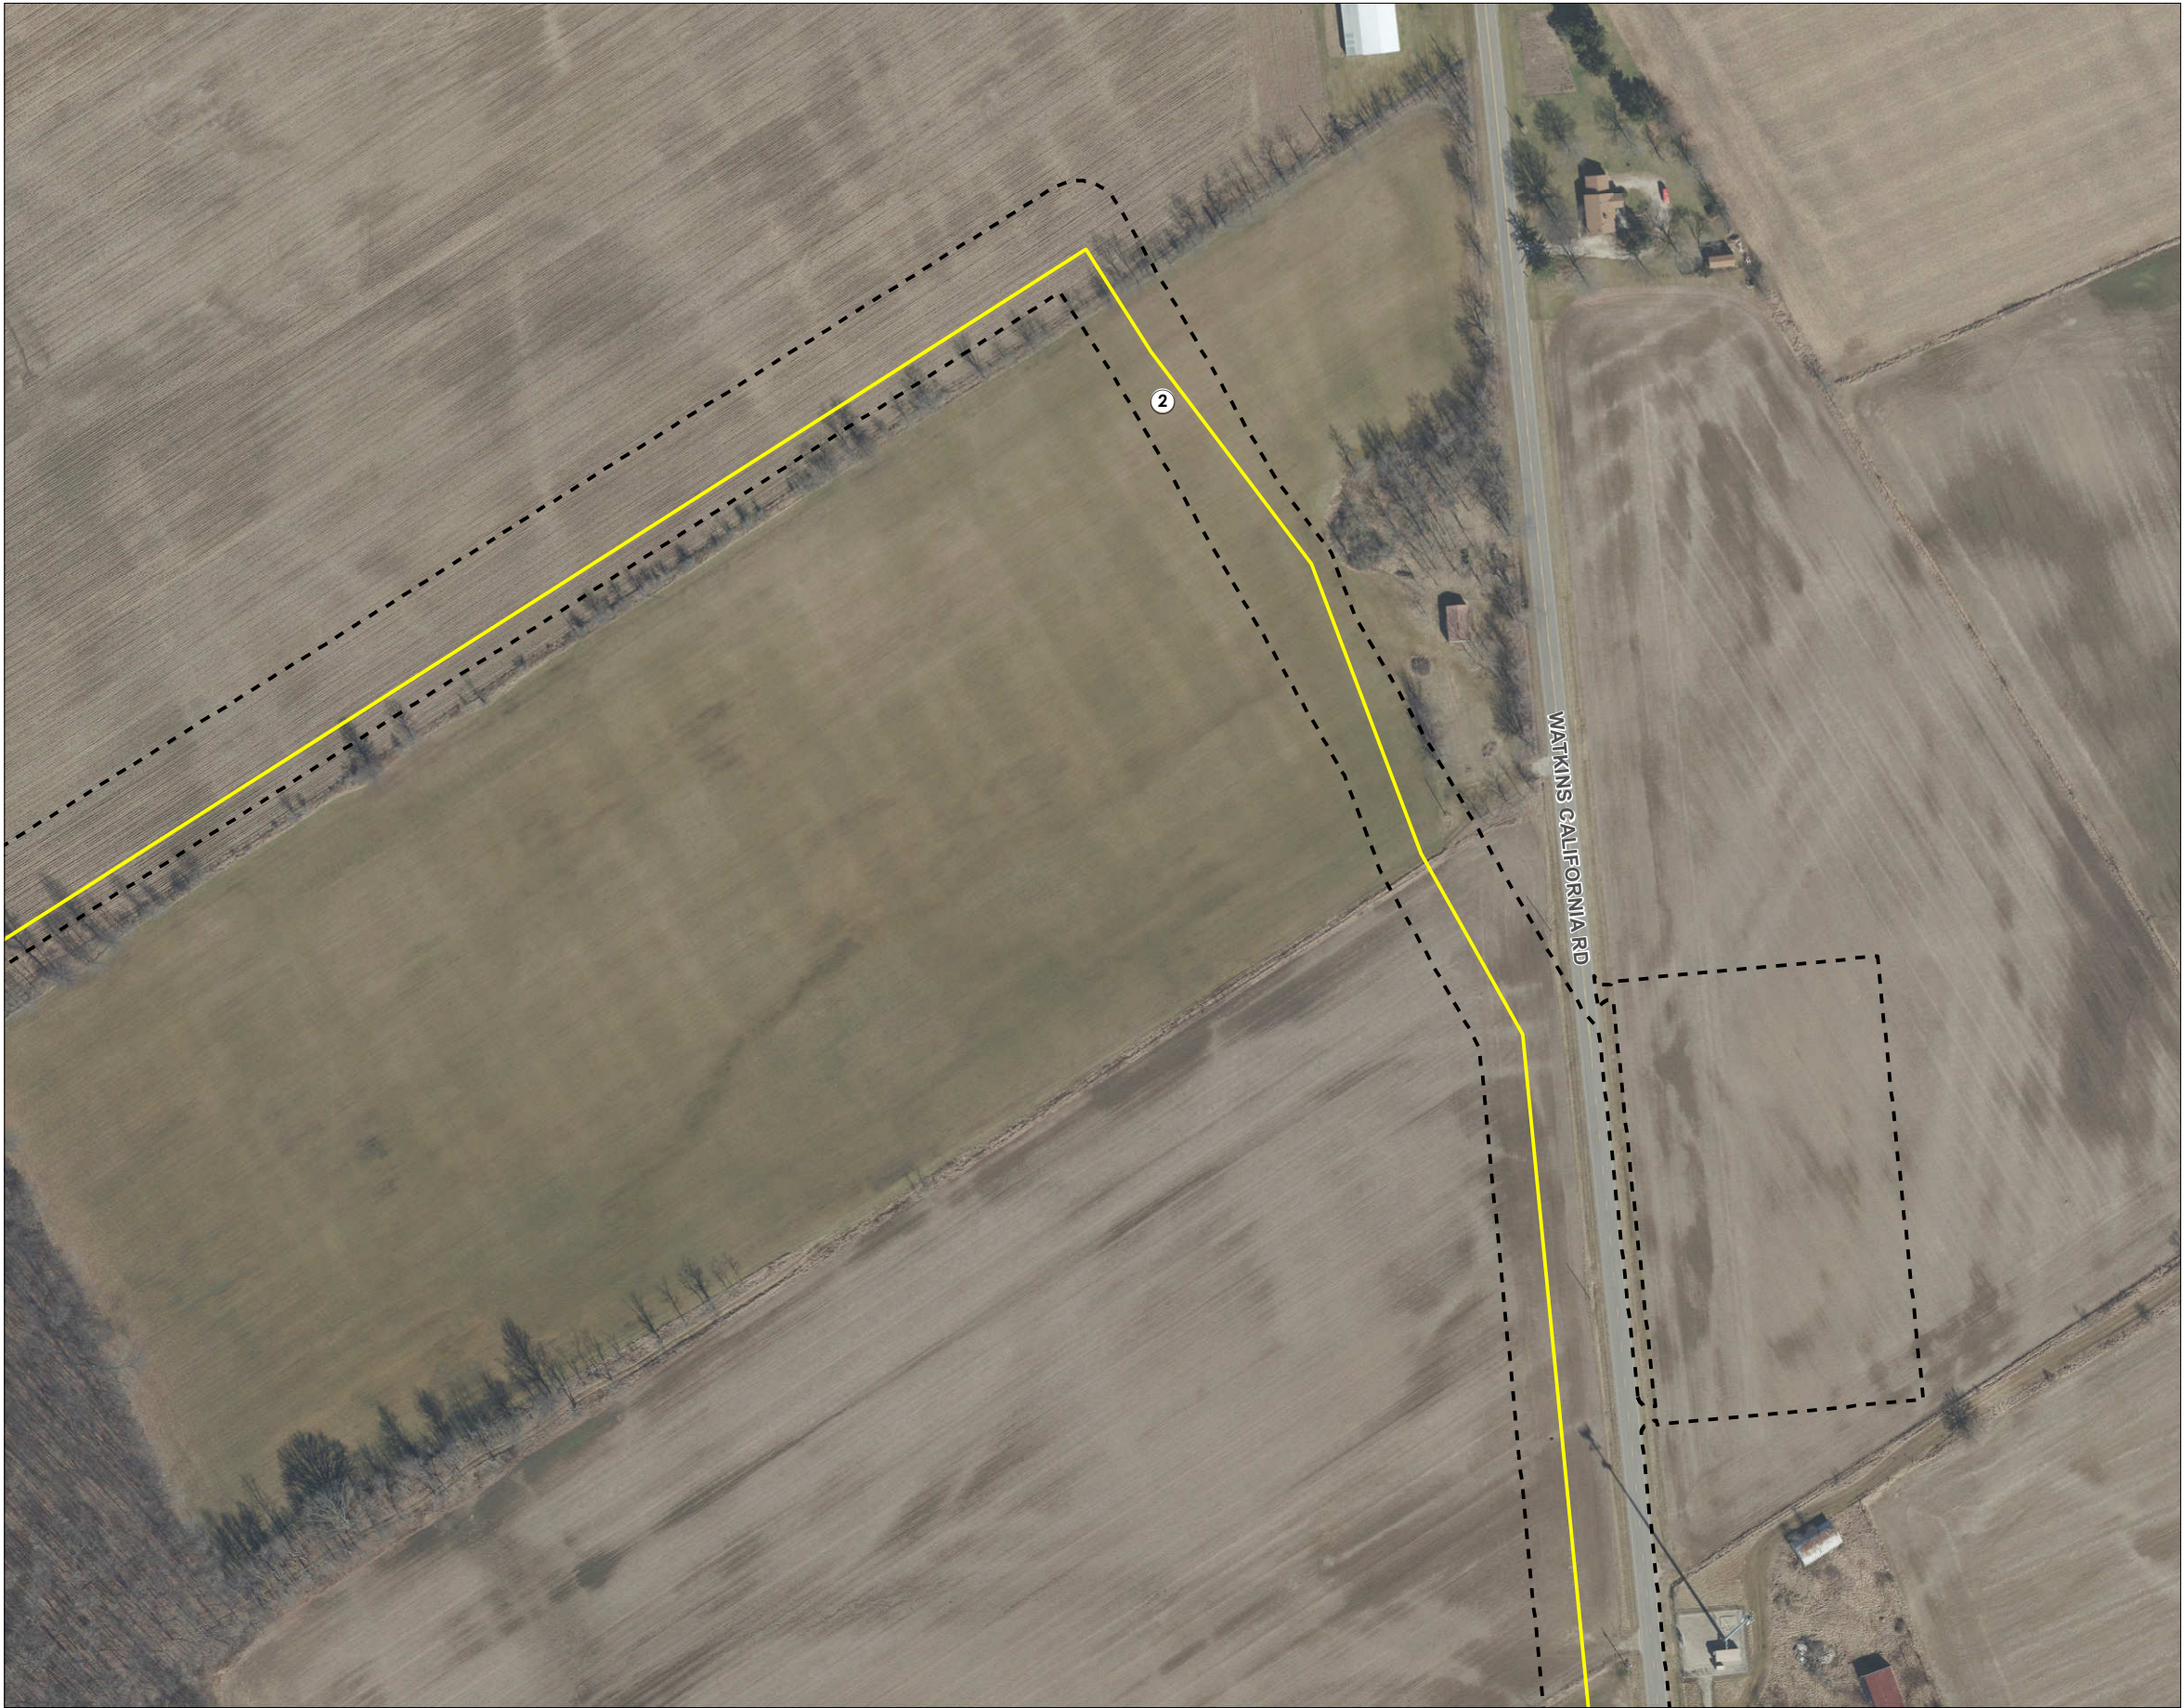
Figure No.  
**4**  
Title  
**Wetland and Waterbody Delineation Map**

Stantec completed the delineation of wetlands and waterbodies on November 20, 2019. The information contained in this report reflects the current site conditions that were observed during the field delineation. Datasheets and photographs of features delineated within the Project area are included in Appendices B and C, respectively.
