**RE: Columbia Gas of Ohio, Inc.**  
**Letter of Notification: Marysville Connector Pipeline Project**  
**OPSB Case No. 19-2148-GA-BLN**

Columbia Gas of Ohio, Inc. ("Columbia") submits this Letter of Notification, pursuant to R.C. 4906.03(F)(3) and Ohio Admin. Code Chapter 4906-6, concerning a proposed pipeline project known as the Marysville Connector Pipeline Project (the "Project").

This document entitled Marysville Connector Pipeline Project Wetland and Waterbody Delineation Report was prepared by Stantec Consulting Services Inc. ("Stantec") for the account of Columbia Gas of Ohio/NiSource ( (the "Client"). Any reliance on this document by any third party is strictly prohibited. The material in it reflects Stantec's professional judgment in light of the scope, schedule and other limitations stated in the document and in the contract between Stantec and the Client. The opinions in the document are based on conditions and information existing at the time the document was published and do not take into account any subsequent changes. In preparing the document, Stantec did not verify information supplied to it by others. Any use which a third party makes of this document is the

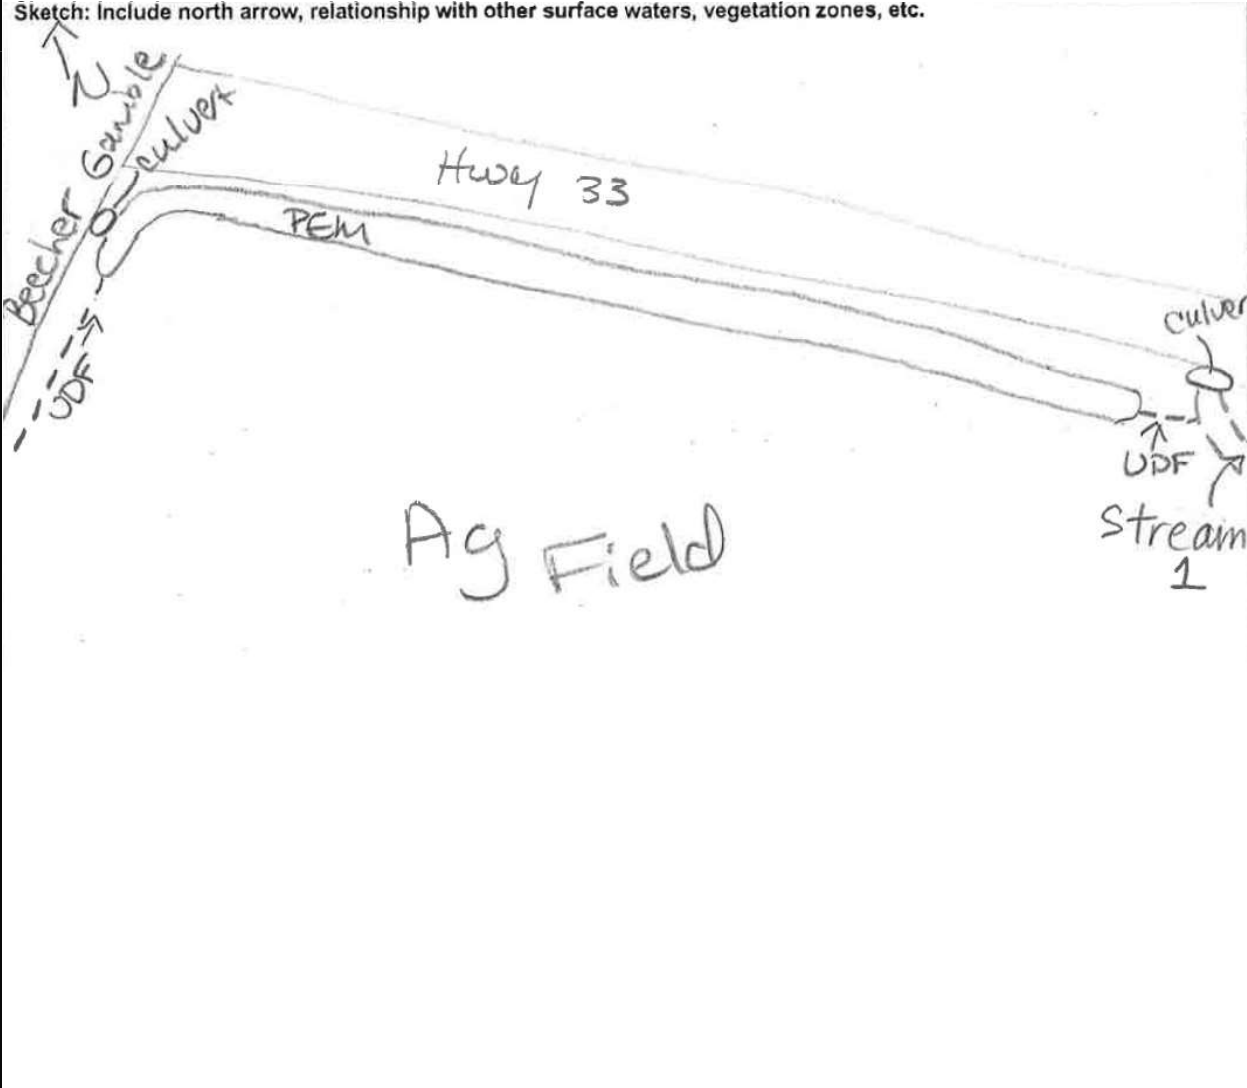
<b>Name of Wetland:</b> Wetland 1	
<b>Wetland Size (acres, hectares):</b> 1.12 acres	
<b>Sketch: Include north arrow, relationship with other surface waters, vegetation zones, etc.</b>

<b>Comments, Narrative Discussion, Justification of Category Changes:</b>	
Wetland is fed by three sources: stormwater runoff from Highway 33 and Beecher - Gamble Road, tile drainage from the agricultural fields, and Stream 4.	
<b>Final score :</b> 32	<b>Category:</b> 2

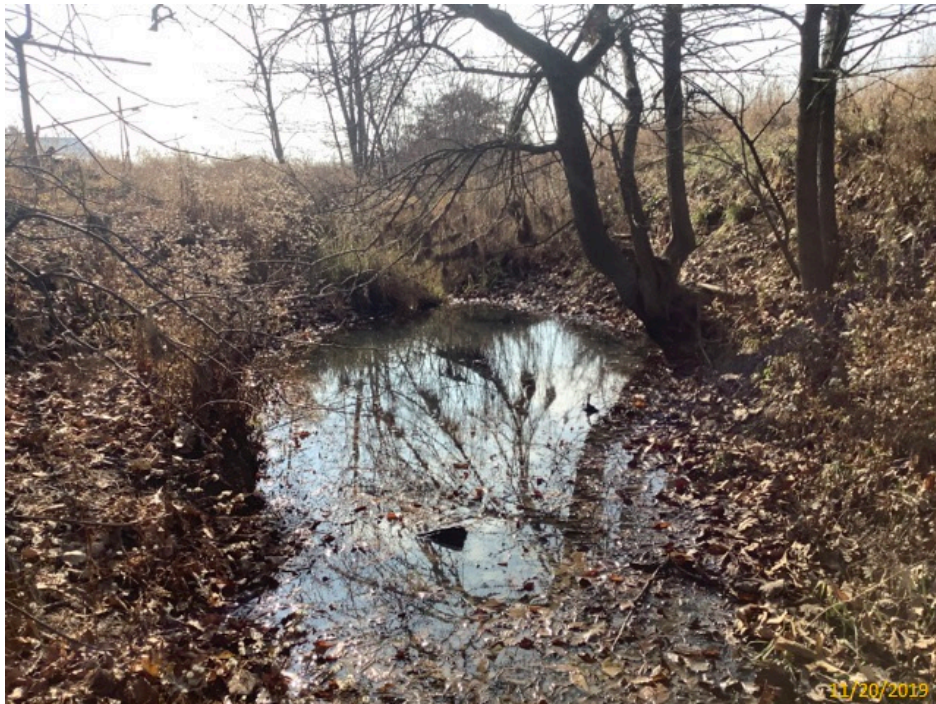
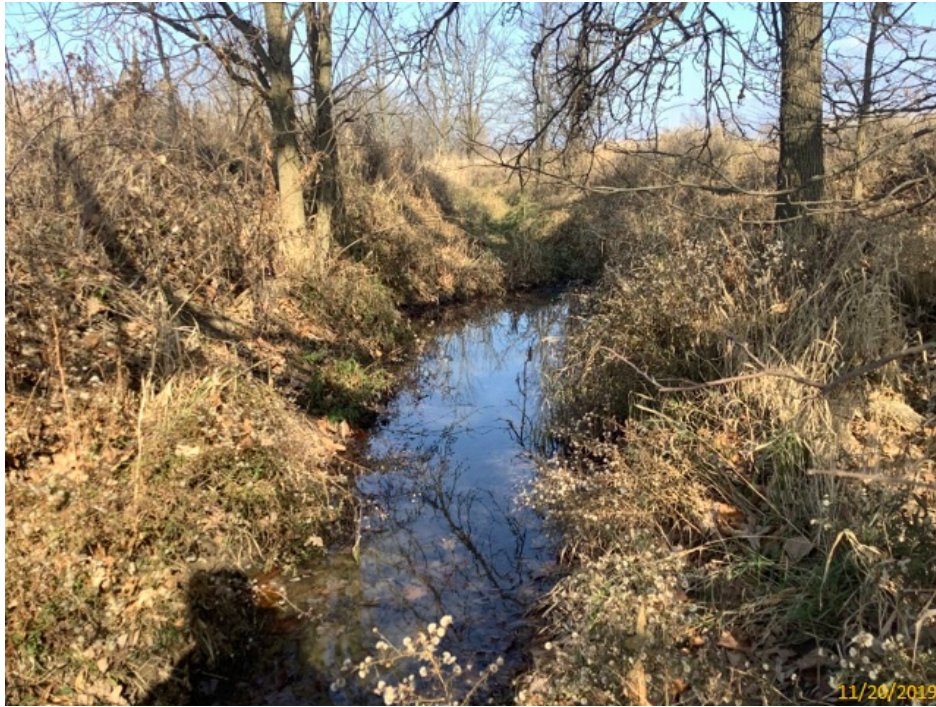
Photo Location 12. View of Stream 2. Photograph taken facing upstream, south.

Stream 2 is an intermittent stream with approximately 321 linear feet within the Project area. The functional assessment (QHEI) of Stream 2 yielded a score of 41, indicating it is a stream of “poor” quality. The stream had a bankfull width of 3.2 feet and a bankfull depth of 3.5 feet and had isolated shallow pools at the time of site visit. Substrates observed were primarily hardpan and silt. Stream 2 drains into Mill Creek outside the Project area.

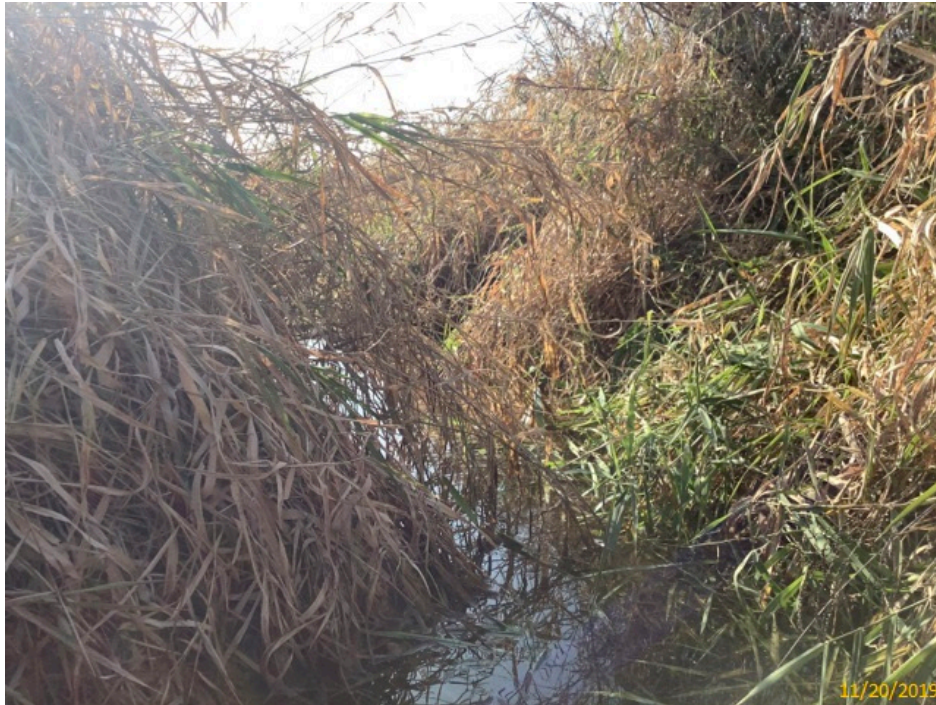
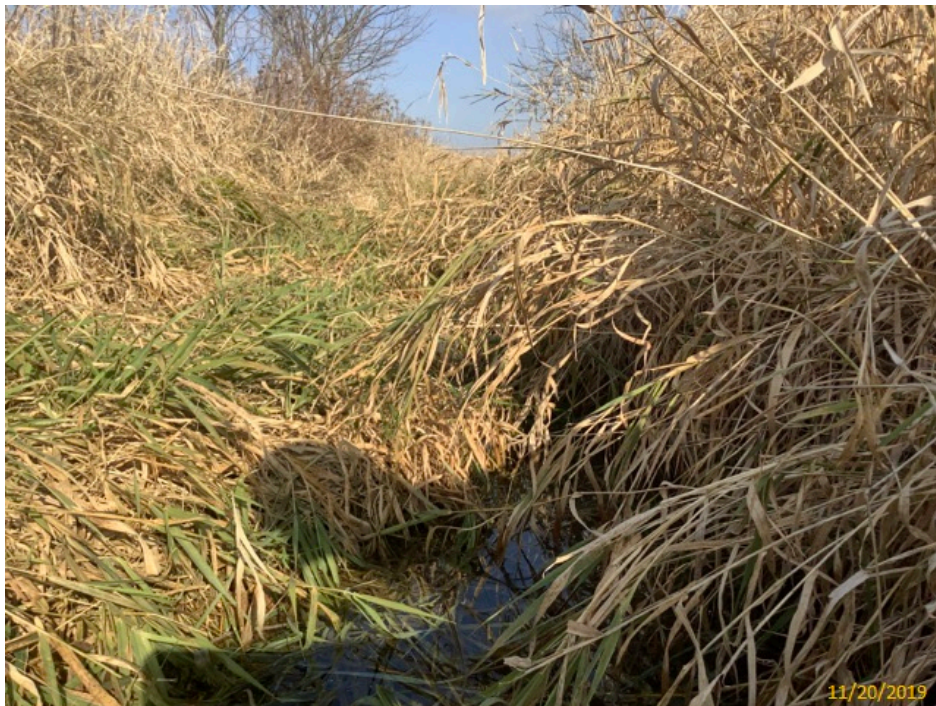
Photo Location 14. View of Stream 3. Photograph taken facing upstream, south.

Stream 3 is an intermittent stream with approximately 144 linear feet within the Project area. The functional assessment (HHEI) of Stream 3 yielded a score of 31, indicating it is a Modified Class II PHWH stream. The stream had a bankfull width of 3 feet and a bankfull depth of 1.5 feet and had isolated shallow pools at the time of site visit. The substrate observed was primarily hardpan. Stream 3 drains into Wetland 2 outside Project area, which drains into Stream 2.

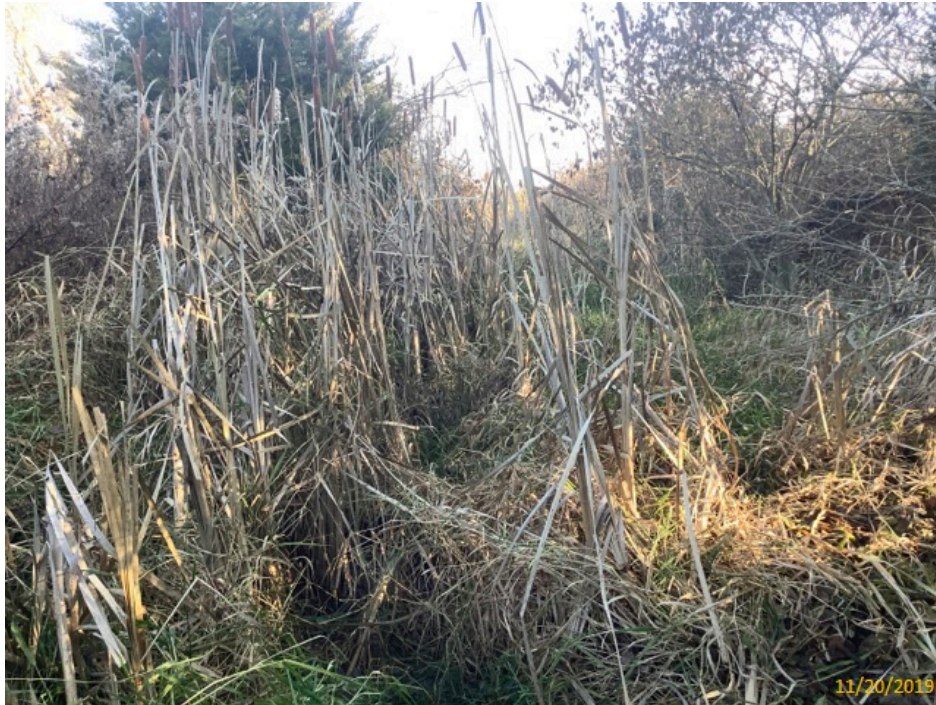
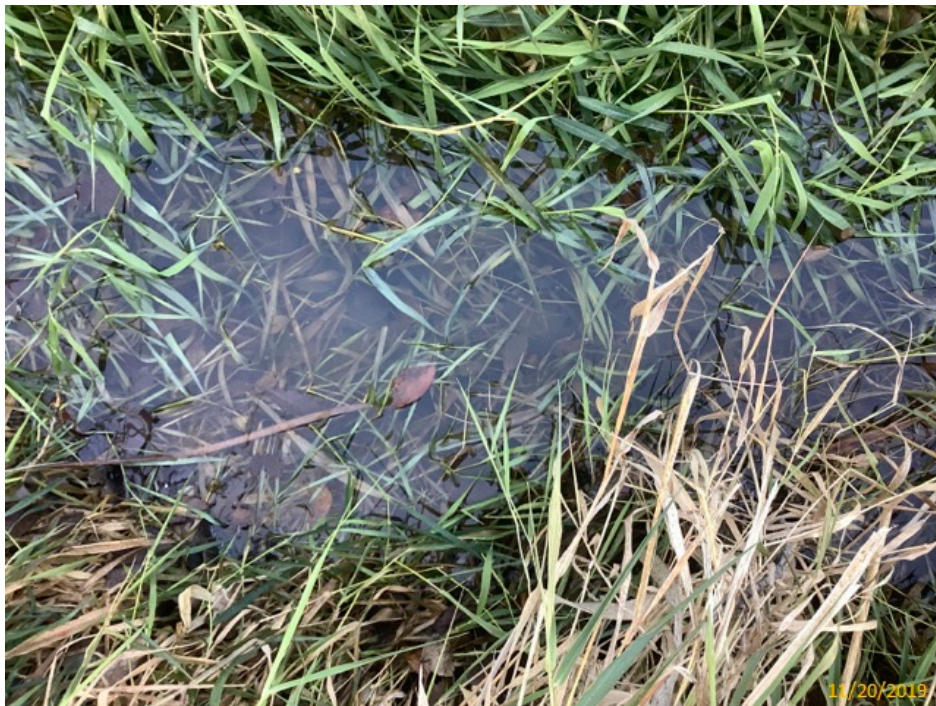
Photo Location 21. View of Stream 4. Photograph taken facing downstream, northeast.

Stream 4 is an ephemeral stream with approximately 92 linear feet within the Project area. The functional assessment (HHEI) of Stream 4 yielded a score of 21, indicating it is Modified Class I-PHWH stream. The stream had a bankfull width of 3 feet and a bankfull depth of 0.5 feet and had isolated shallow pools at the time of site visit. The substrate observed was primarily hardpan. Stream 4 drains into Wetland 4 within the Project area.
