Wetland Delineation Report

University Project

Colliers Engineering & Design Project Number: 21004202A

May 22, 2023

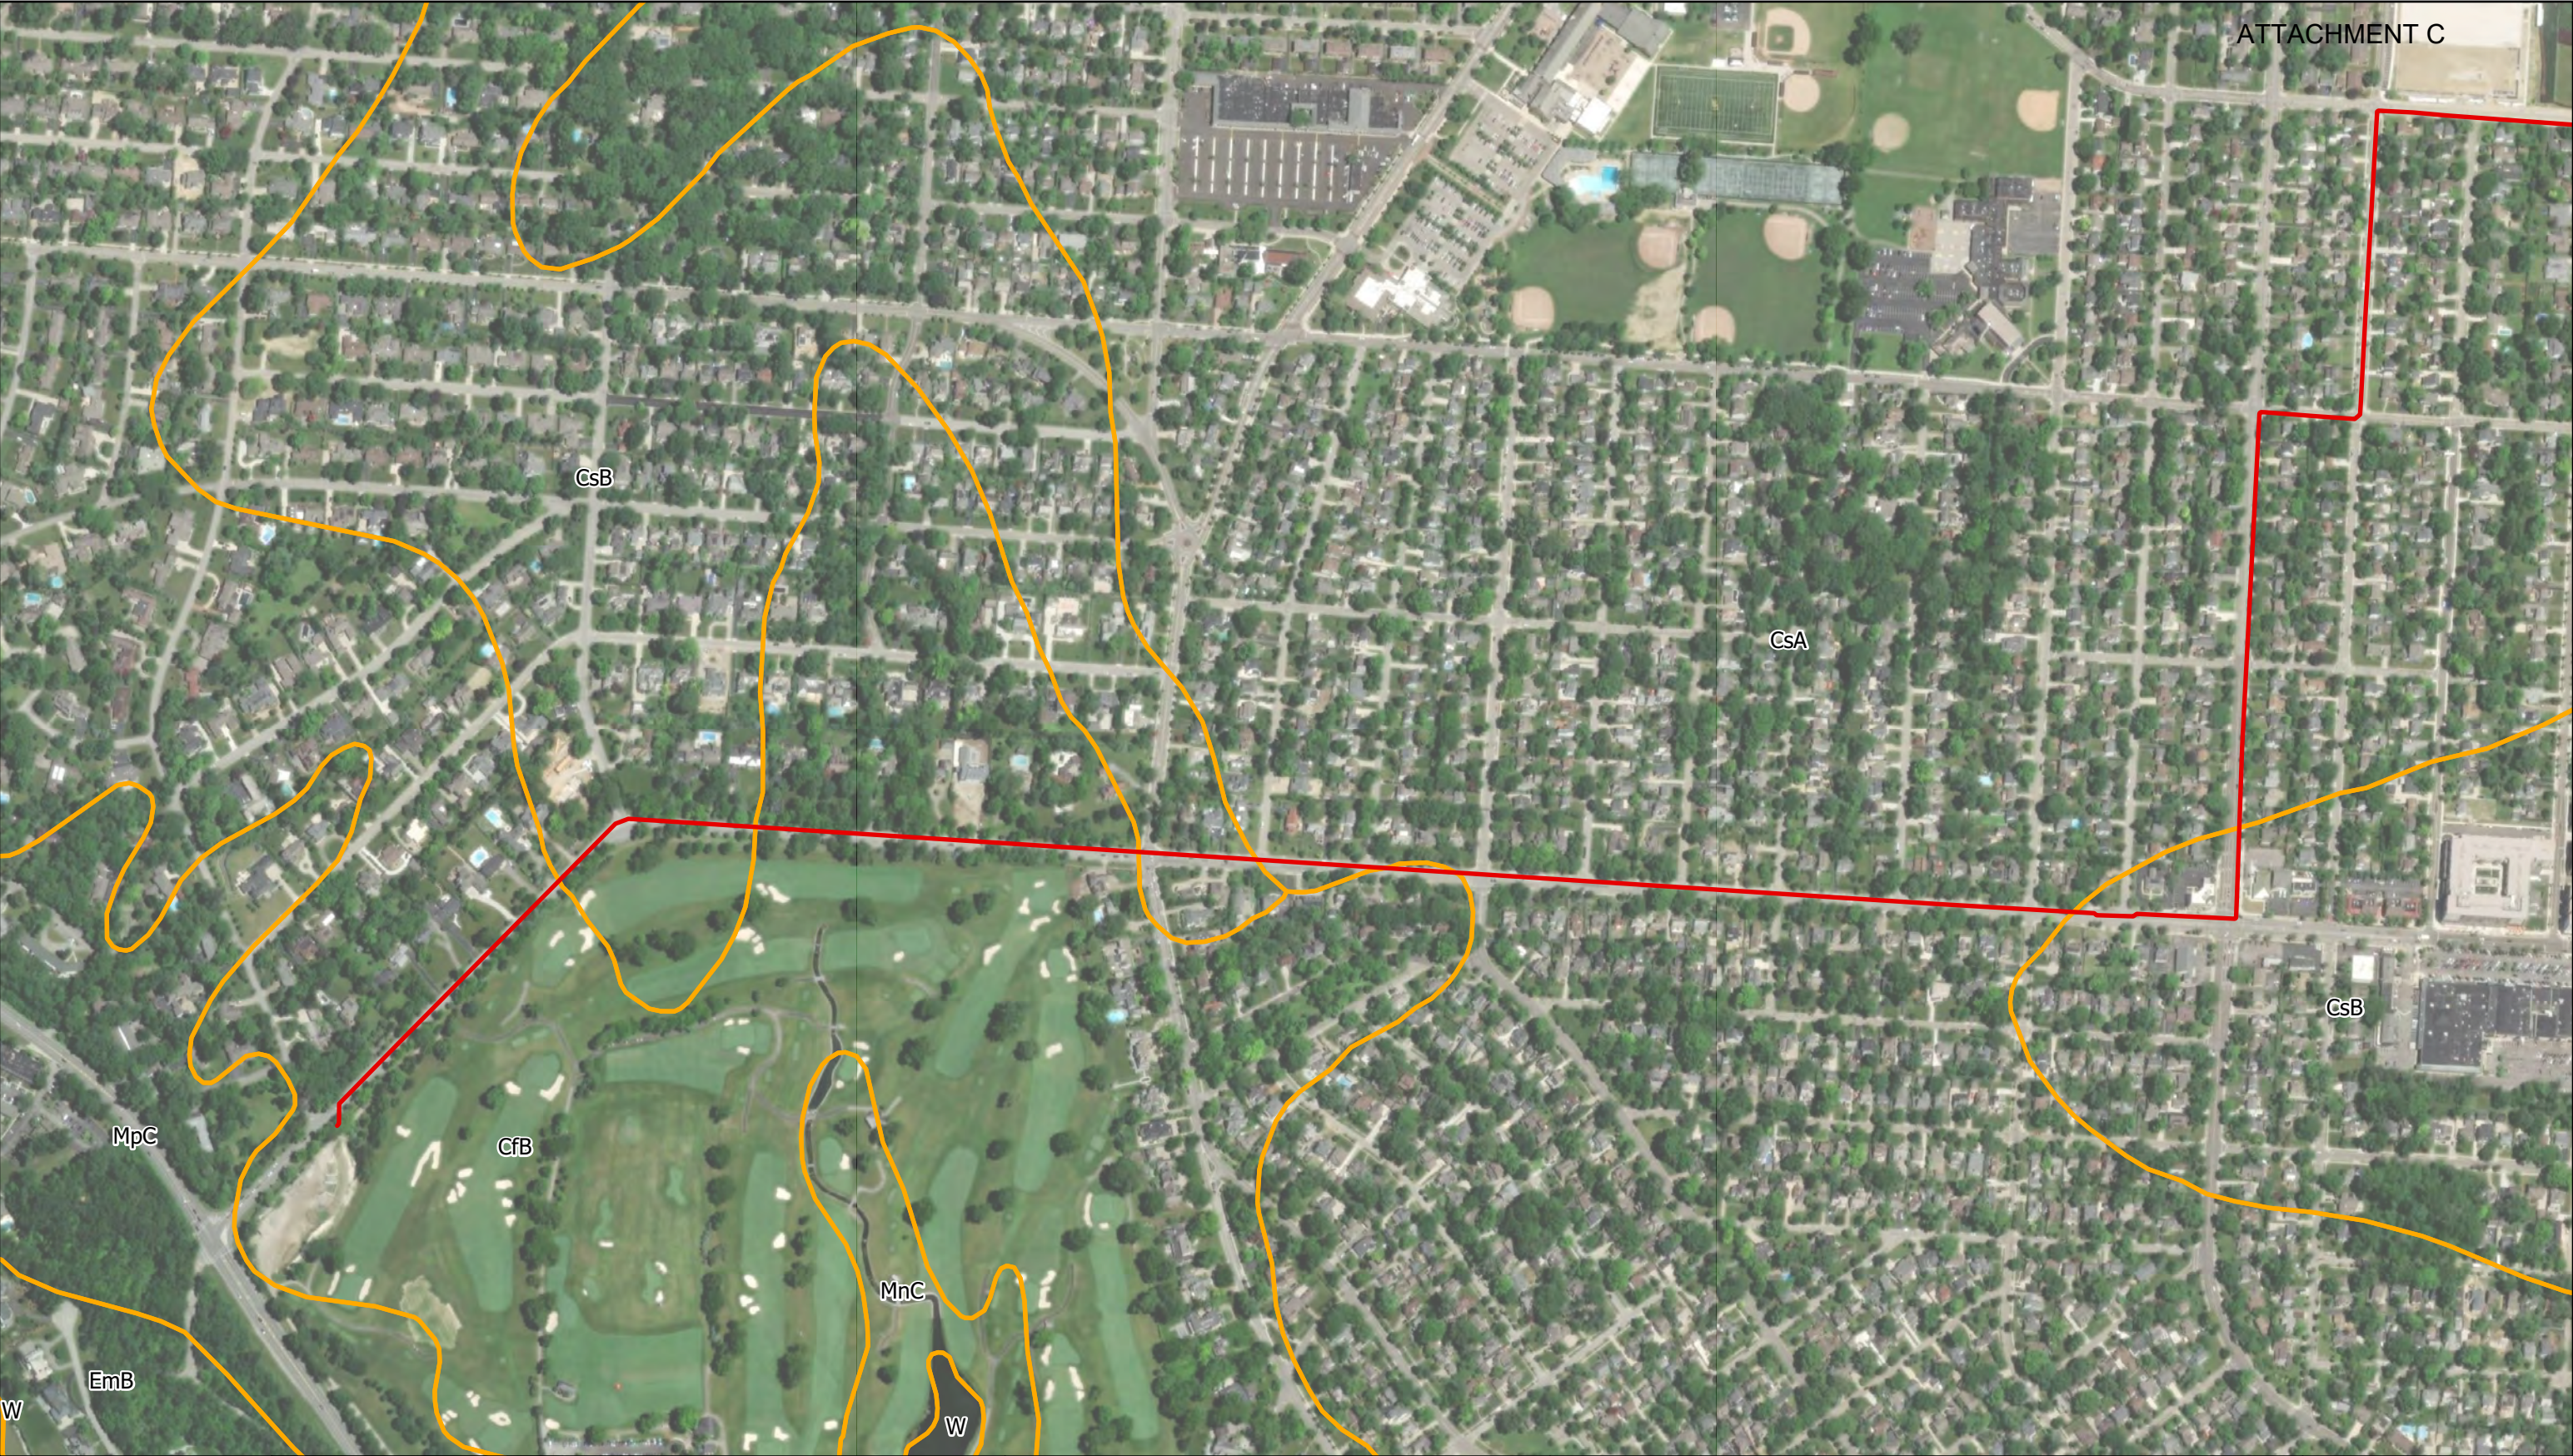
Figure 2 - Soil Series Map

The NRCS Web Soil Survey depicts the following Table Soil Series map units within the Survey Corridor and provides a description of the properties and qualities of each soil:

Of the six (6) mapped soil units in the Survey Corridor, one (1) soil unit (Kokomo silty clay loam) is listed as being hydric.

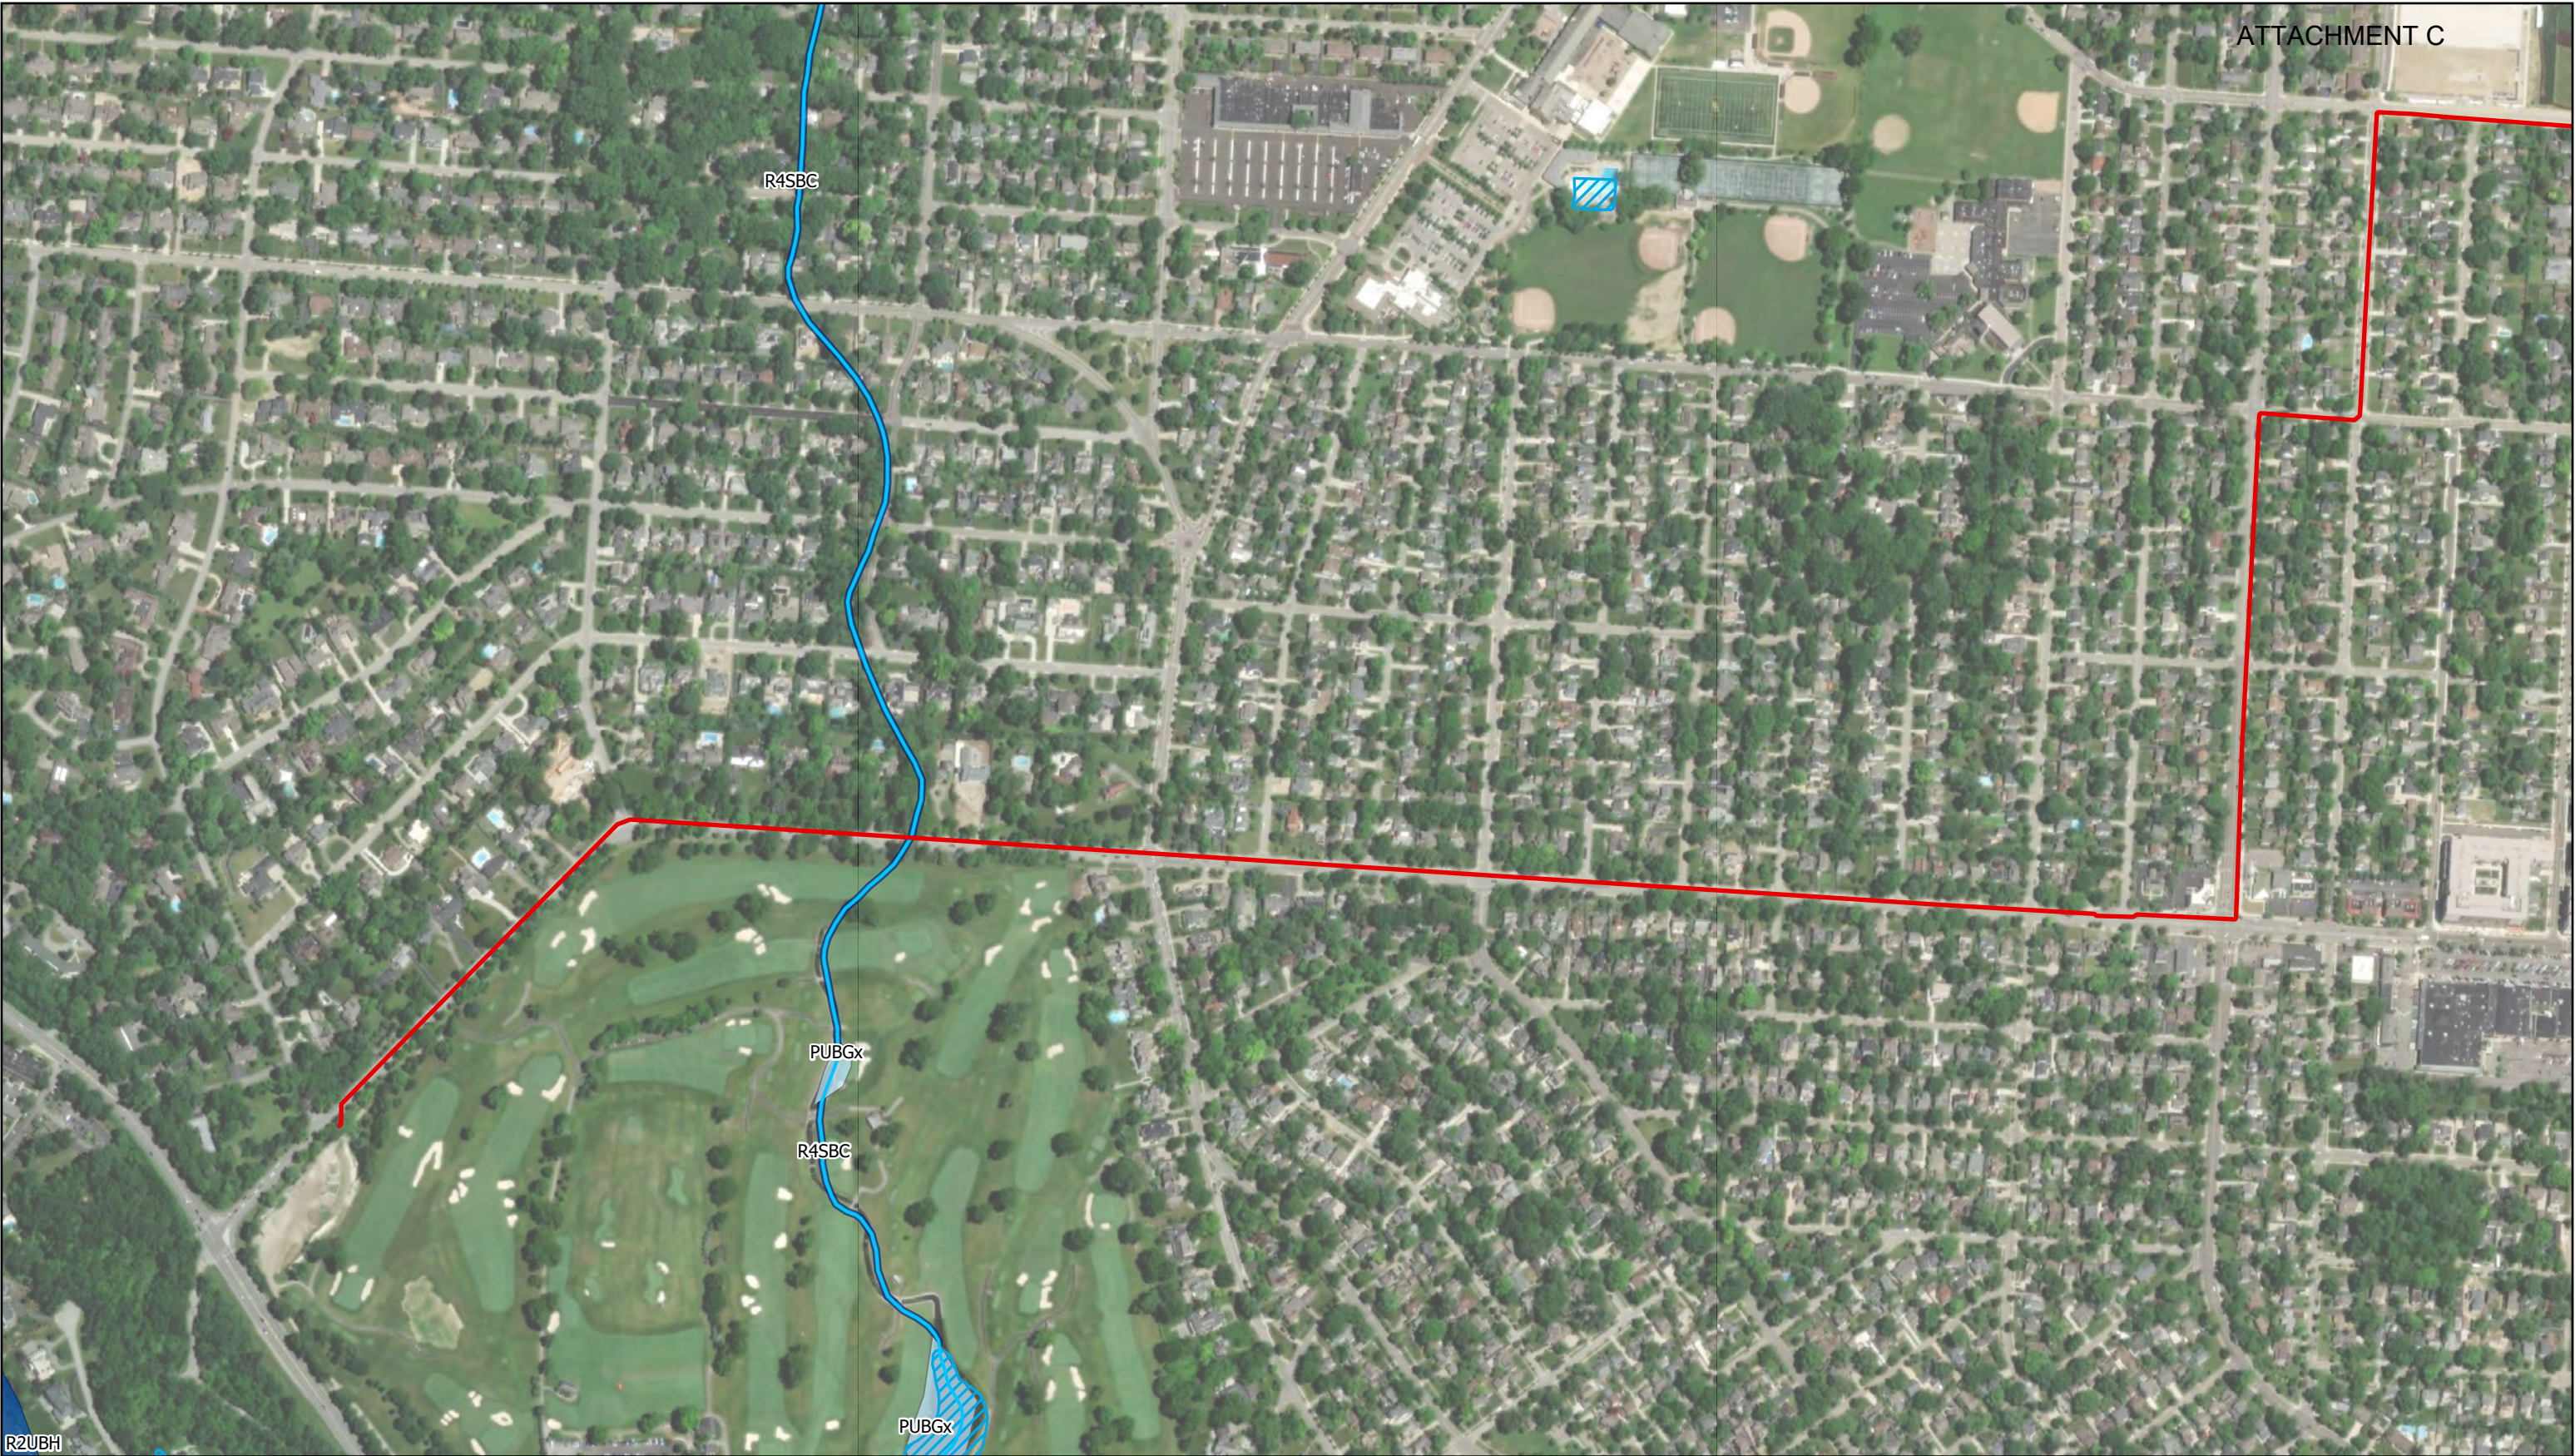
Figure 3 - NWI Series Map
University
Franklin County, Ohio

Prior to on-site field investigations, several publicly available sources of information were reviewed to determine the likelihood of wetlands and surface waters occurring within Survey Corridor. These mapping resources generally include, but are not limited to, the United States Geological Survey (USGS) maps (Figure 1. Project Location Map, **Appendix A**), the U.S. Department of Agriculture - Natural Resource Conservation Service (NRCS) soils database (Figure 2. Soil Series Map, **Appendix A**), National Hydrography Dataset (NHD), and the U.S. Fish & Wildlife Service National Wetlands Inventory (NWI) database (Figure 3. National Wetlands Inventory Map, **Appendix A**).

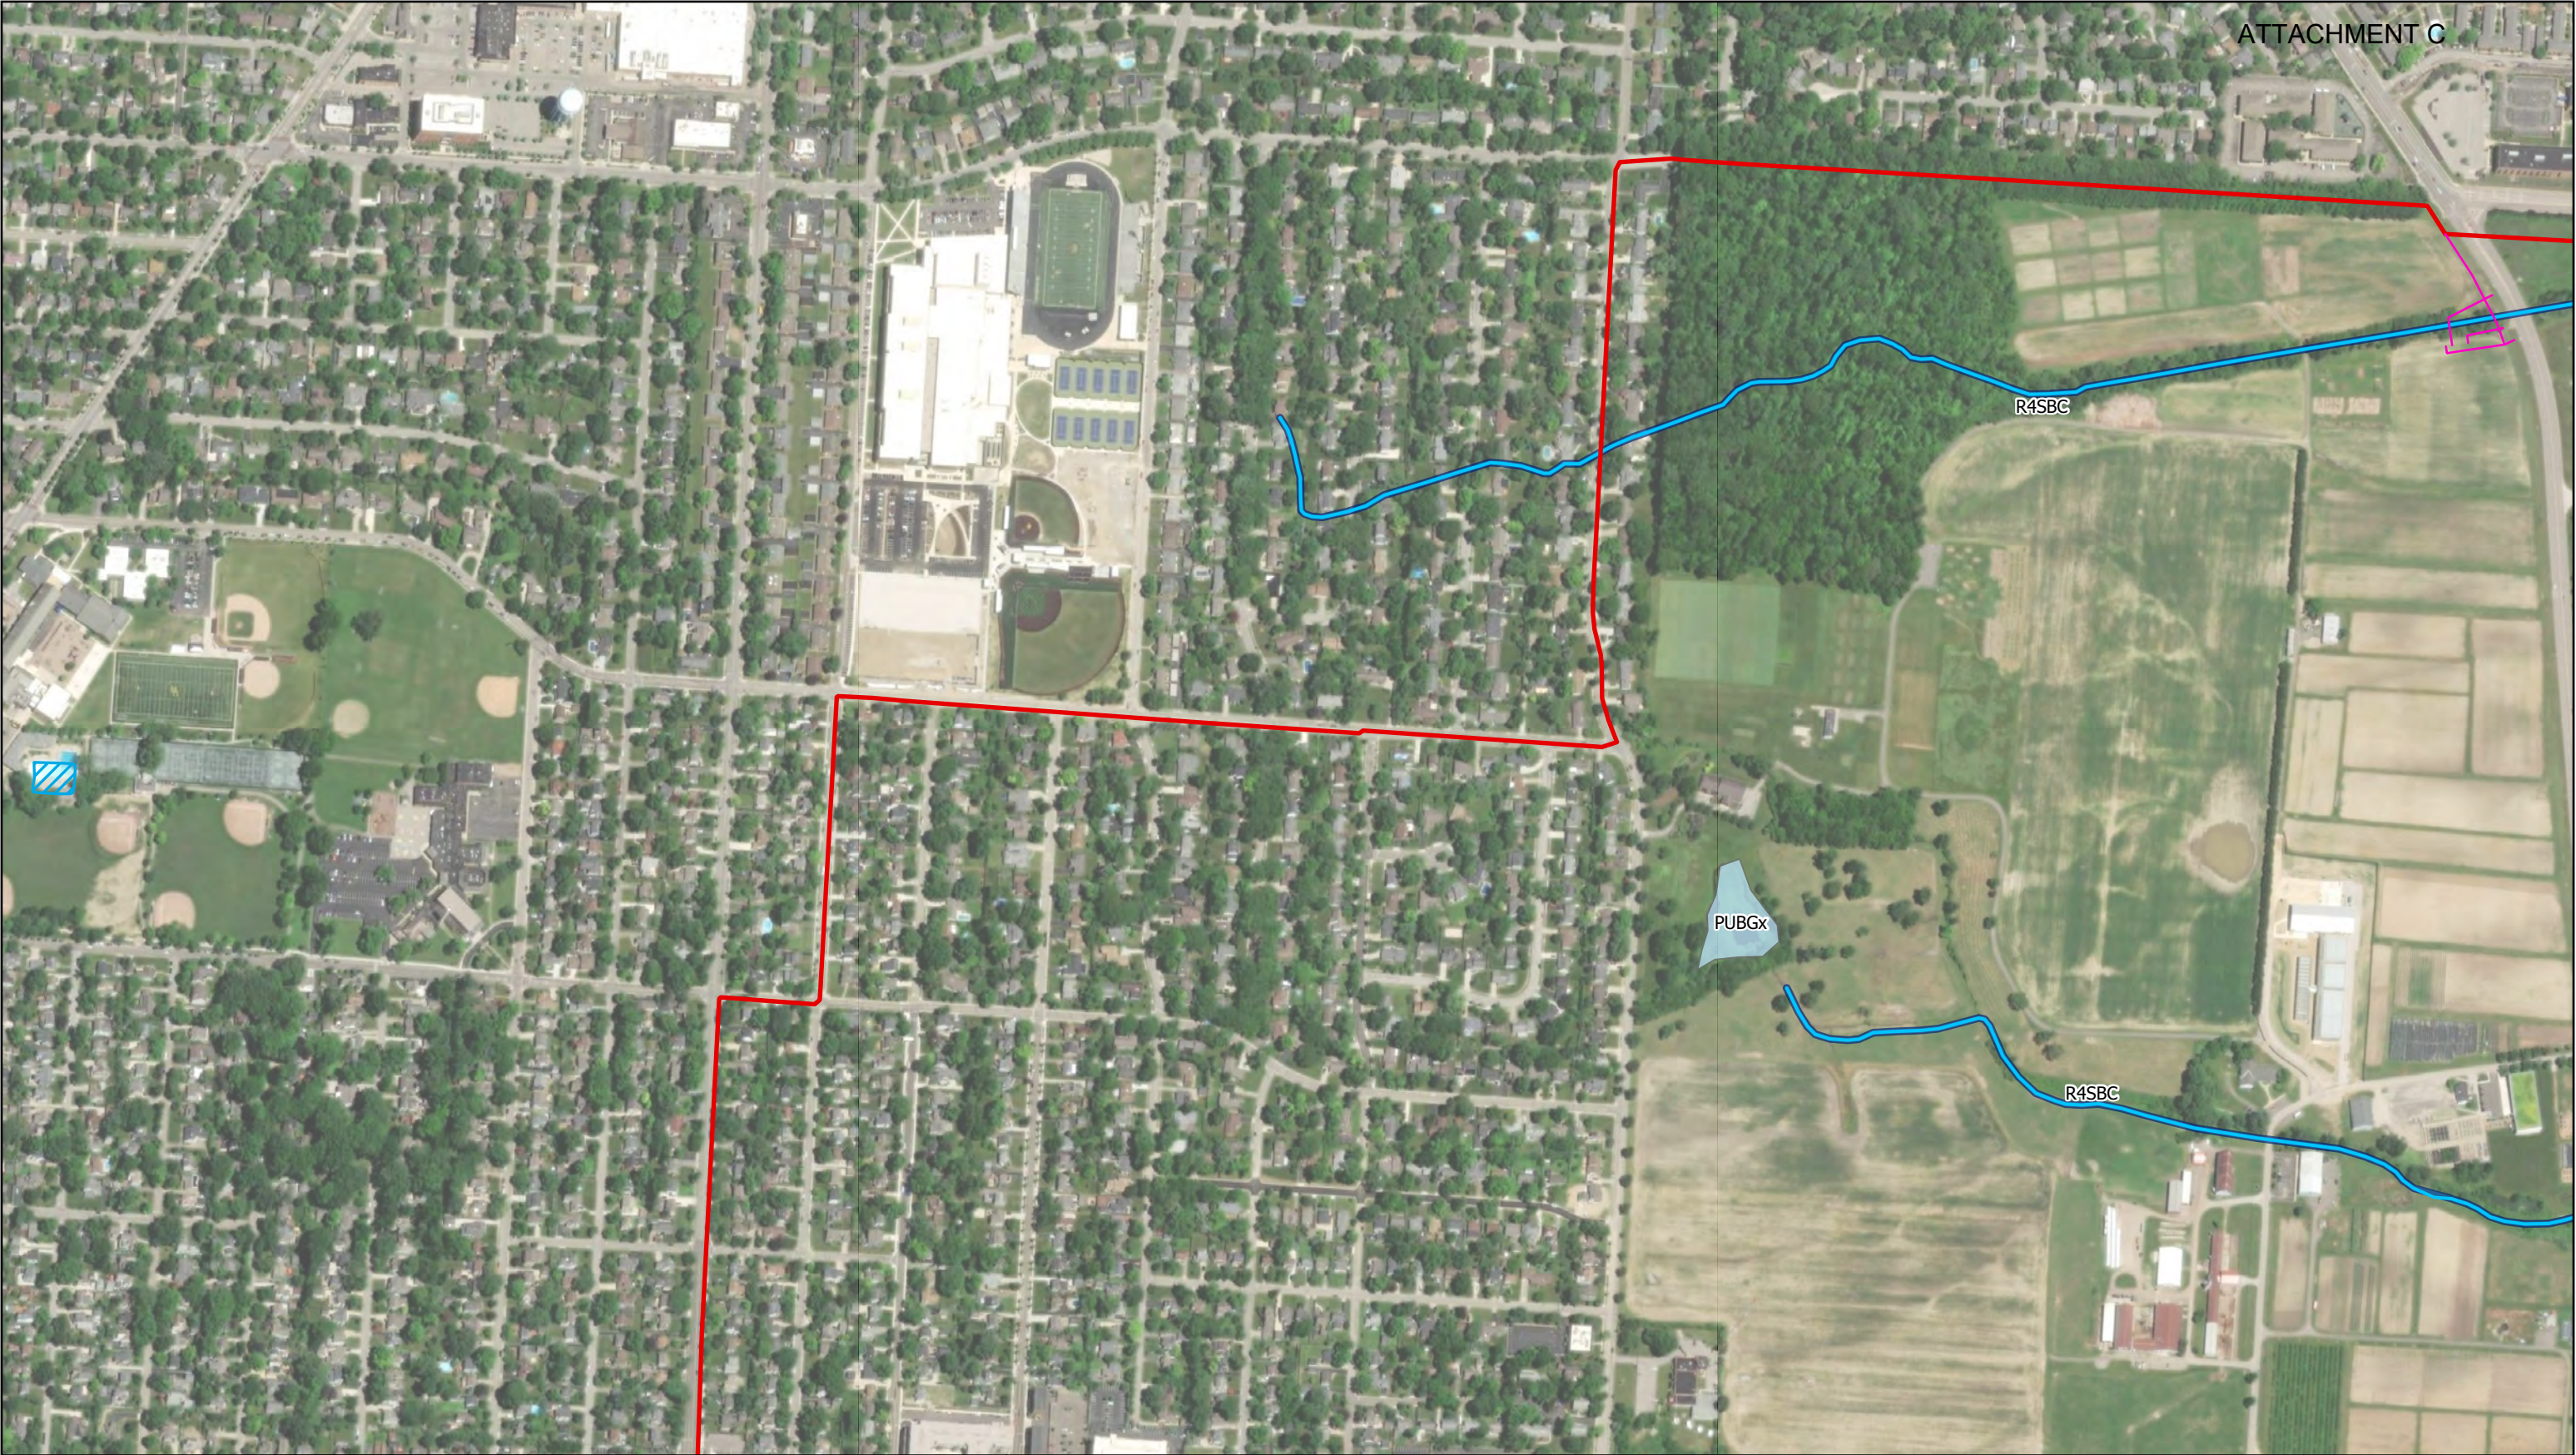
Lateral	Waterbody (NHD)
Main Line	Wetland Type
Stream (NHD)	Freshwater Pond
	Riverine

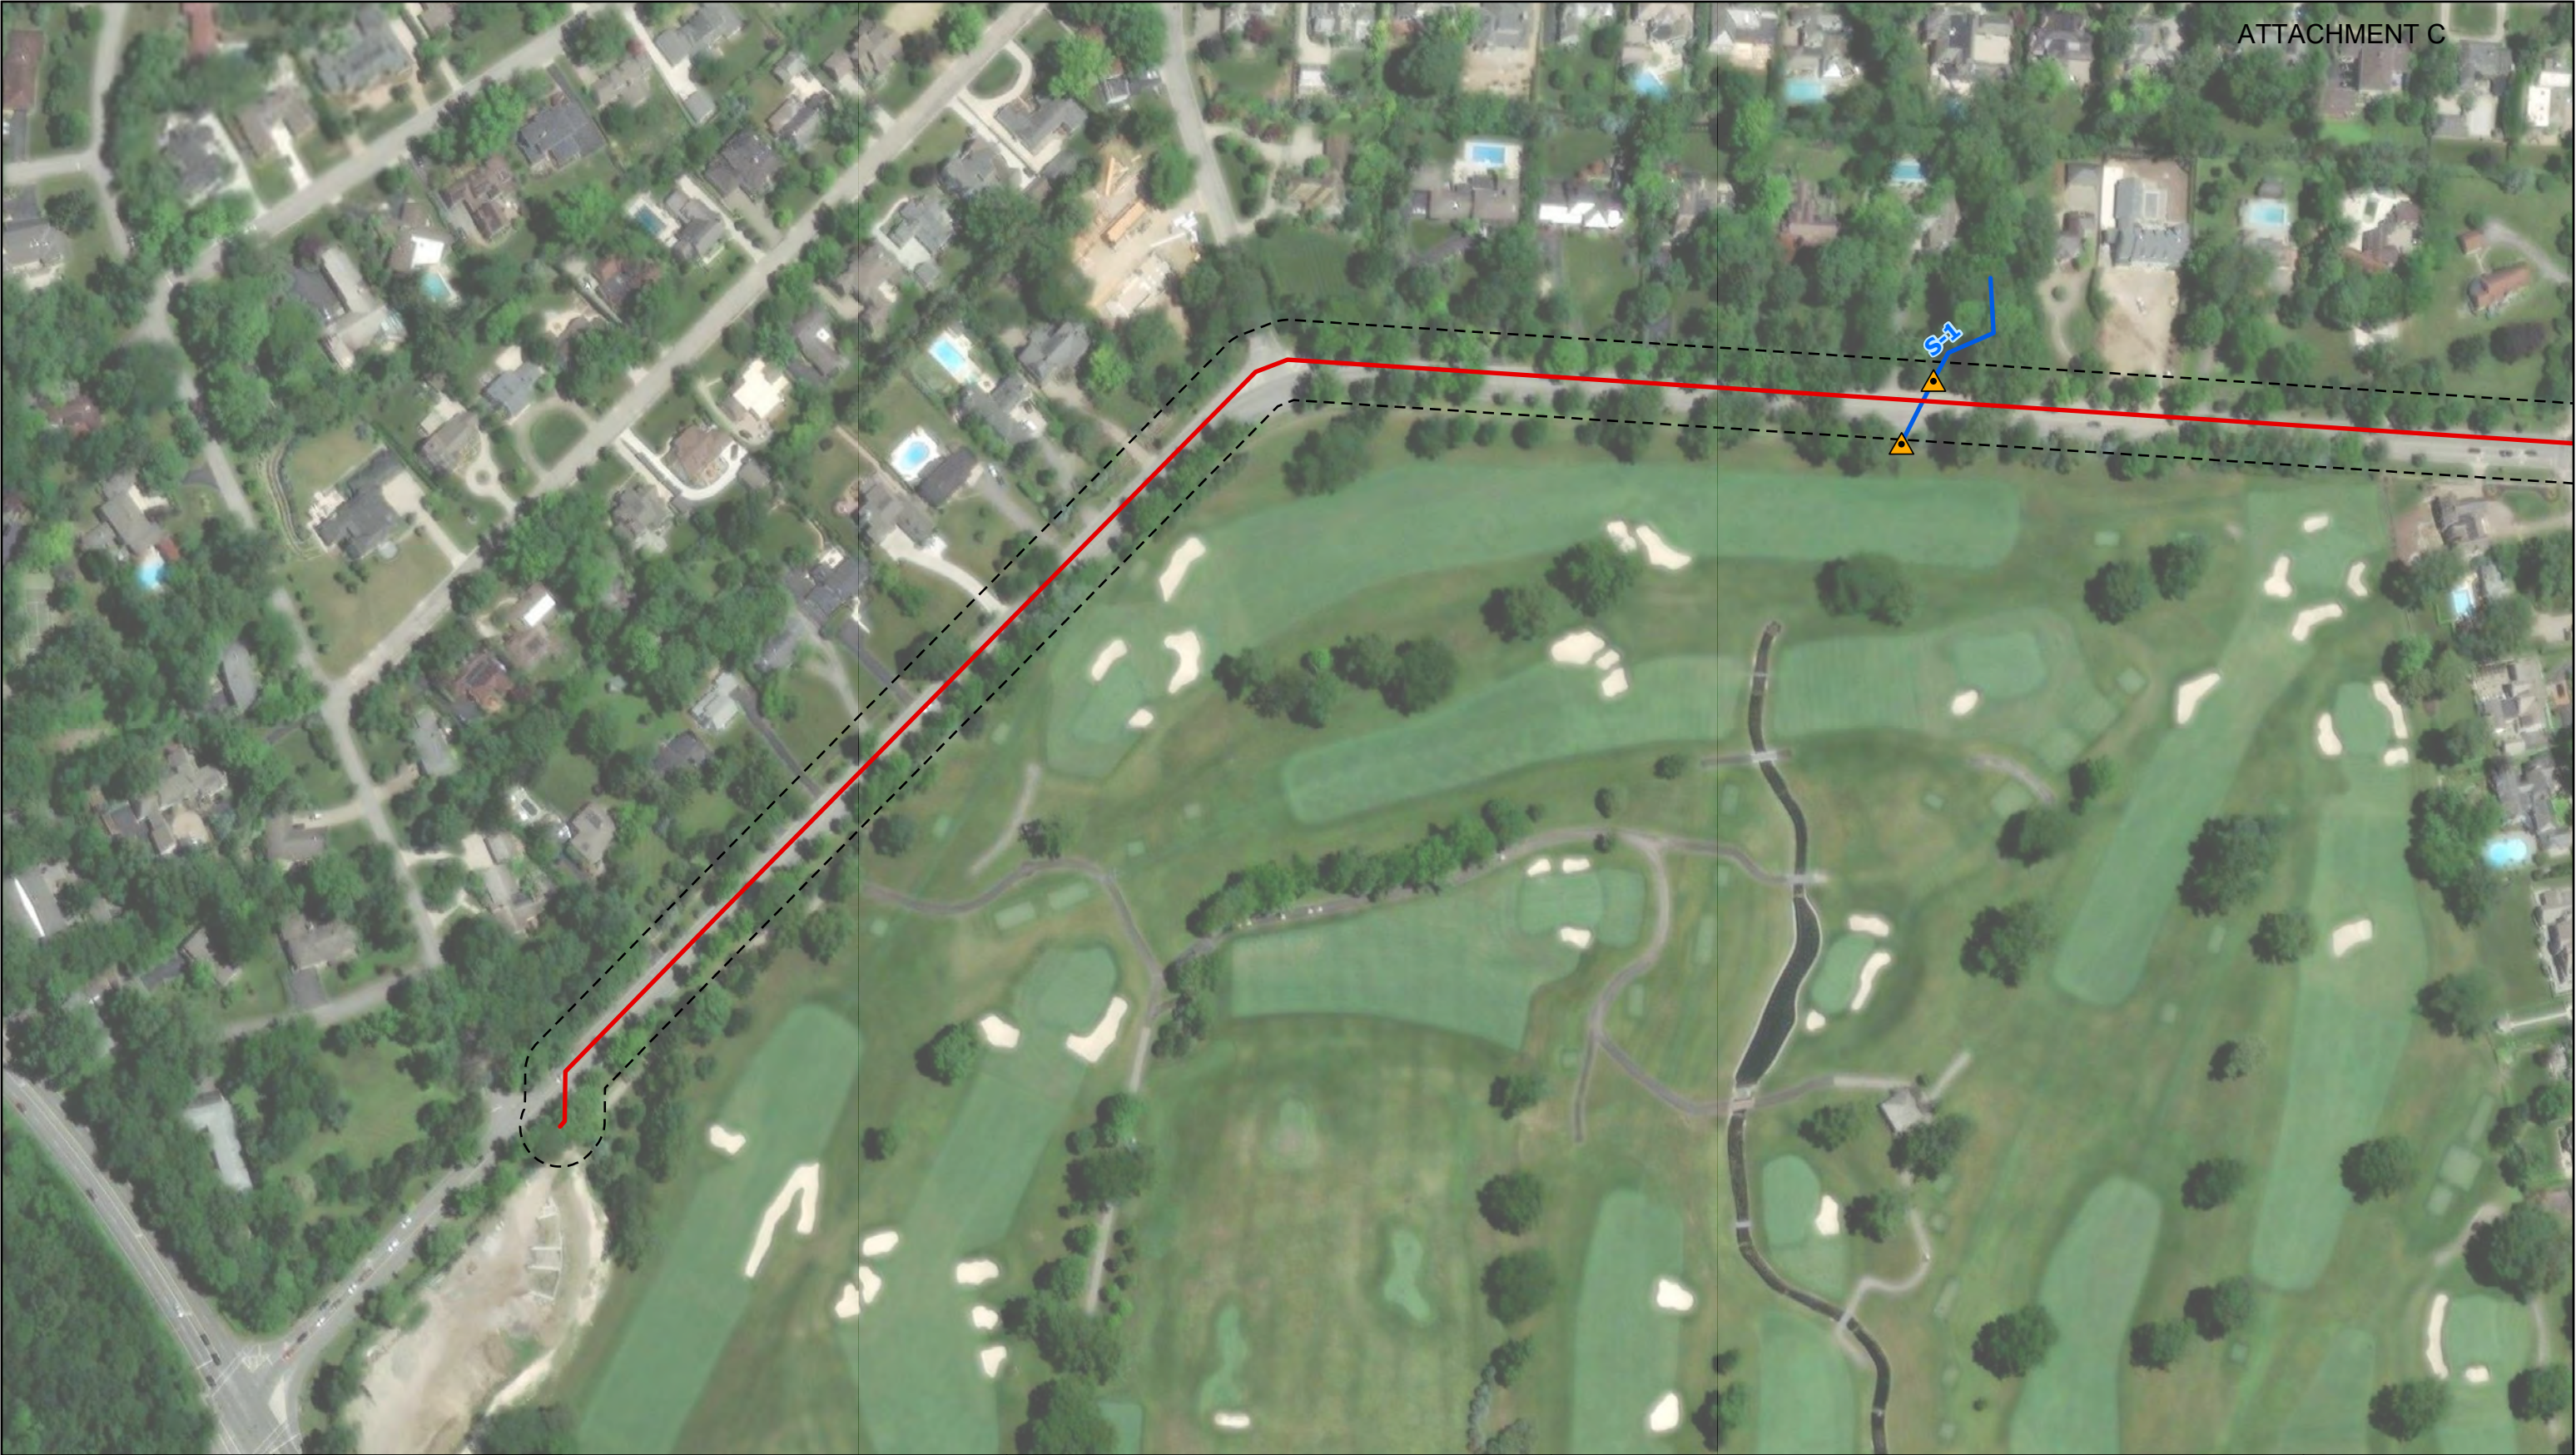
Figure 5 - Delineation Results		
University		
Franklin County, Ohio		
Date:	MC Project #:	Drawn By:
5/25/2023	21004202A	KHY

Based on the field investigations, two (2) stream features and one (1) wetland feature were delineated within the Survey Corridor by CED on March 2nd & 3rd, 2022 and May 19th, 2023. A total of 2,552 linear feet of perennial (R3) stream, 562 linear feet of intermittent (R4), and 0.23 acres of palustrine emergent (PEM) wetland were delineated. It is CED's professional opinion that Stream Features "1" and "2", and the proximal wetland, are considered jurisdictional WOTUS since they drain into Olentangy River and Scioto River. These stream features can be considered jurisdictional WOTUS since they connect and/or are directly connected to Olentangy River and Scioto River. The location and size of jurisdictional areas delineated are shown on Figure 5. Delineation Results (**Appendix A**).

On-site field investigations of the Survey Corridor were conducted by CED on March 2nd & 3rd, 2022 and May 19, 2023. The on-site delineation did verify the presence of surface waters within Survey Corridor. A summary of the aquatic resources identified within the Survey Corridor is provided below in Table 2: Aquatic Resource Summary. The location and size of the aquatic resources delineated are shown on Figure 5. Delineation Results (Appendix A).

Two (2) stream features and one (1) wetland feature were delineated within the Survey Corridor by CED on March 2nd & 3rd, 2022 and May 19th, 2023. A total of 2,552 linear feet of perennial (R3) stream, 562 linear feet of intermittent (R4), and 0.23 acres of palustrine emergent (PEM) wetland were delineated. Field investigations were conducted in accordance with the manuals, methodologies, and regulatory guidance procedures as stated in Section 5.0 Wetland and Surface Water Delineation Methodology.

It is CED's professional opinion that Stream Features "1" and "2" are considered jurisdictional WOTUS since they drain into Olentangy River and Scioto River. The wetland can be considered jurisdictional WOTUS since it drains directly to the unnamed tributary to Olentangy River and Scioto River. The location and size of jurisdictional areas delineated are shown on Figure 5. Delineation Results (**Appendix A**).

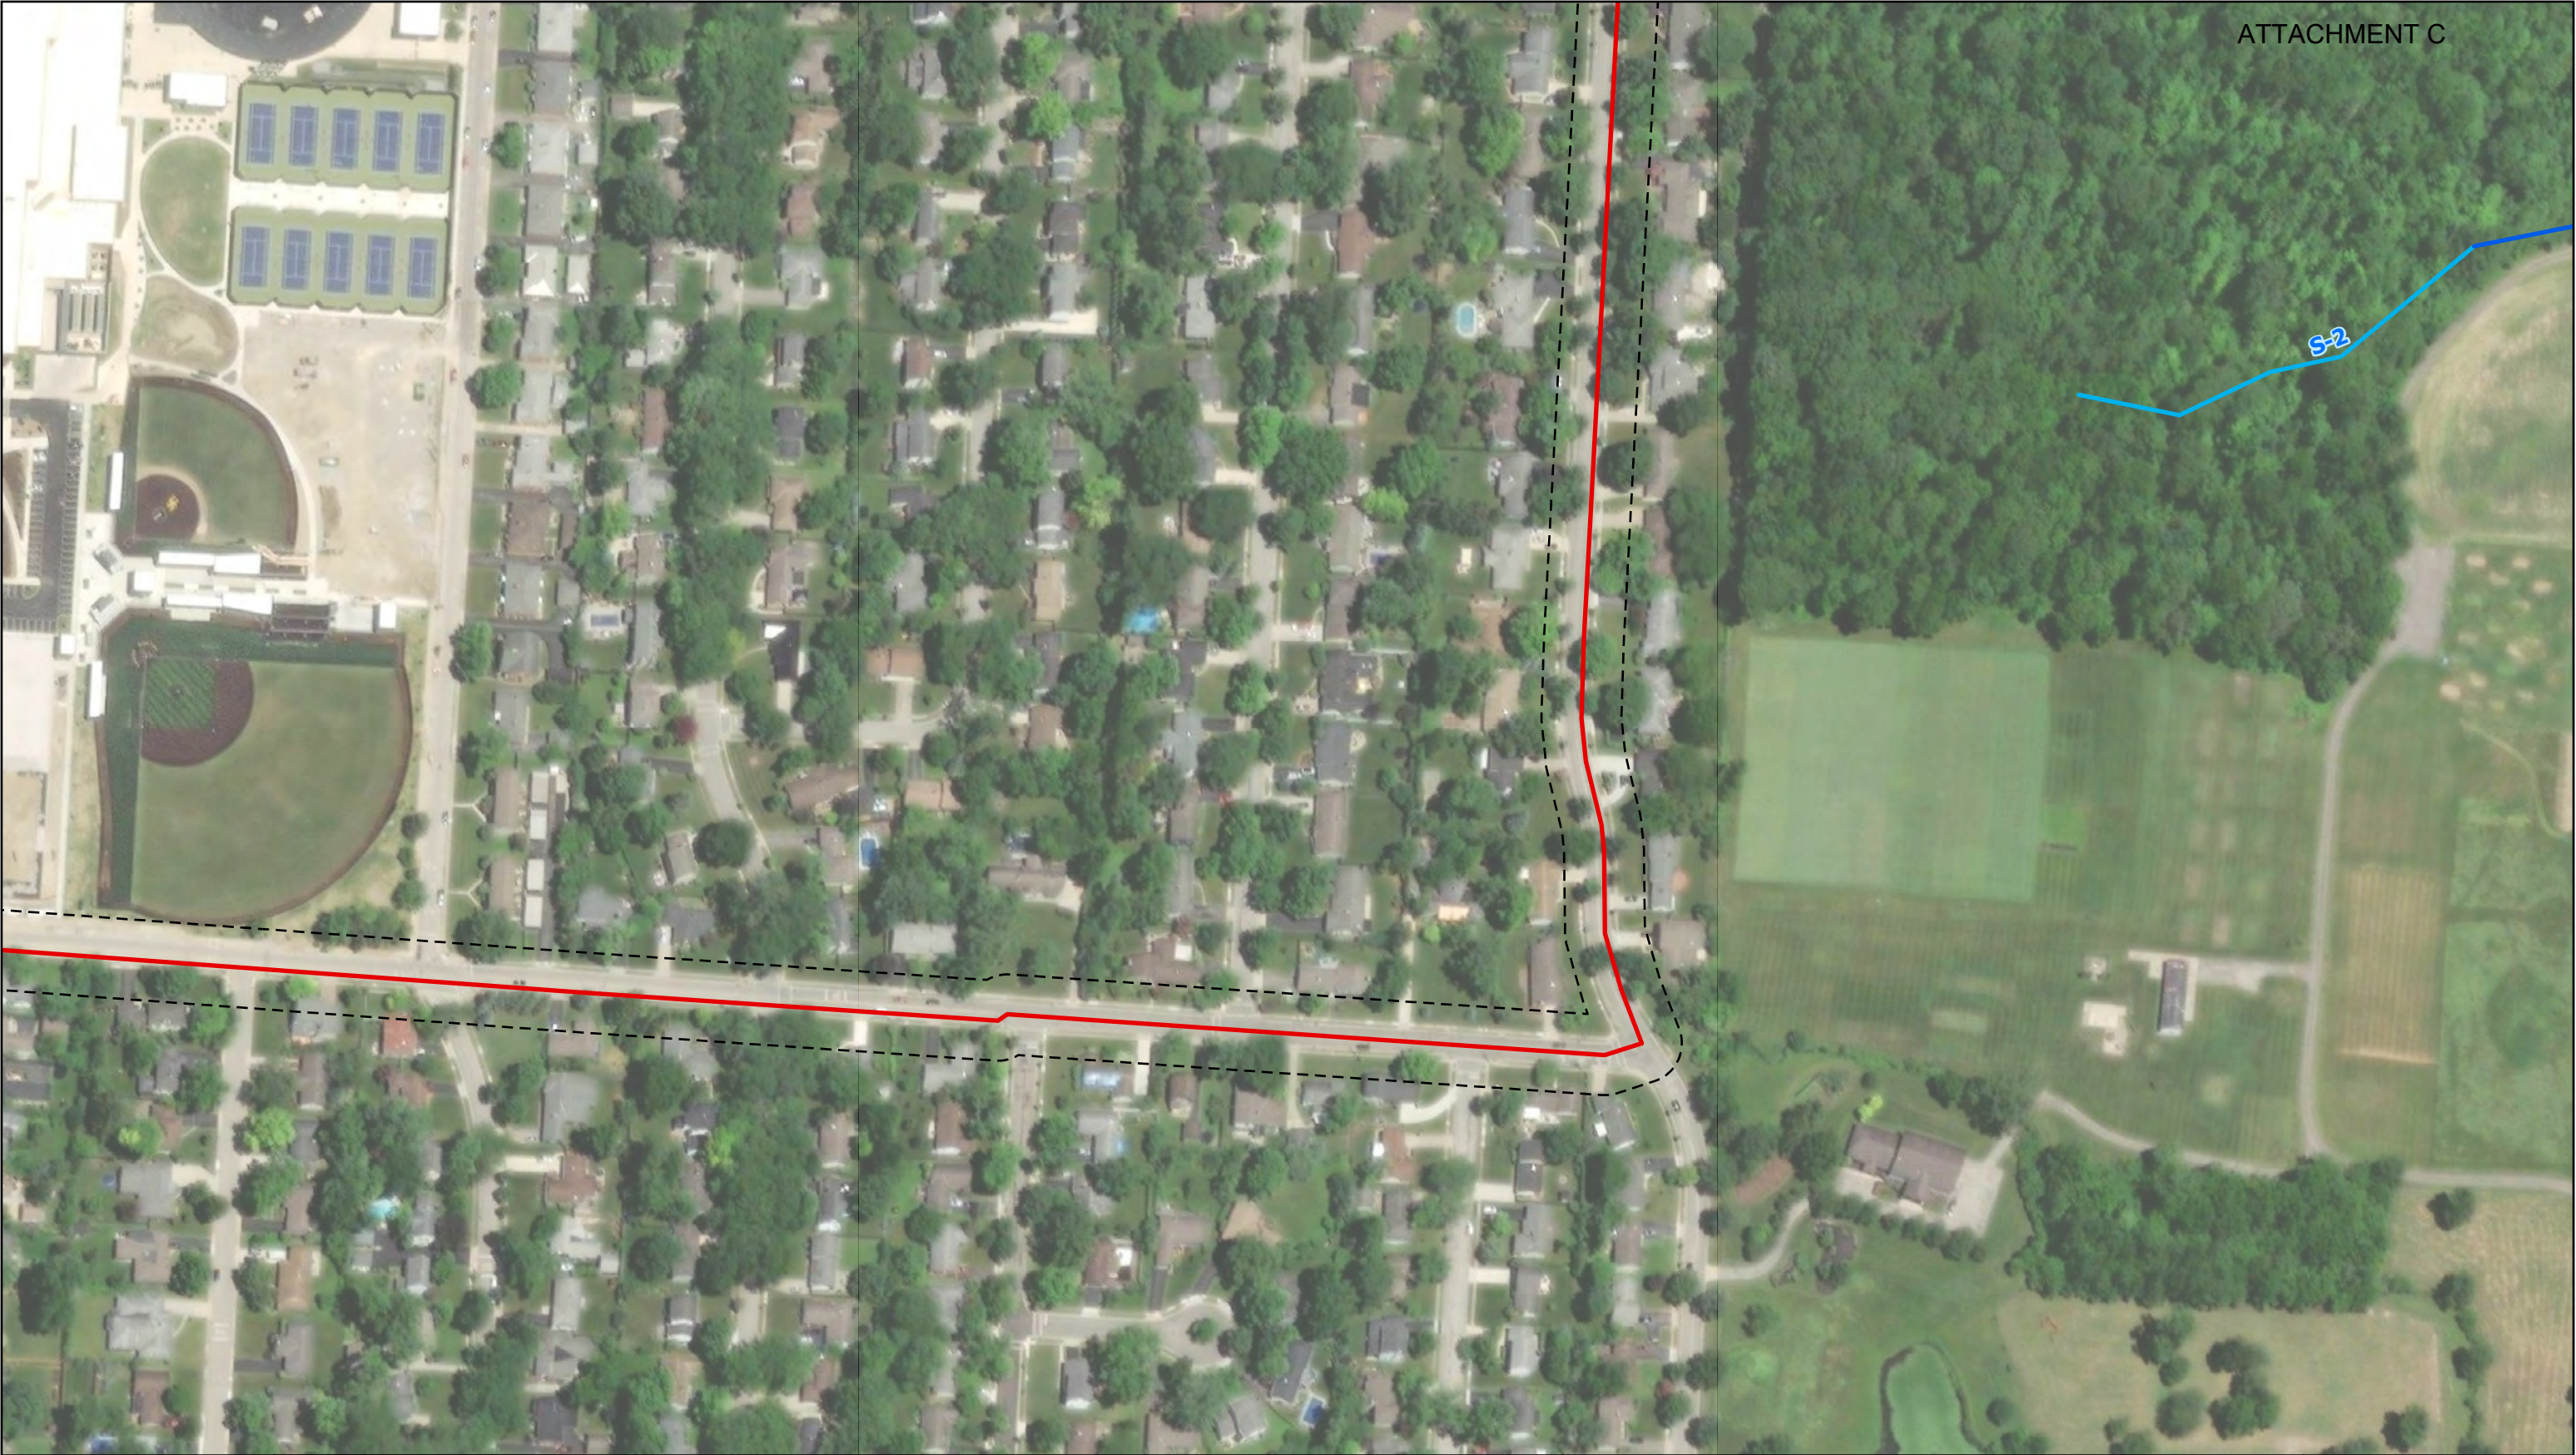
Figure 5 - Delineation Results

- Study Corridor
- Stormwater Erosions
- PEM Wetland
- Lateral
- Main Line

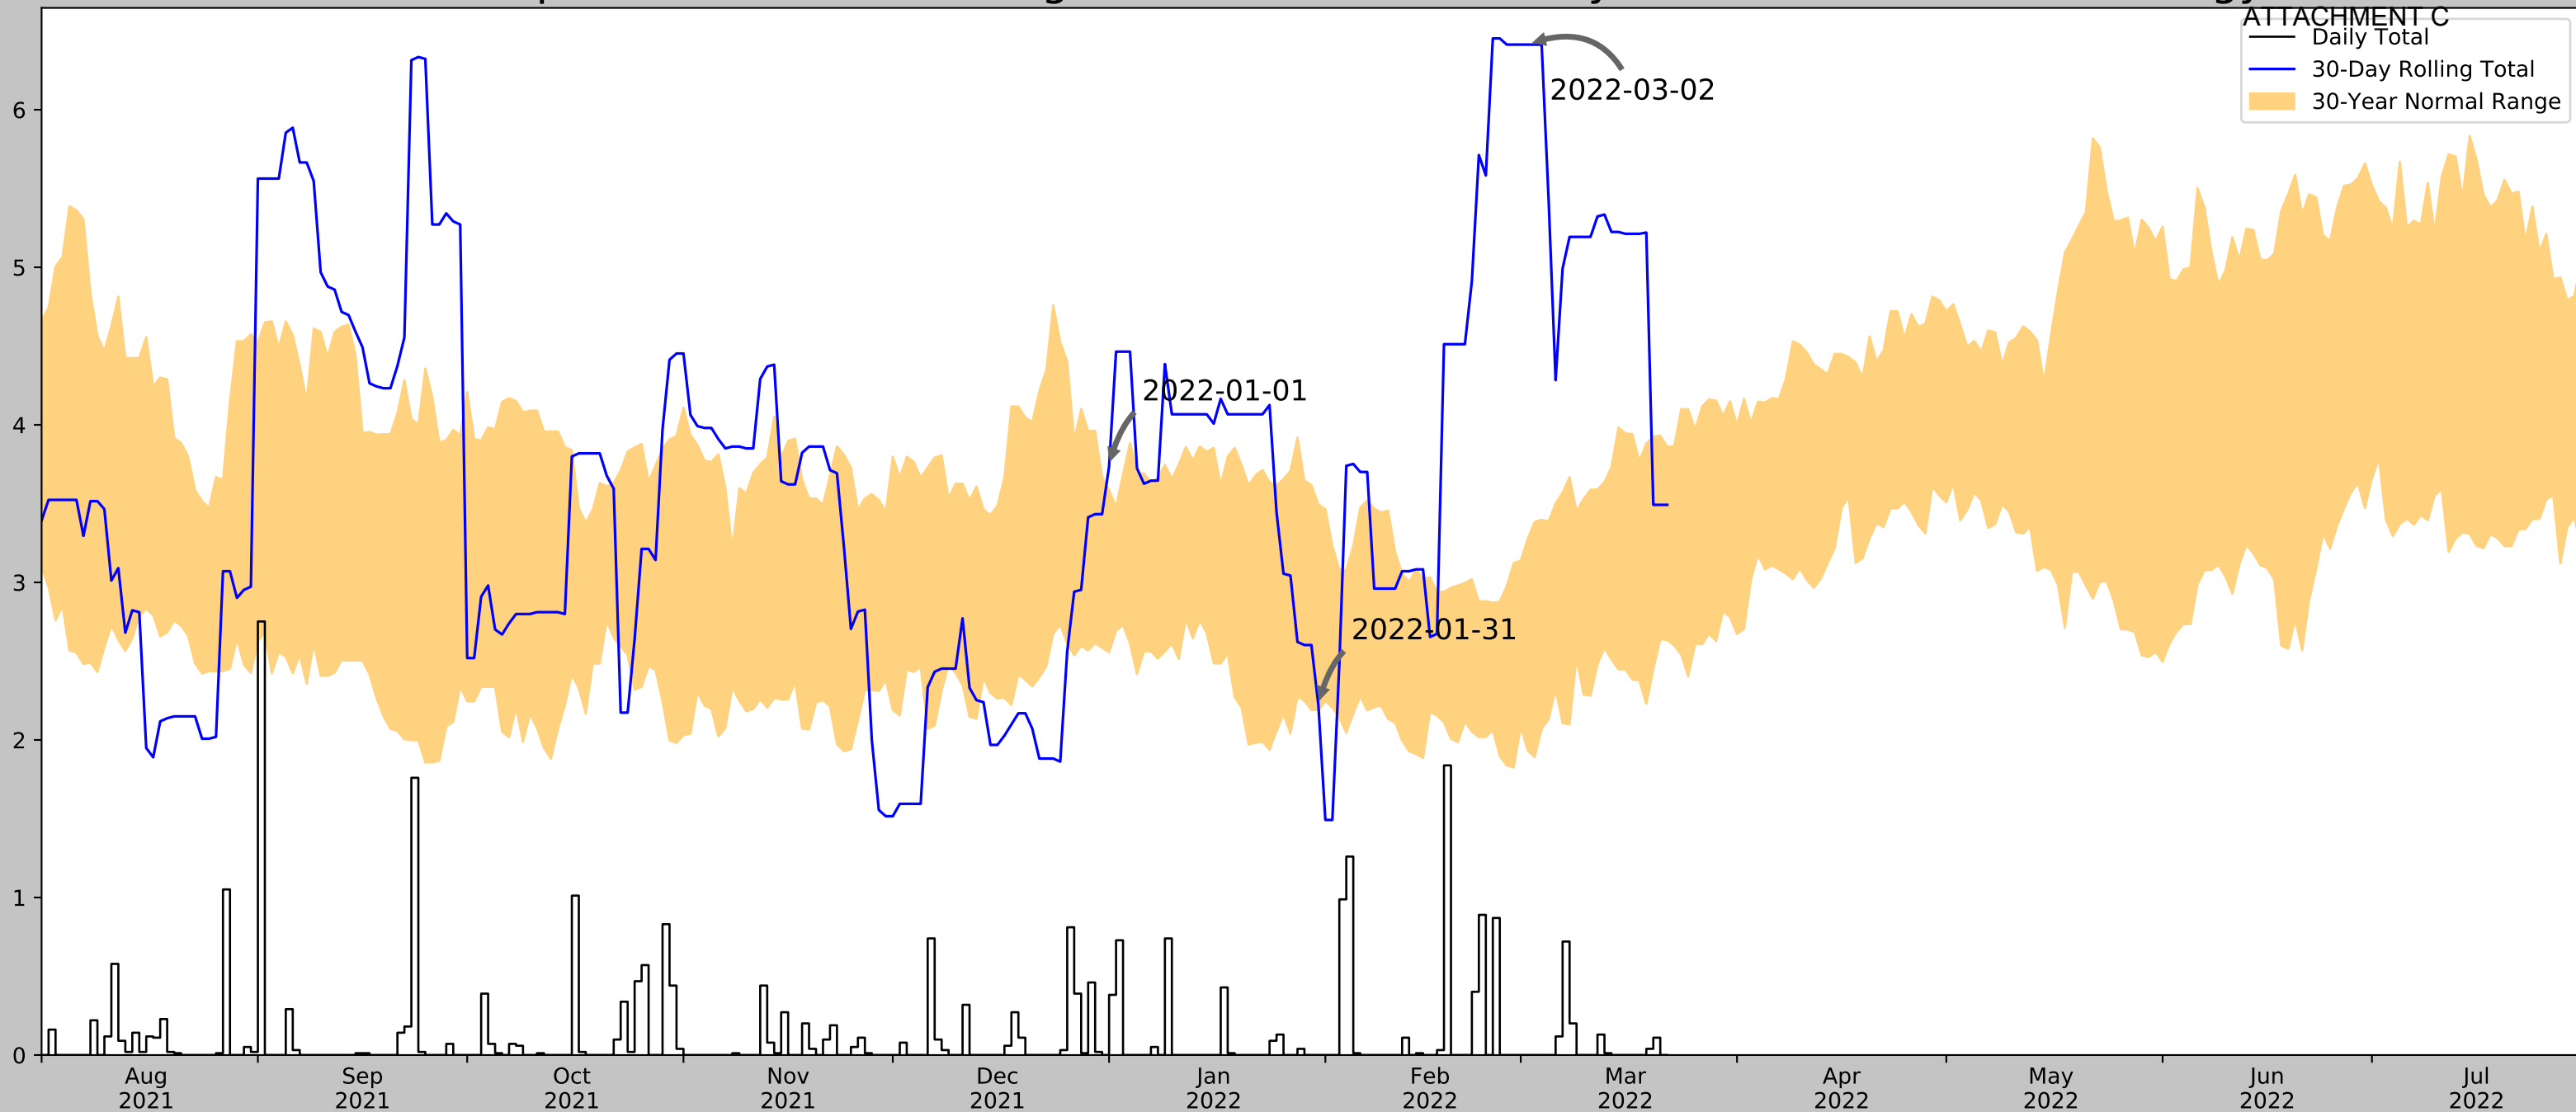
Antecedent Precipitation vs Normal Range based on NOAA's Daily Global Historical Climatology Network

Coordinates	40.011997, -82.572119
Observation Date	2022-03-02
Elevation (ft)	1094.88
Drought Index (PDSI)	Severe wetness (2022-02)
WebWIMP H ₂ O Balance	Wet Season

30 Days Ending	30 th %ile (in)	70 th %ile (in)	Observed (in)	Wetness Condition	Condition Value	Month Weight	Product
2022-03-02	1.933071	3.275197	6.413386	Wet	3	3	9
2022-01-31	2.189764	3.494882	2.220473	Normal	2	2	4
2022-01-01	2.555906	3.585433	3.736221	Wet	3	1	3
Result							Wetter than Normal - 16

On-site field investigations of the Survey Corridor were conducted by CED on March 2nd & 3rd, 2022 and May 19, 2023. The USACE Antecedent Precipitation Tool (APT) was utilized for the Survey Corridor and is provided in **Appendix C**. Based the USACE APT tool, the on-site field investigations were conducted in "Wetter than Normal" precipitation conditions with a 30-day rolling total during the March 2nd & 3rd, 2022 investigations. The on-site field investigations were conducted in "Drier than Normal" precipitation conditions for the May 19th, 2023 investigation.
