Wetland Delineation Report

University Project

Colliers Engineering & Design Project Number: 21004202A

May 22, 2023

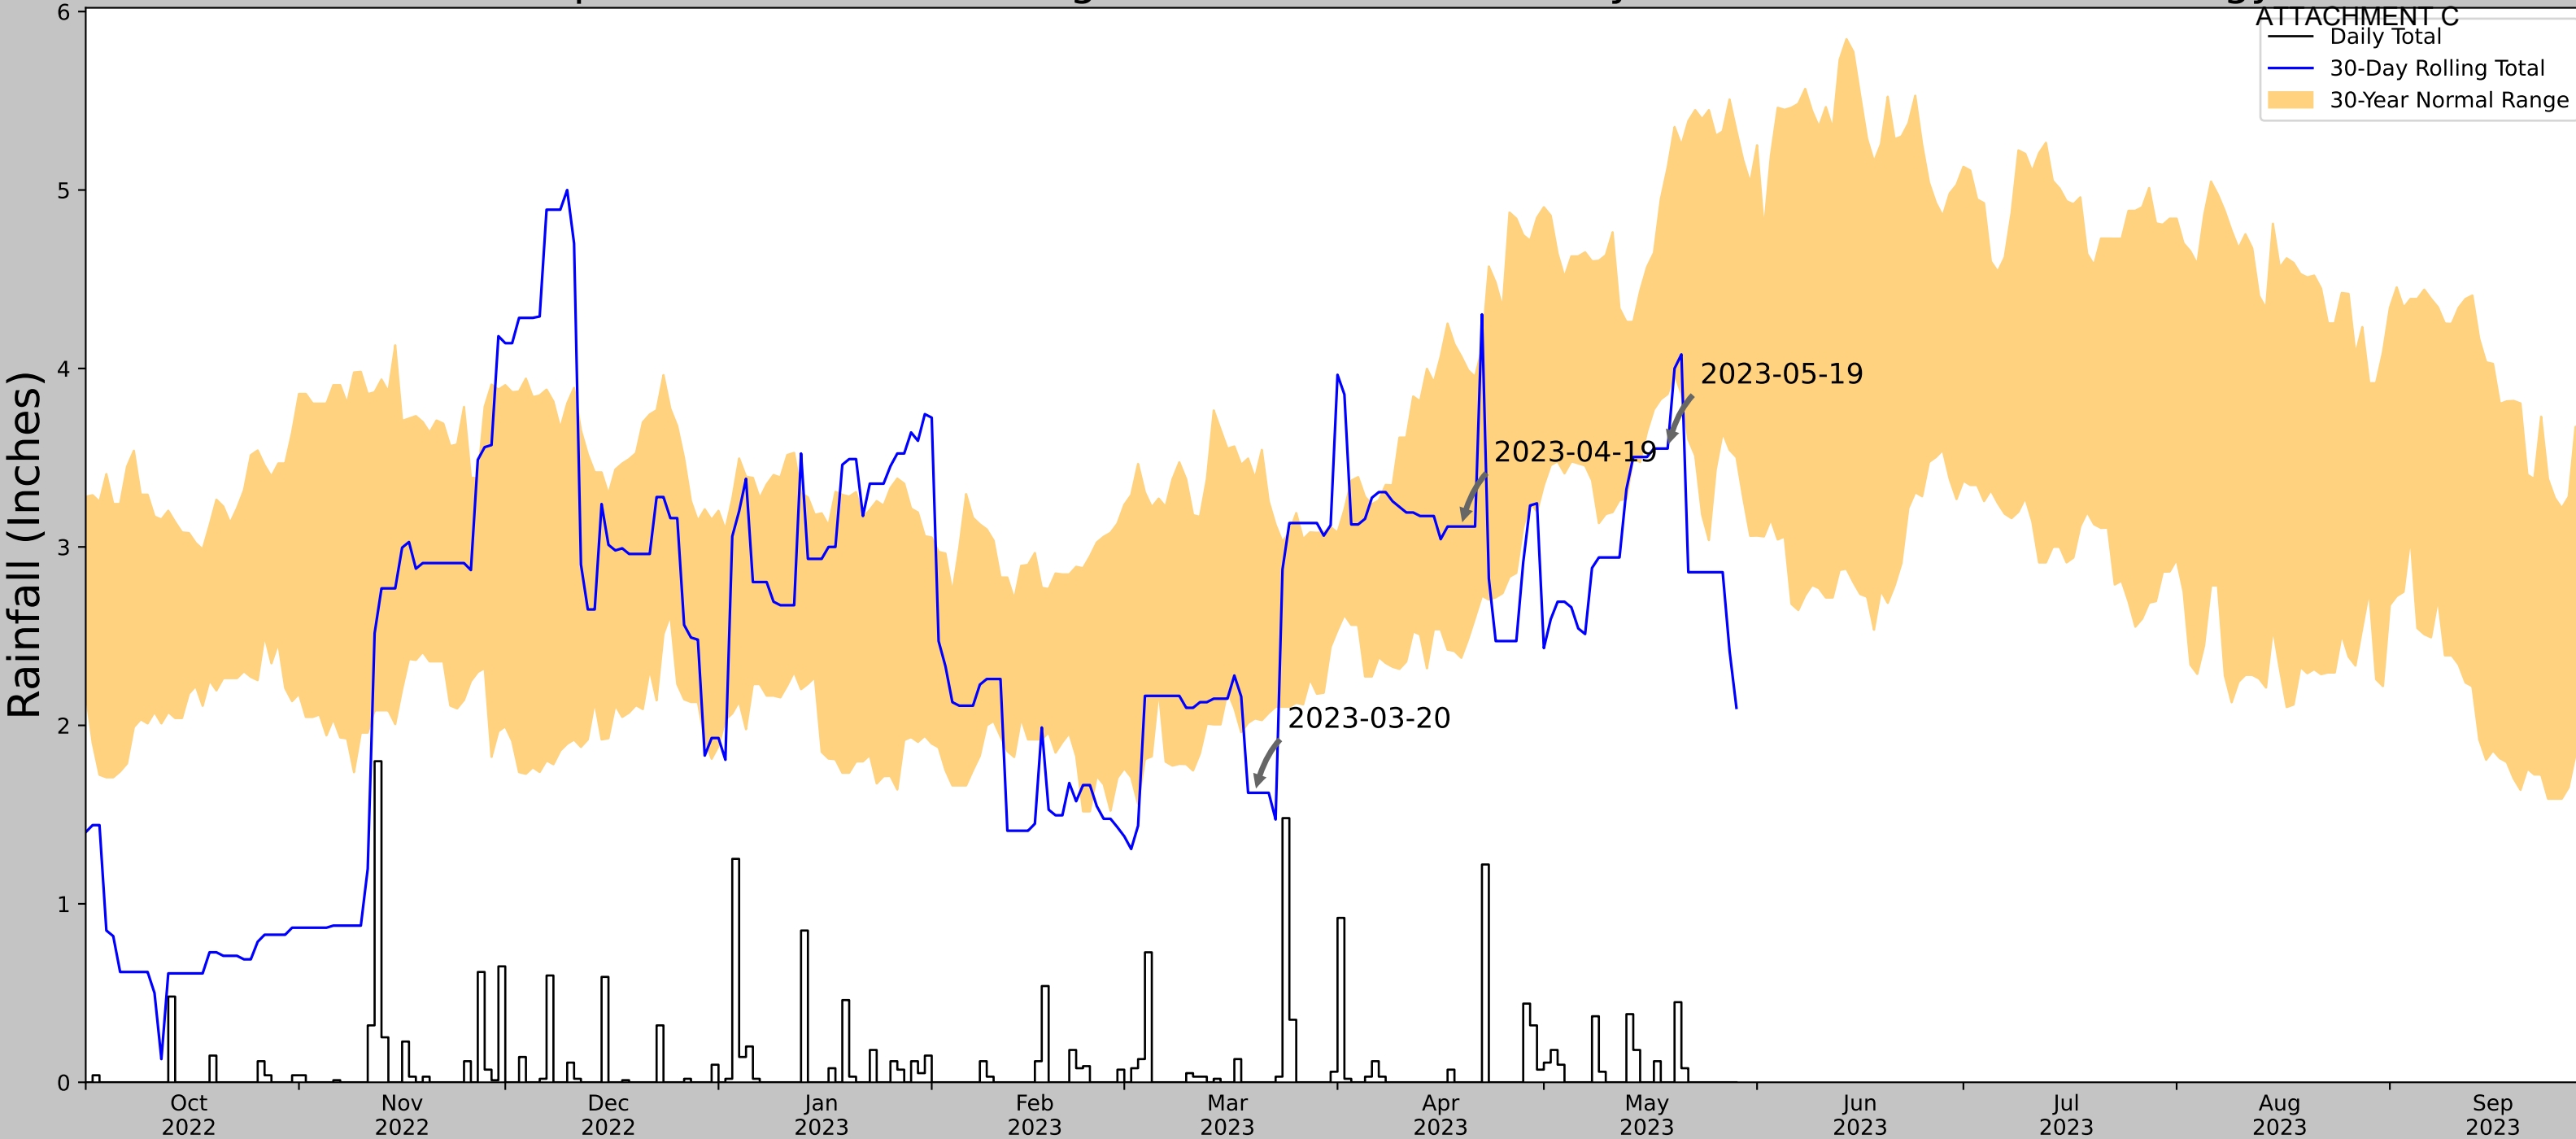
Antecedent Precipitation vs Normal Range based on NOAA's Daily Global Historical Climatology Network

Coordinates	40.021777, -82.950994
Observation Date	2023-05-19
Elevation (ft)	834.369
Drought Index (PDSI)	Mild wetness (2023-04)
WebWIMP H ₂ O Balance	Wet Season

30 Days Ending	30 th %ile (in)	70 th %ile (in)	Observed (in)	Wetness Condition	Condition Value	Month Weight	Product
2023-05-19	3.856299	5.127953	3.551181	Dry	1	3	3
2023-04-19	2.378347	4.067717	3.114173	Normal	2	2	4
2023-03-20	2.038583	3.383858	1.622047	Dry	1	1	1
Result							Drier than Normal - 8

On-site field investigations of the Survey Corridor were conducted by CED on March 2nd & 3rd, 2022 and May 19, 2023. The USACE Antecedent Precipitation Tool (APT) was utilized for the Survey Corridor and is provided in **Appendix C**. Based the USACE APT tool, the on-site field investigations were conducted in "Wetter than Normal" precipitation conditions with a 30-day rolling total during the March 2nd & 3rd, 2022 investigations. The on-site field investigations were conducted in "Drier than Normal" precipitation conditions for the May 19th, 2023 investigation.
