Wetland Delineation Report

University Project

Colliers Engineering & Design Project Number: 21004202A

May 22, 2023

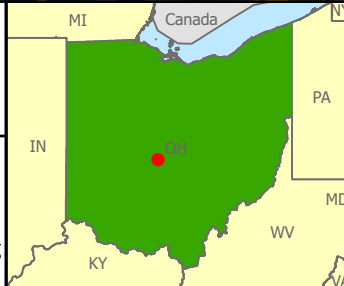
Figure 2 - Soil Series Map

Source: USDA NRCS SSURGO

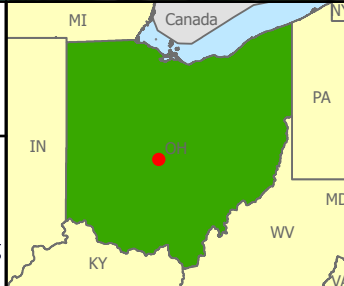
Figure 4 - Floodplain Series Map

Source: FEMA, USGS NHD

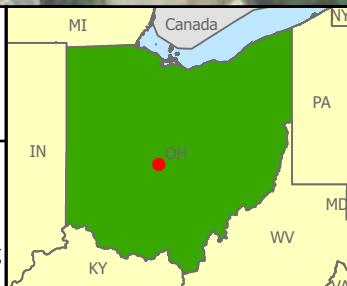
Figure 5 - Delineation Results

Source: Colliers Engineering & Design

The Project Study Area is comprised of a 100-foot wide survey corridor centered on the proposed pipeline alignment for 3.7 miles. The Project Study Area or "Survey Corridor" includes the proposed installation of 3.7 miles of 20-inch pipeline. The Survey Corridor was investigated to identify potential jurisdictional Waters of the U.S. (WOTUS) and wetlands subject to Federal or State regulatory jurisdiction. The delineation methodologies developed by the USACE and the USEPA, as described in the *1987 Corps of Engineers Wetlands Delineation Manual, Technical Report Y-87-1* and the *Regional Supplement to the Corps of Engineers Wetland Delineation Manual: Midwest Region (Version 2.0)* and the subsequently issued USACE regulatory guidance regarding the identification of jurisdictional stream channels through the recognition of field indicators of an ordinary high-water mark within drainage features (Environmental Laboratory, 1987; USACE 2012; USACE 2005) were utilized during our investigation. The location and size of jurisdictional areas delineated are shown on the attached Figure 5. Delineation Results (**Appendix A**).

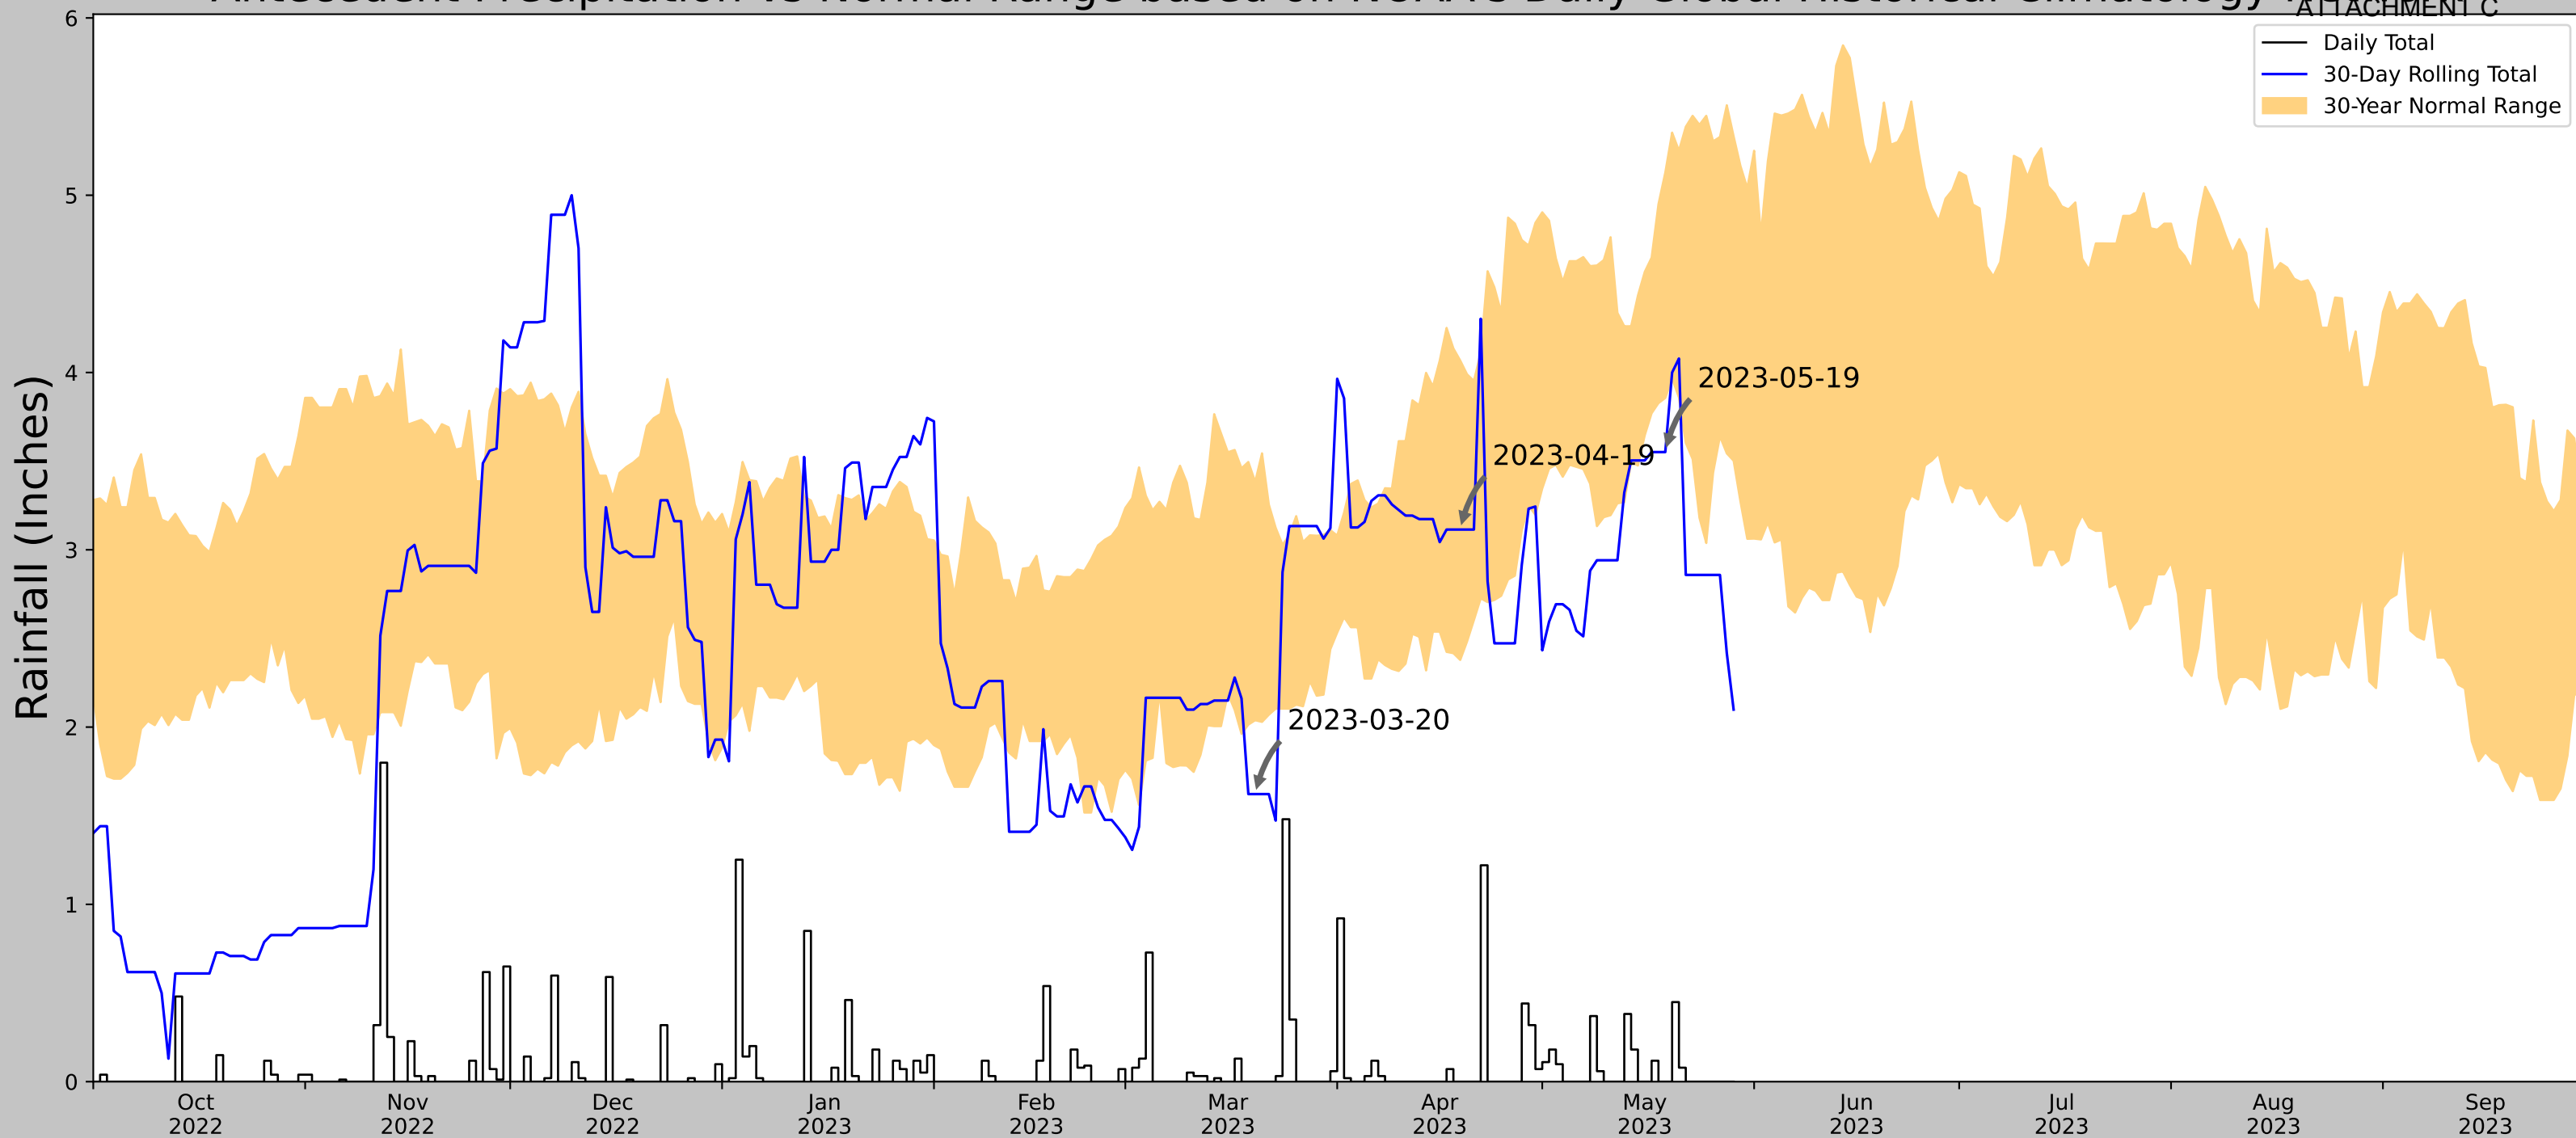
Coordinates	40.021777, -82.950994
Observation Date	2023-05-19
Elevation (ft)	834.369
Drought Index (PDSI)	Mild wetness (2023-04)
WebWIMP H ₂ O Balance	Wet Season

30 Days Ending	30 th %ile (in)	70 th %ile (in)	Observed (in)	Wetness Condition	Condition Value	Month Weight	Product
2023-05-19	3.856299	5.127953	3.551181	Dry	1	3	3
2023-04-19	2.378347	4.067717	3.114173	Normal	2	2	4
2023-03-20	2.038583	3.383858	1.622047	Dry	1	1	1
Result							Drier than Normal - 8

On-site field investigations of the Survey Corridor were conducted by CED on March 2nd & 3rd, 2022 and May 19, 2023. The USACE Antecedent Precipitation Tool (APT) was utilized for the Survey Corridor and is provided in **Appendix C**. Based the USACE APT tool, the on-site field investigations were conducted in "Wetter than Normal" precipitation conditions with a 30-day rolling total during the March 2nd & 3rd, 2022 investigations. The on-site field investigations were conducted in "Drier than Normal" precipitation conditions for the May 19th, 2023 investigation.
